Sash Window & Fabric Upgrade
Harbour Masters Lodge
Dun Laoghaire
Co Dublin

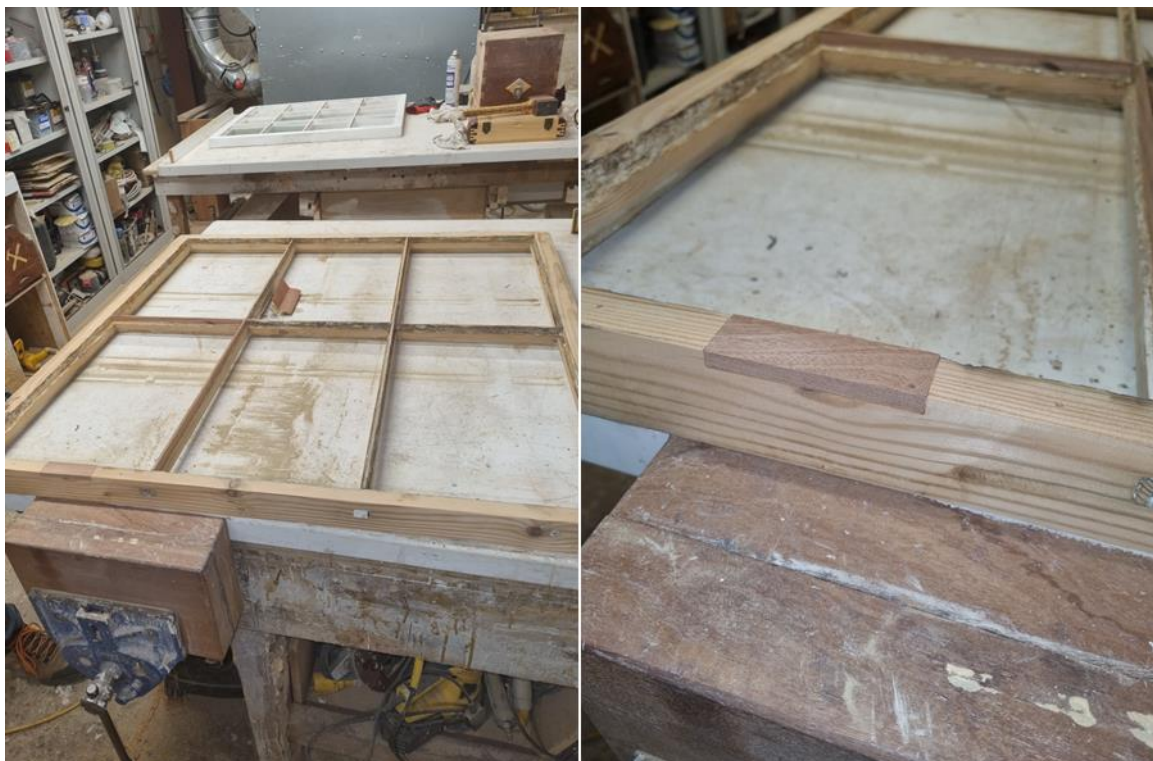
- If the glazing bars or frames are rotting or damaged these will be replaced with Mahogany timber.

Figure 4 Frame & glazing bars repaired with Mahogany

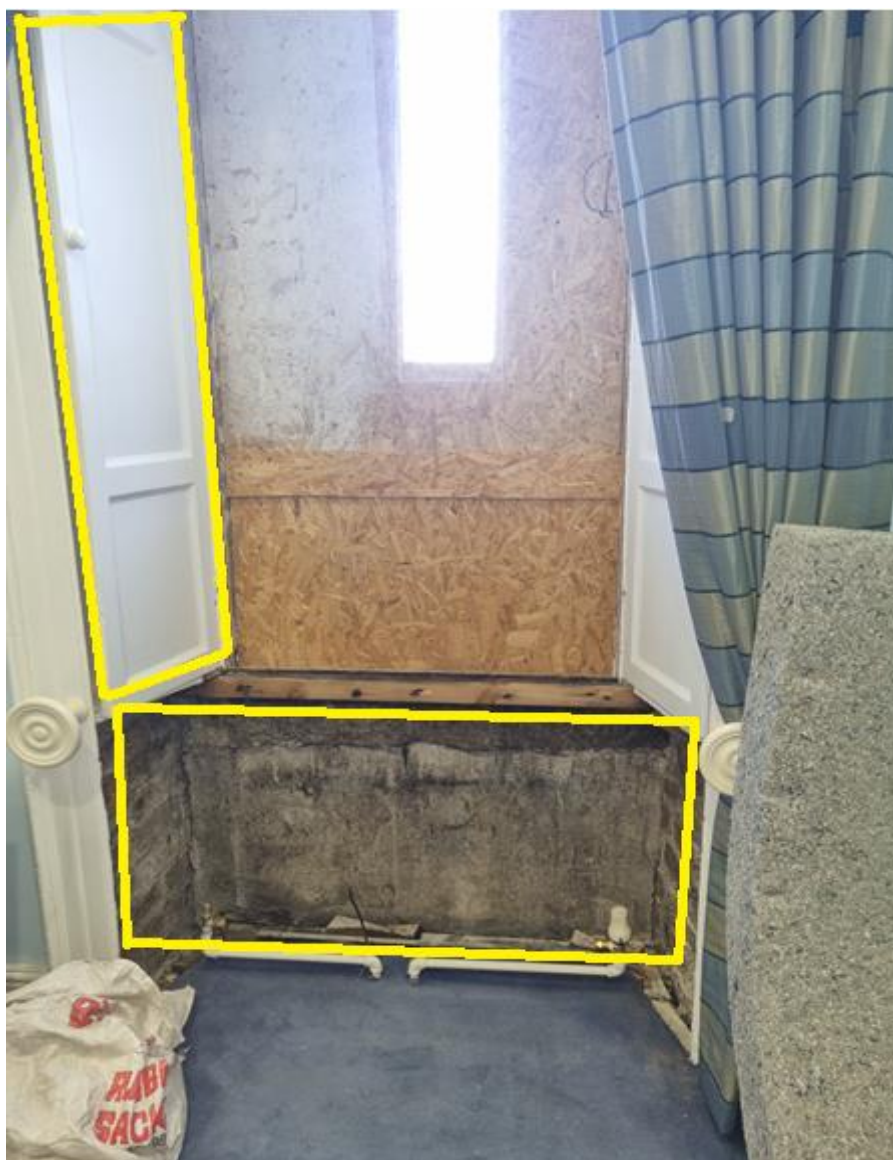
- Voids behind radiators – varying depths
- Voids behind shutter boxes – varying depths
- Voids at the heads of bay windows – unknown depths

Figure 9 Void behind radiator exposed & behind shutter box marked in yellow

It is proposed to insulate behind various voids around the bay window areas as this will further reduce the current u-values and increase the efficiency and comfort of the protected structure.

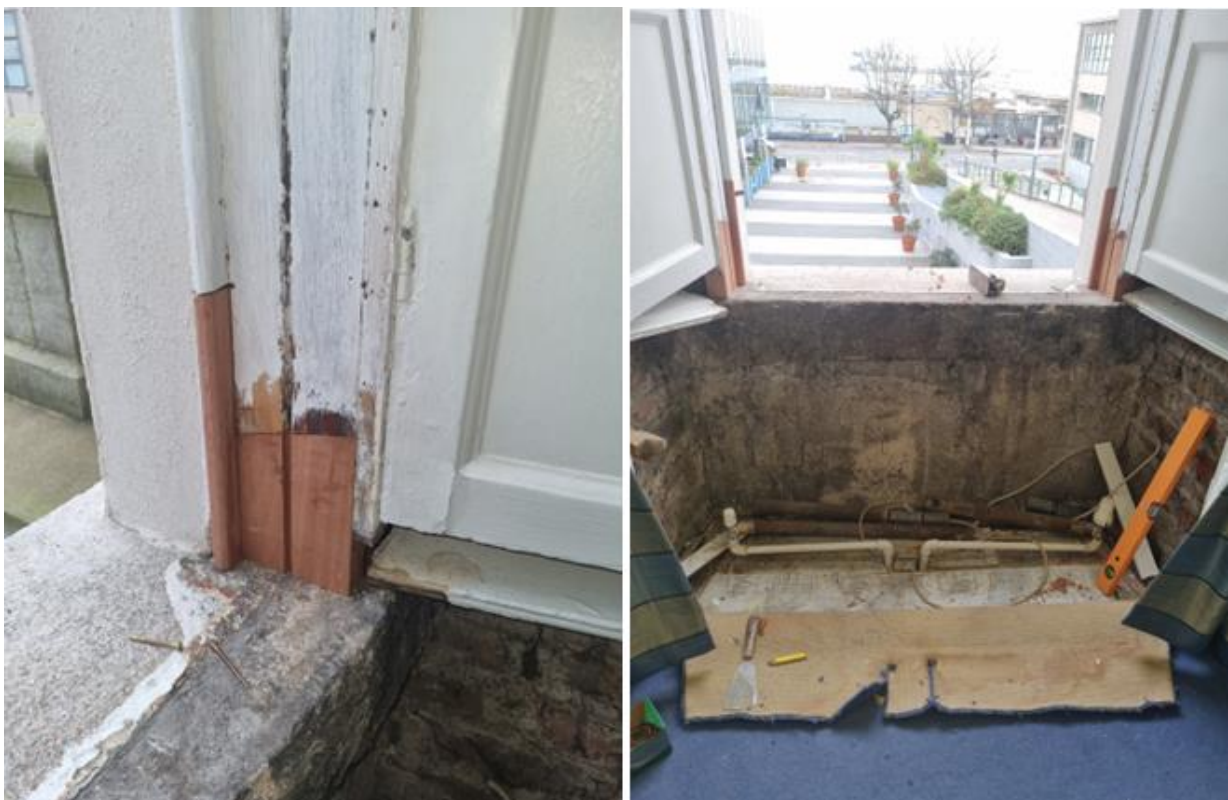
All sash windows removed from the boardroom and brought to Maclyn's workshop for repairs and refurbishment. The secondary glazing will be manufactured at the same time. The radiators have been removed and all panelling behind and to the sides of radiators exposed for inspection of the voids. Masonry was found to be in good condition and dry. However, there are varying depths in voids, this will have an impact on the thickness of insulation to be installed with slightly differing u-values. The bottoms of existing window frames were found to be rotten; these have been repaired with mahogany seen in the image below.

Figure 10 Bottoms of all window frames rotting and repaired with Mahogany

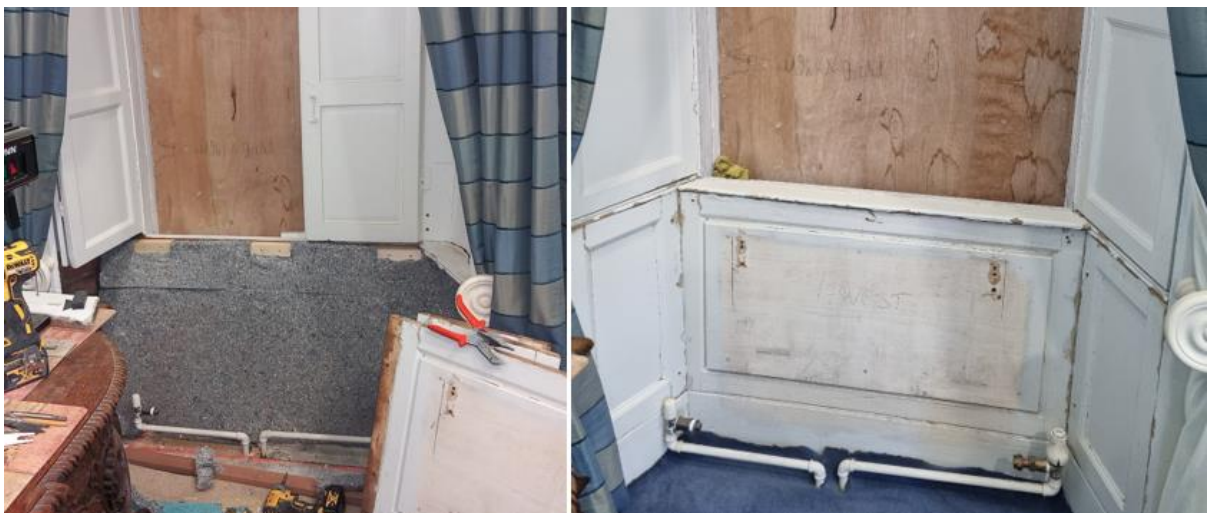
Figure 12 Boardroom window 1 west insulated with 50mm Pavacell & panel reinstalled

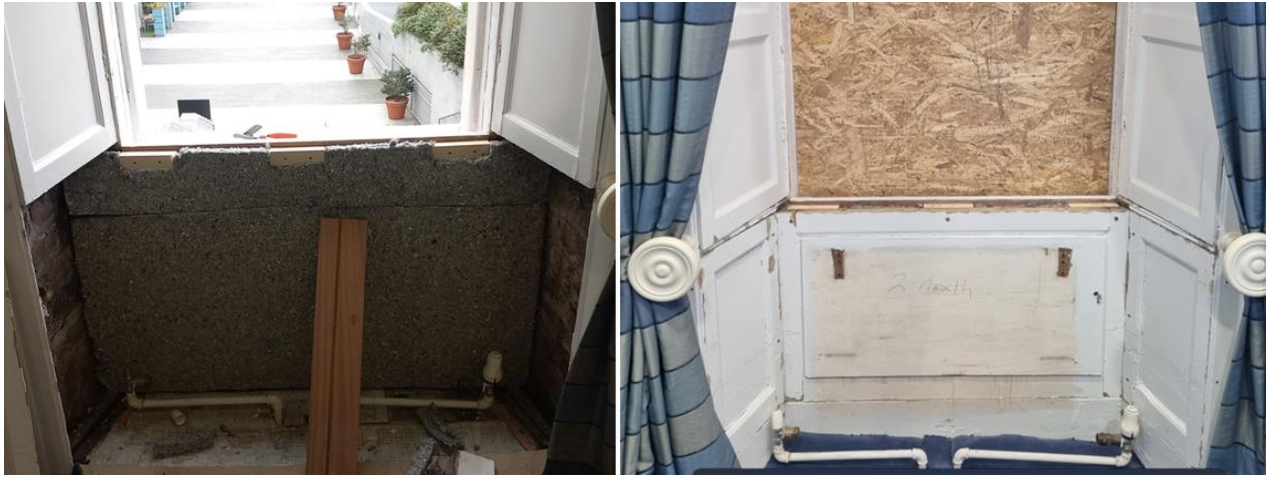
Figure 13 Boardroom window 2 north insulated with 70mm Pavacell & panel reinstalled

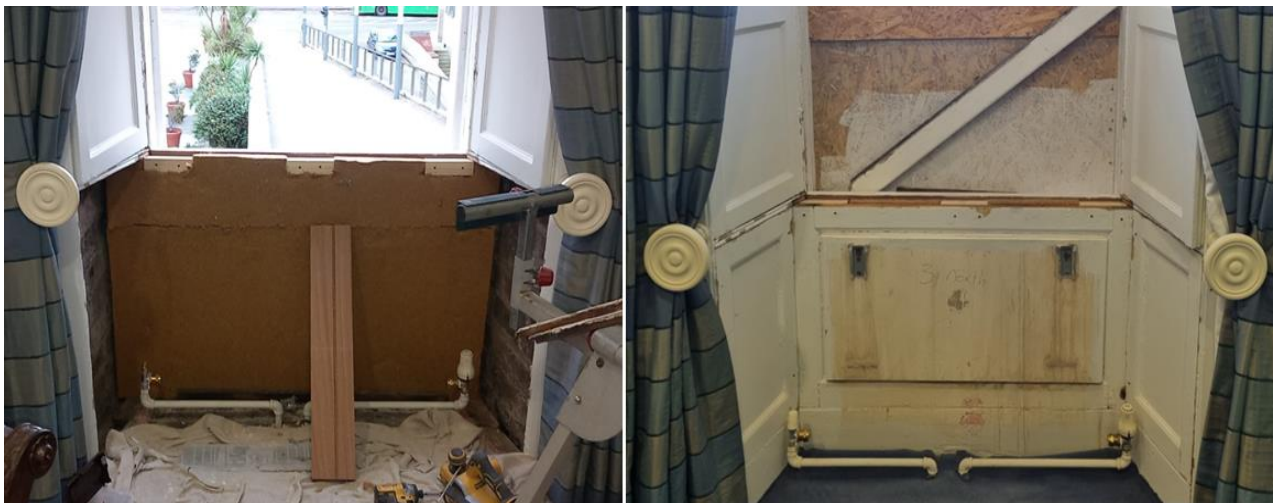
Figure 14 Boardroom window 3 north insulated with 80mm Woodfibre & panel reinstalled

The results from the U-value tests conducted on the panel below the window 3 at the DLR Harbour Master Lodge's boardroom window. There were two test areas, the centre point and the bottom of the panel.

The results from the U-value tests conducted on the panel below the window 3 at the Harbour Master Lodge's boardroom, post-retrofit U-value of 0.38 W/m²K over a 6-day test period with 80mm thickness wood-fibre insulation. This is a 67% reduction in U-value in relation to the average and will have a further positive impact on the building energy efficiency and building comfort.

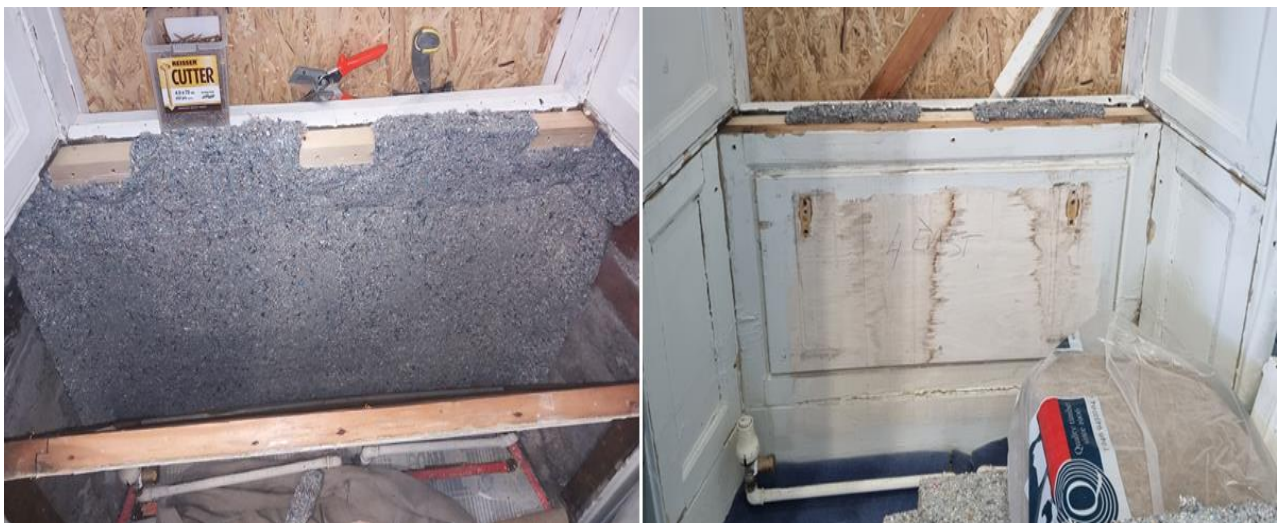
Figure 15 Boardroom window 4 east insulated with 50mm Pavacell & panel reinstalled

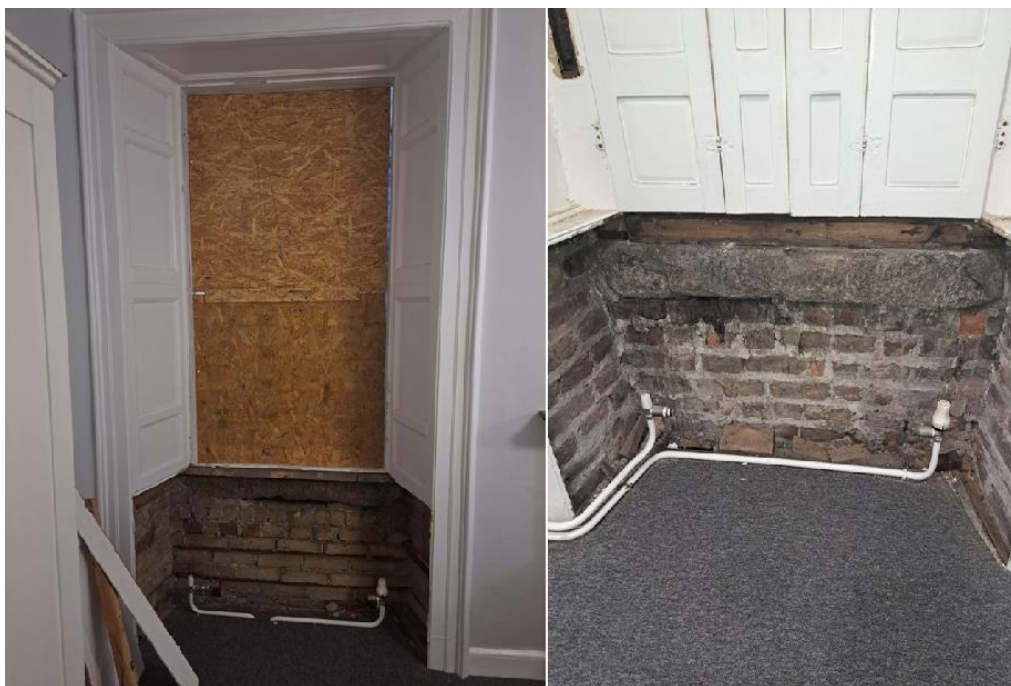
The stripping out works have begun in the downstairs offices and WC areas. The same works process as the boardroom, remove windows, remove alarm sensors, secure openings etc. The masonry was found to be in good condition, dry and free from rot. The voids behind the radiators were again found to be varying thicknesses, this impacts the u-value.

Figure 19 Office window opening secured & masonry exposed

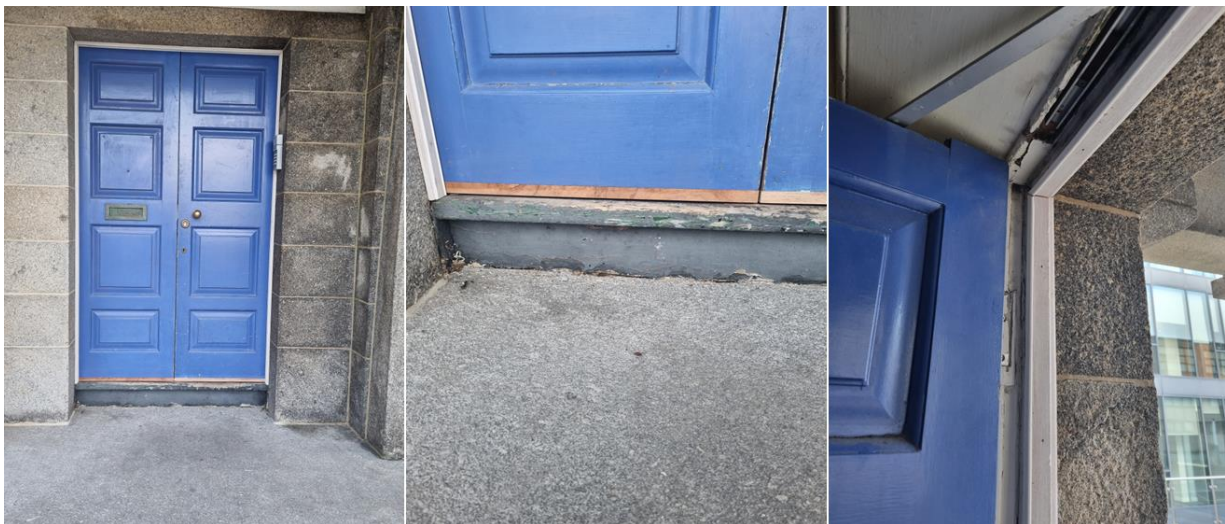
All the radiator panels have been filled and painted, this is an additional extra and is required to facilitate the reinstallation of the radiators, which have also been completed. The main front double doors have been repaired at the base and new seals have been installed as an additional air tightness measure.

Figure 22 Slips installed on main double doors & retro seals

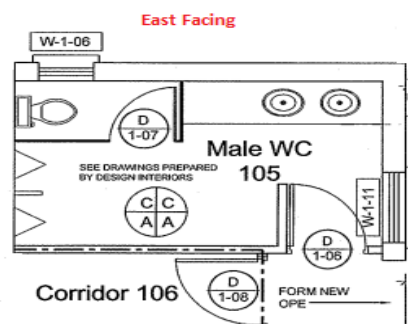
Figure 24 First floor WC sash window to be double glazed

Double glazing panels are to be fitted to the first floor WC window, there was no scope to install secondary glazing

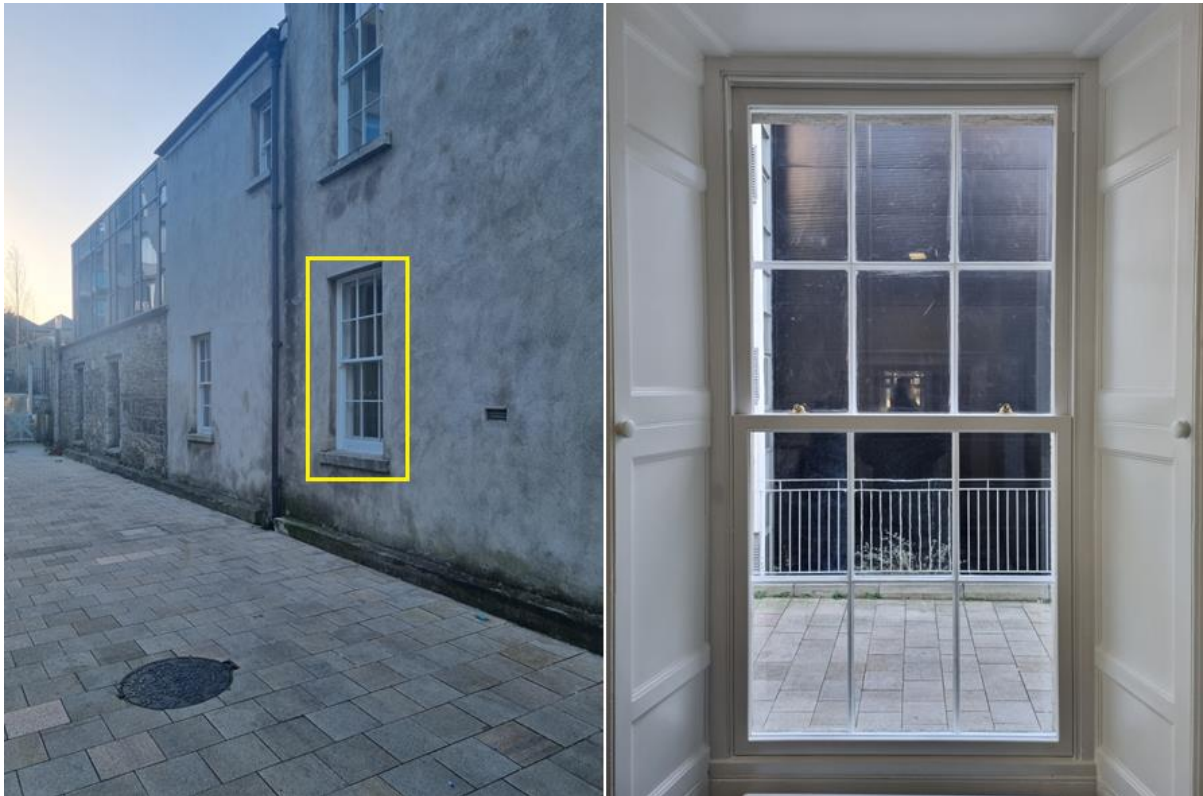
One office window will require a solar and privacy blind, there has been a build up of pedestrian traffic since the new walkway has been constructed with the student apartments. The walkway is directly linked to the east side of the office in question and has a clear view into a DLR staff workstation and PC.

Figure 25 Blind to be installed on one window adjacent to pedestrian walkway

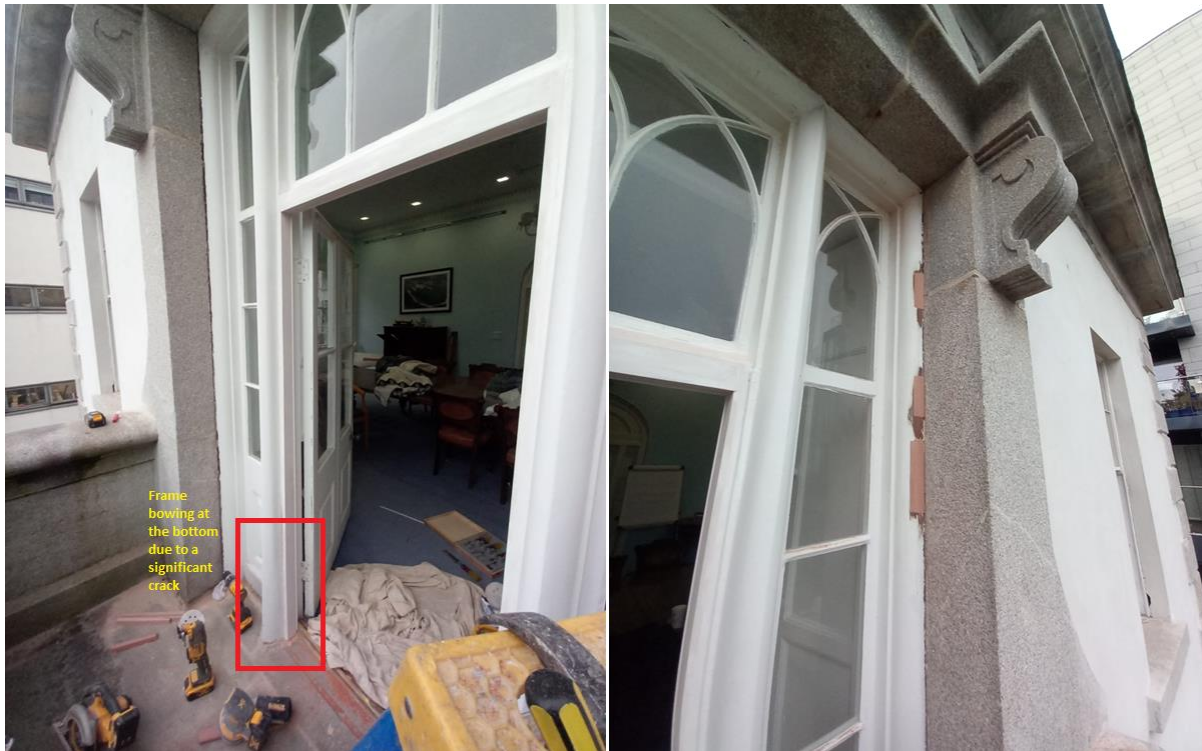
The frame for the balcony doors required two different repairs,

1. The frame was significantly cracked on the hinge side at the bottom, required to be cut out and replaced with mahogany.
2. Driving rain was getting into the right side of the frame where it meets the granite, this had live rot due to this.

Figure 26 Areas repaired at the balcony doors

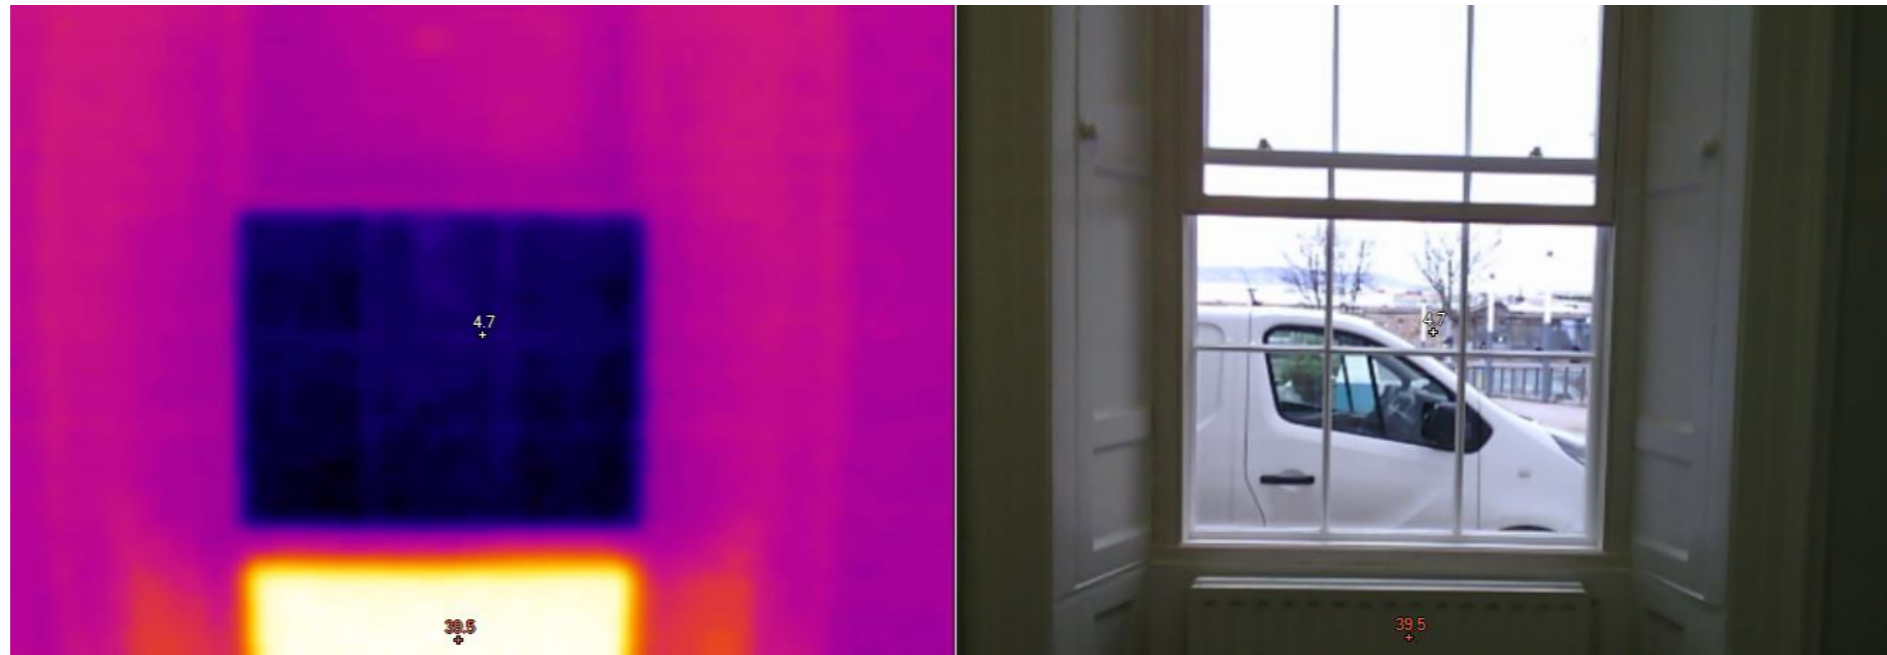
The below thermal images were taken on January 16th, 2024, at 12pm on a north facing window in the downstairs office, the outside air temperature was 4 degrees. The pictures are depicting the same window with the secondary glazing open in the top image and closed in the lower image. The picture with the open glazing exposing the original single pane sash window has a minimum temperature of 4.7 degrees, when the secondary glazing is closed the temperature very quickly increases to 14.9 degrees, this is a temperature difference of 10.2 degrees or a 68% increase in surface temperature.

Figure 28 Thermal image with secondary glazing open

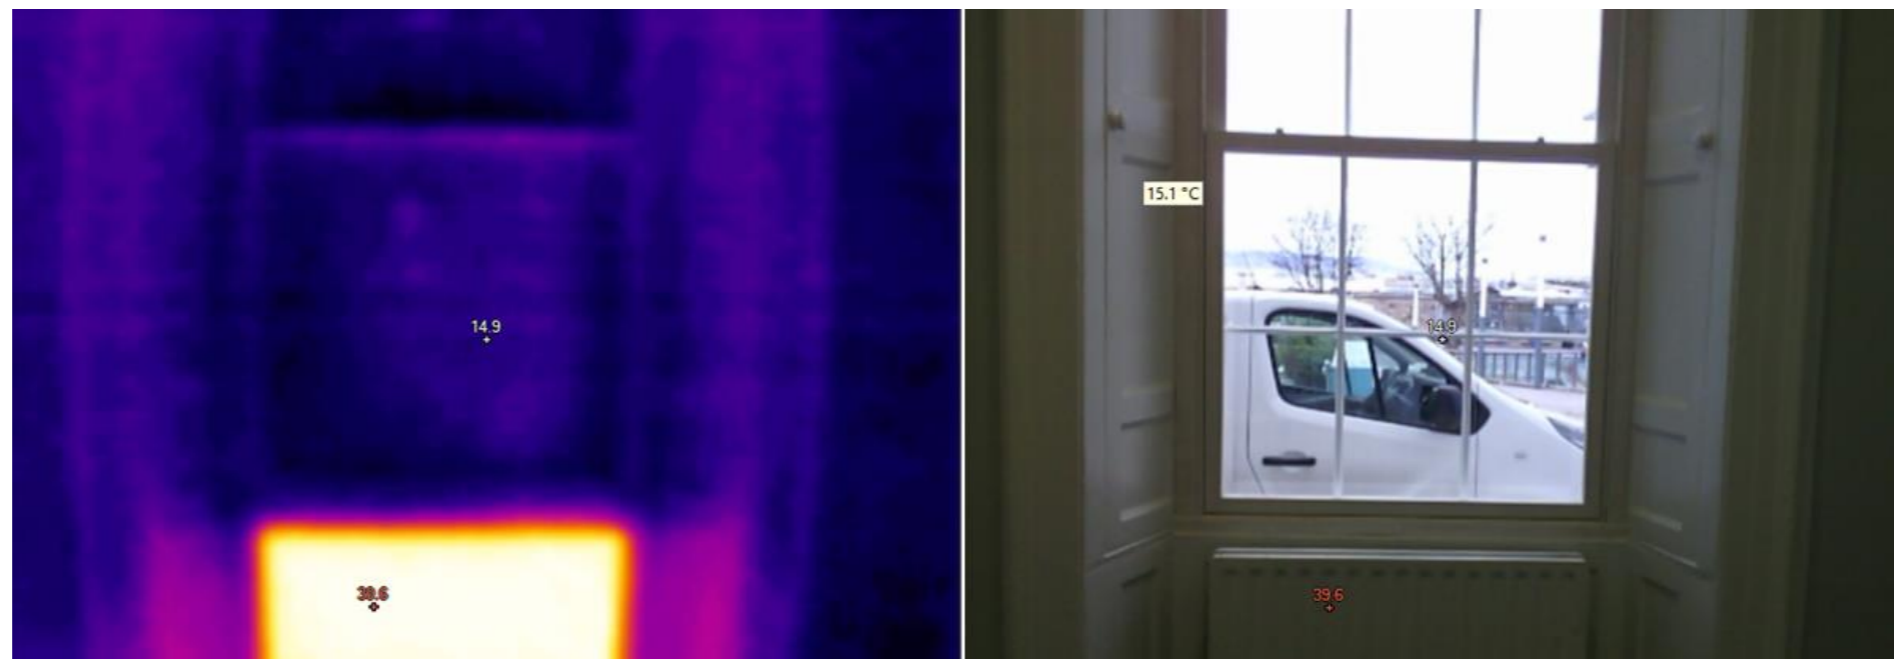
Figure 29 Thermal image with secondary glazing closed

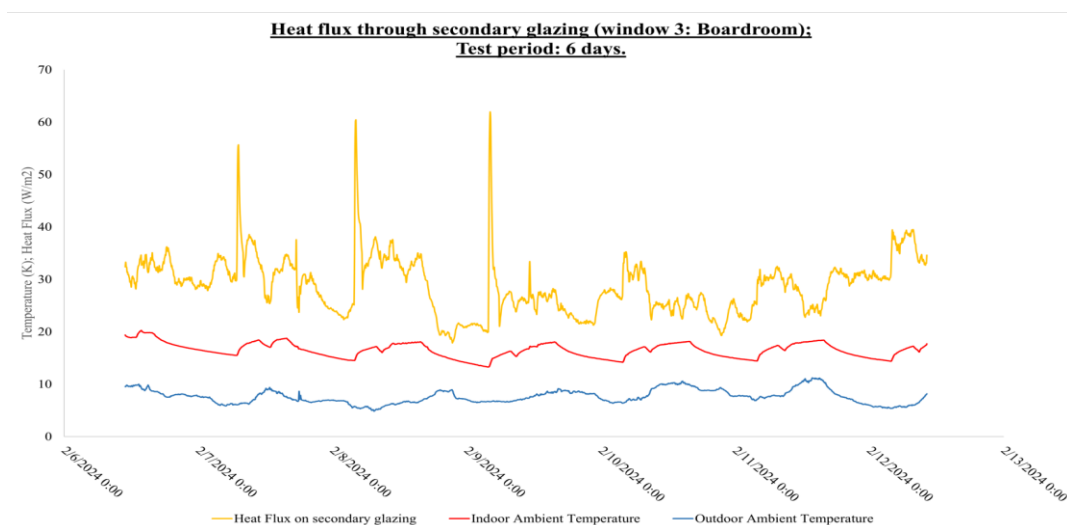
The test results with the secondary glazing in position gave a result of 3.24 W/m²K and was conducted over a six-day period. These results do not align with TGD guidelines or test results from Glasgow Caledonian University which are stating 1.6 to 1.7 W/m²K. However, a note from the test team in UCD states *“Please note: the results are not accurate as per ISO standards as the U-value fluctuations are too high. This is visible in the heat flux fluctuations when the radiators below the windows were turned on as represented in the graph. Actual U-values are expected to be lower”*.

The below graph shows high fluctuations which indicates radiators being turned on through the six-day test period.

Figure 30 U-Value results graph on secondary glazing

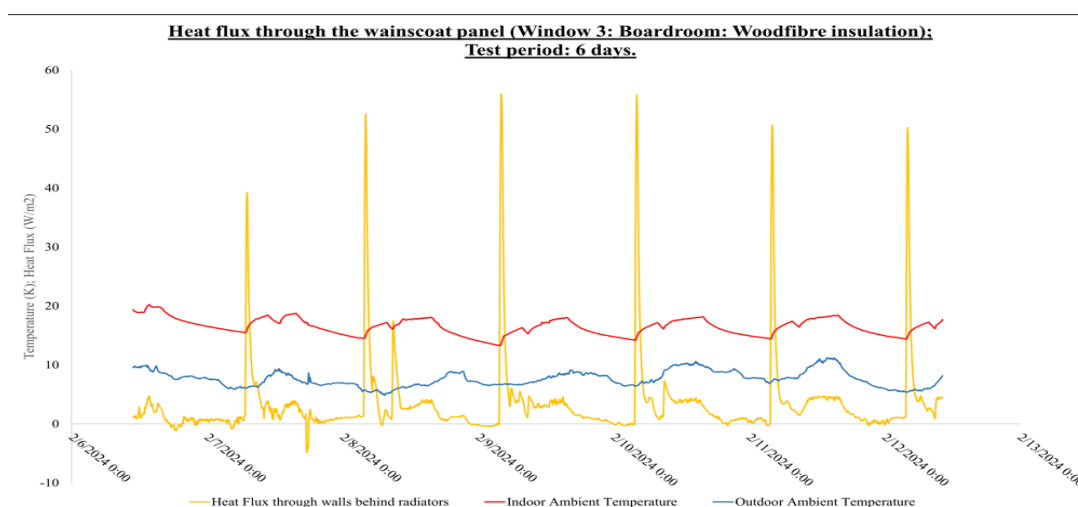
1. U-value at the centre of the wainscot panel – 0.85 W/m²K
2. U-value at the bottom panel – 1.48 W/m²K
3. Average U-value for both test areas – 1.16 W/m²K
4. Average indoor ambient temperature – 19.5°C
5. Average outdoor ambient temperature – 16.4°C

Comment from the UCD test team – “The U-values shall be treated as indicative only as the testing standards recommend a minimum of 10°C difference between the indoor and outdoor ambient temperature. Here we only have a 3°C difference.”

Figure 31 U-value result graph on Wainscot panel
