**PATENT SLIP AT
DUN LAOGHAIRE HARBOUR**

**ARCHITECTURAL HERITAGE
REPORT**

10th July 2023

**Historic Building Consultants
Old Bawn
Old Connaught
Bray**

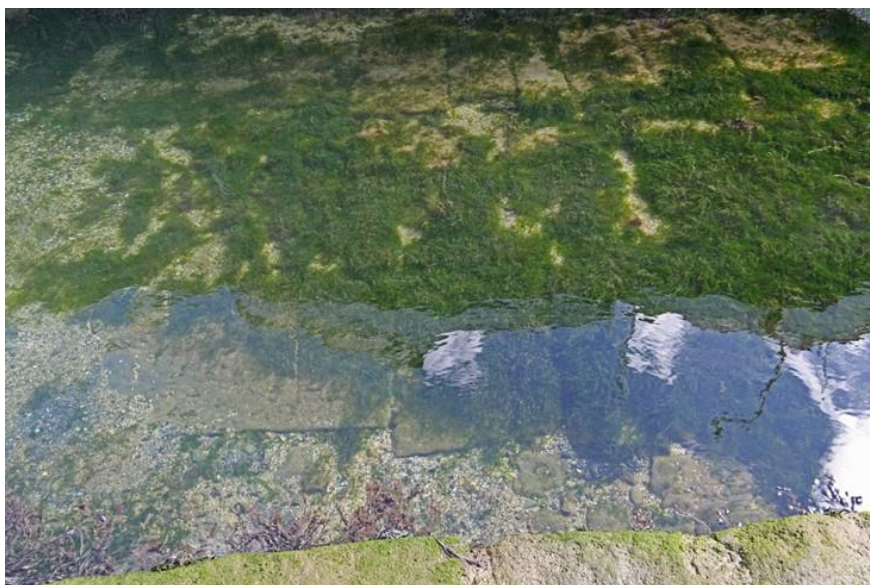
As noted above, the patent slip runs at a steeper angle than the main slipway and at its lower end, to the north, it runs below the level of the adjacent slipway, as seen in the photograph above. The photograph also shows that there is a shelf of masonry alongside the quay wall that is at the same level as the main slipway, suggesting that this section was left in place when the patent slip was constructed, and that the construction of the patent slip involved removal of part of the original slipway. The photograph below shows the lowest level of the patent slip, as seen below water level at low tide. Two lines of granite flagstones are seen, aligned with the two ramps on the patent slip, while flanking the two lines and between them the surface is of loose sand. It is not known whether there is stonework below the sand.

Plate 8: Lowest section of patent slip, below water level

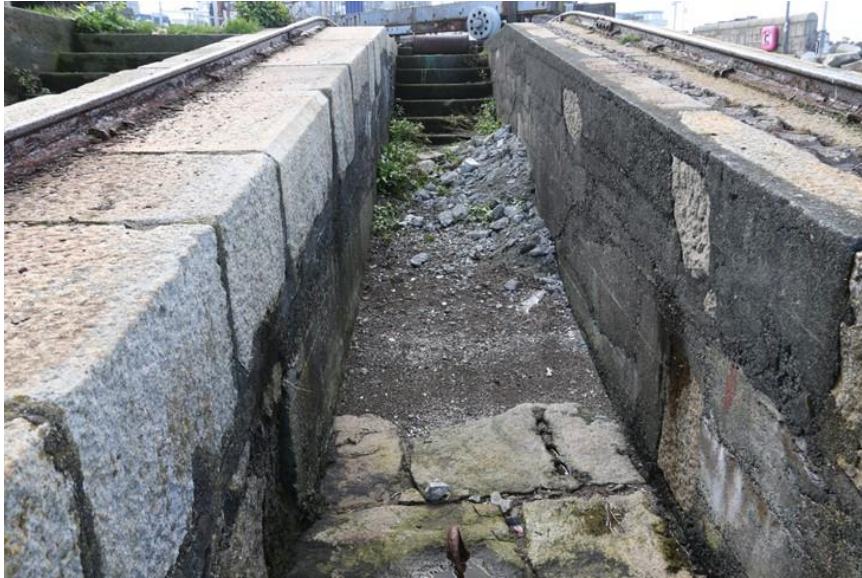
Plate 27: Upper end of area between the ramps

At the upper level of the area between the ramps there is an area of spoil that has been deposited in recent times. From the earlier inspection in 2006 it is clear that the paving continues upward beneath this spoil, though at that earlier date the topmost part of the slope was concealed beneath a growth of vegetation on deposited material.

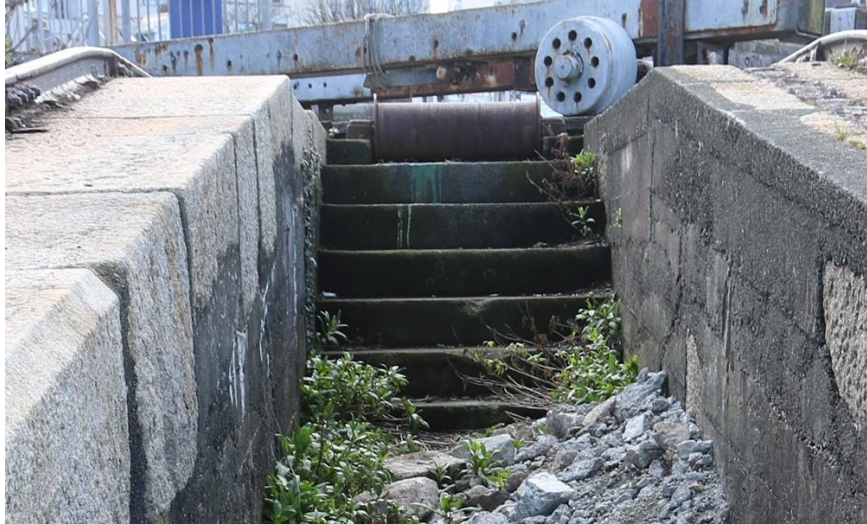
Plate 29: Steps at top of area between the ramps

At the upper end of the area between the ramps a flight of six steps leads up to the level of the platform on the turntable. The steps are of mass concrete. At the top of the steps is a short landing of mass concrete at the end of which is a metal roller, the axles of which rest on the lower halves of bearings, the upper halves of which are missing, probably to remove the liners for scrap.

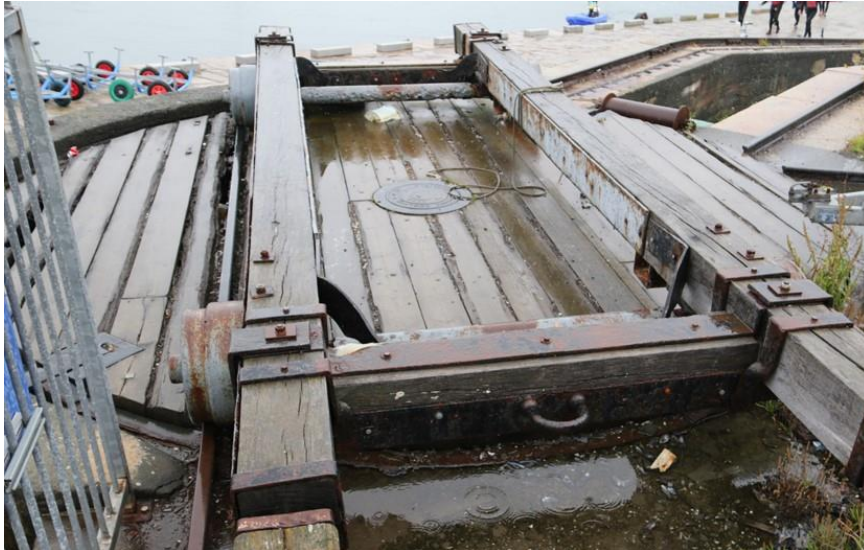
Plate 39: Boarded surface of turntable

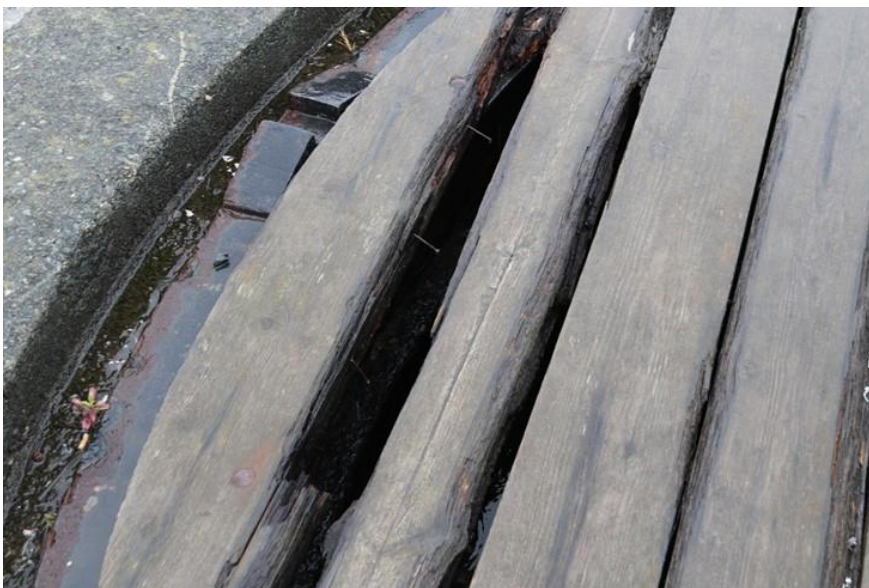
There is a significant amount of damage through rot in the timbers on the surface of the turntable, as seen in the photograph below. It is noted that in the photographs taken on the visit to the site in 2006 the boards looked relatively clean and fresh (see Plate 35 above and Plate 65 below). On this evidence it seems likely that the lifespan of the boarding in the damp conditions is less than twenty years.

Plate 40: Rot in boards on the turntable platform

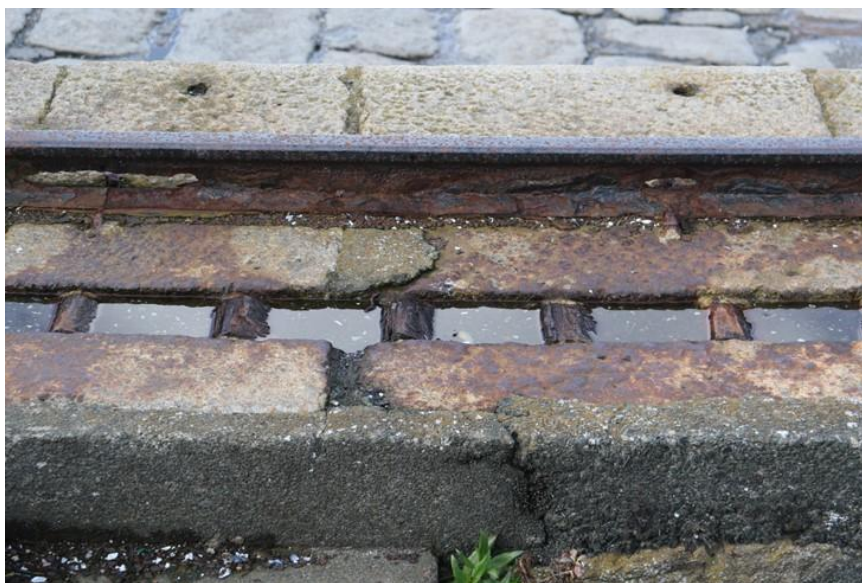
Plate 52: Rack alongside track

In the photograph above the brown colour on either side of the rack is rust staining on the granite; there is no metal on the surface in the area adjacent to the rack.

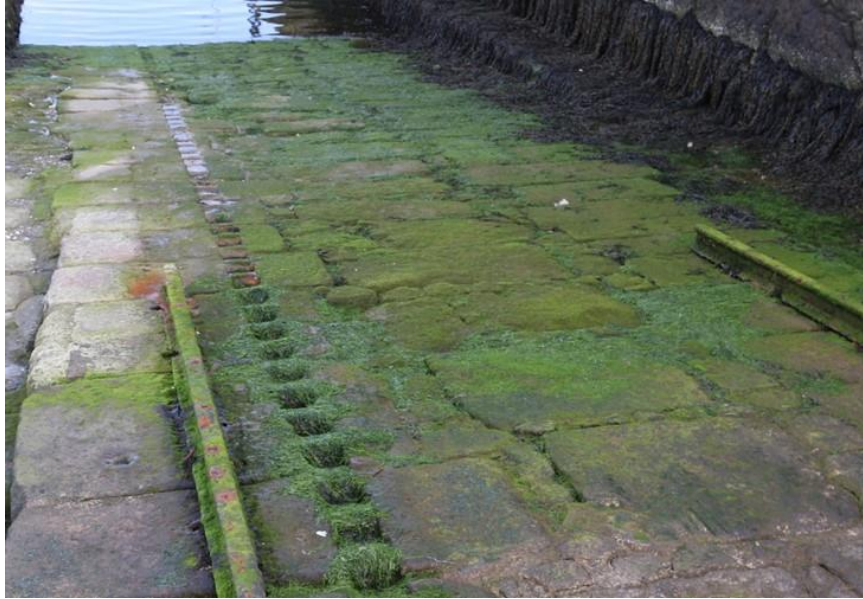
Plate 53: View down the lower part of the patent slip

Toward the bottom of the patent slip the rails stop, while the rack continues onward to the bottom. This is not part of the original design, as there were rails along the full length of the patent slip originally, though the rails have either become detached from the base through failure of the fixings or they have been deliberately removed. The holes for the fixings of the rail are visible in the photograph below. The rails are missing from approximately 17.7 metres of the patent slip at the northern or downhill end.

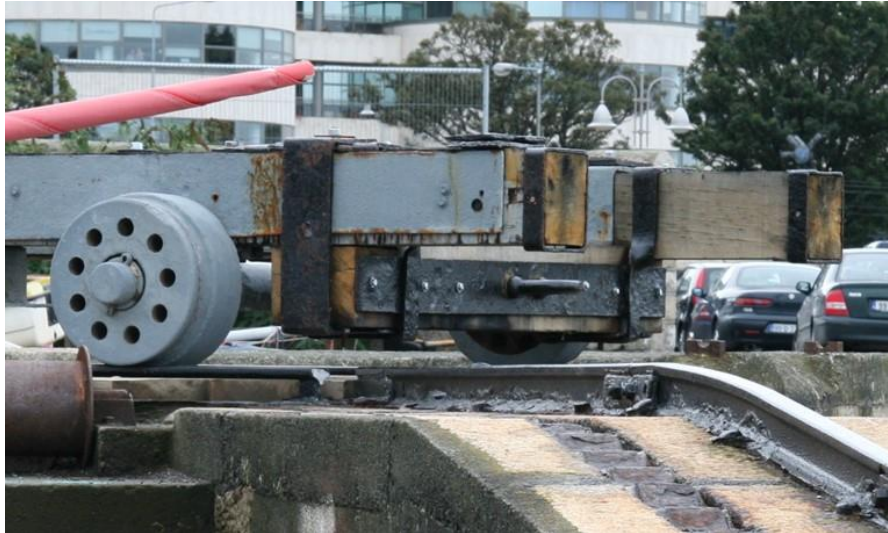
Plate 67: End of larger carriage

The wheels are broad, with the inner part having a slightly wider diameter than the outer part. The smaller diameter element is the part of the wheel that runs on the rail, while the adjacent area with the wider diameter is also of greater width and would act as the wheel when the carriage is off the rails within the boatyard, while also acting as the flange to keep the wheel on the rails. The wheels are set on a cylindrical axle solid metal and held at the ends of split pins. The outer ends of the wheels are perforated. The axles are heavily pitted due to corrosion.

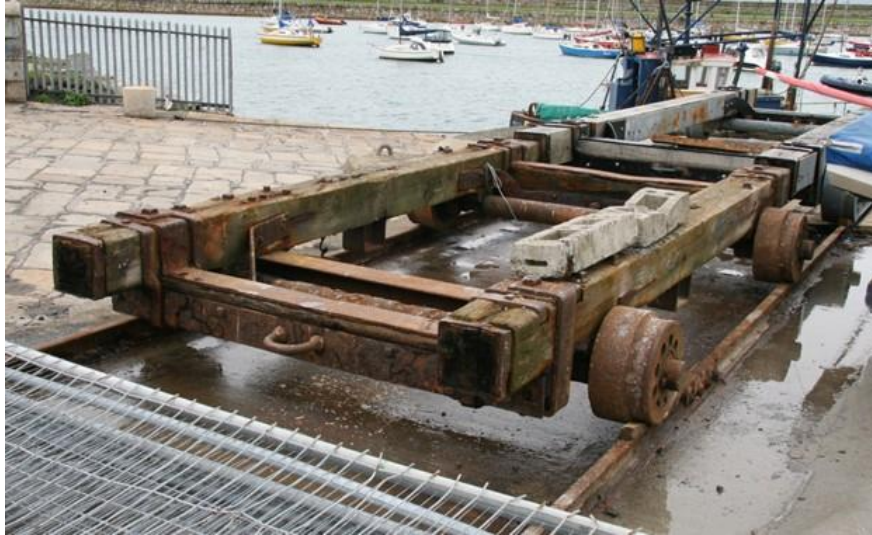
Plate 69: Smaller carriage

The smaller carriage is similar in construction to the larger carriage, and while it is the same width it is shorter, being only 4.25 metres long. This carriage is not painted, and the timber appears to be older and in poorer condition than that on the larger carriage. There are no metal plates fixed to the sides of the long timber beams. As with the larger carriage, there are towing eyes at either end, set into metal plates that are fixed to the cross beams.

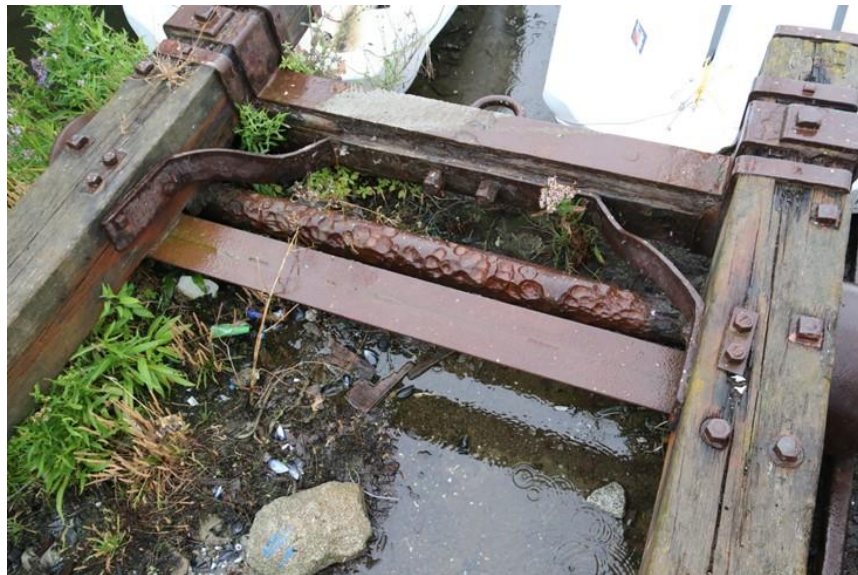
The axle of the smaller carriage is more slender than that of the larger carriage and it exhibits the same level of corrosion pitting as on the other carriage.

Plate 72: Detail of smaller carriage showing pitting of axle
