Appendix E: Tufa Springs Mitigation Requirements

1 Introduction

Phase I Hydrogeology Assessment of the Cherrywood SDZ

2018s1302
Dún Laoghaire - Rathdown
County Council
May 2019
Alex Jones BSc MSc CGeol
Tufa Catchment Study

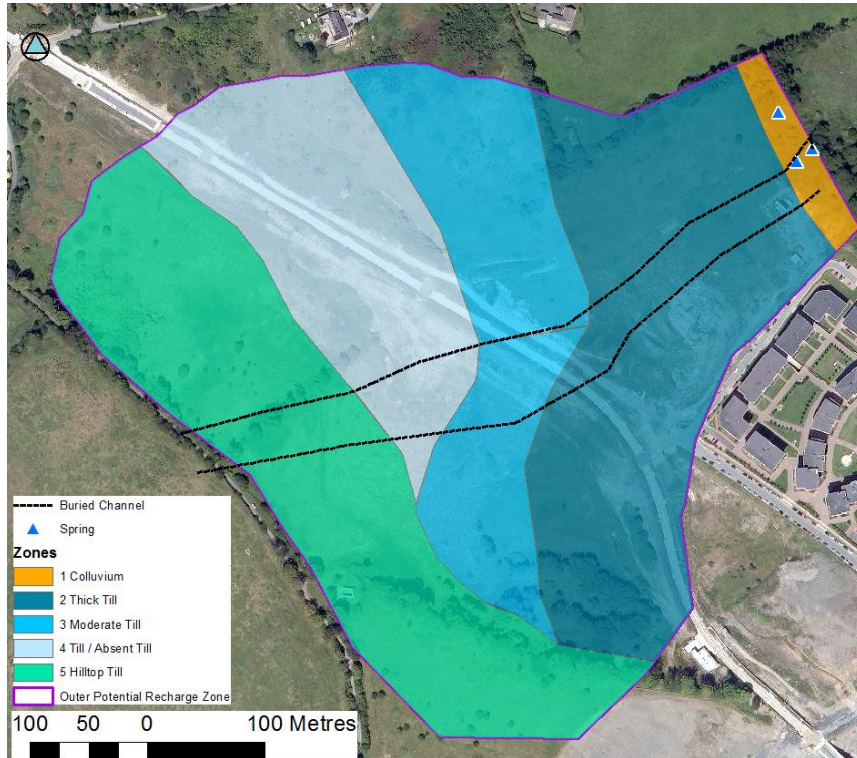
Figure 3-1: Catchment Sensitivity Classification

The JBA Catchment Study has divided the catchment into zones (see **Figure 3-1** below). These are based on the underlying geology and how the spring is supported by these areas.

Such work, anywhere within the Precautionary Spring Catchment as defined in Figure 3-1, should be supported by a hydrogeological risk assessment and an appropriate level of site investigation.

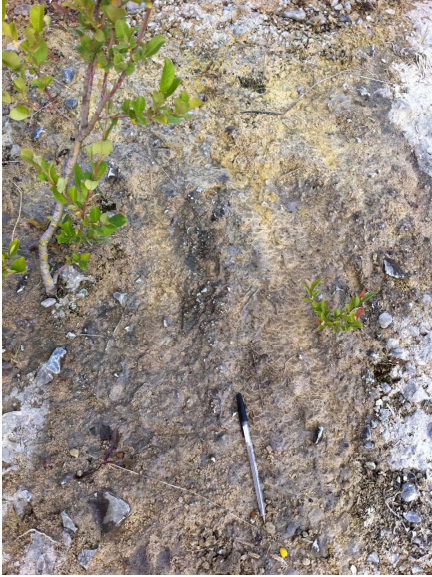
Photograph 1 – Close up view of new tuffa formation observed along slope break (ref Location 1 on Figure 3).

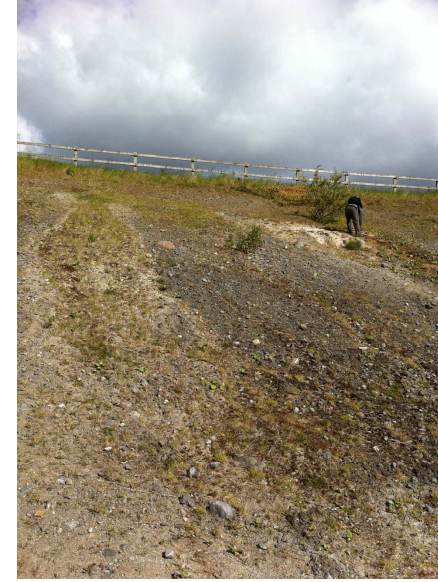
Photograph 2 – View of new tuffa formation (where person is standing) observed from a distance along slope break (ref Location 1 on Figure 3).

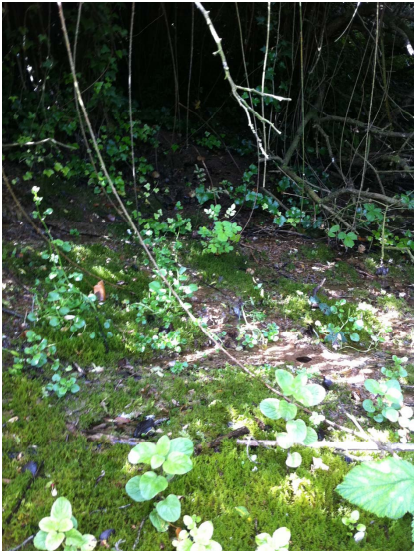
Photograph 3 – Close up of tuffa (orange material surrounded by moss) and spring located along southwest bank of valley at location 5 (refer to Figure 3).

The mature tuffa spring formations observed at location 5 (**Figure 3**) are the only maturely developed tuffa formations within the limits of the SDZ. RPS also understands from Scott Cawley that the tuffa spring formations at location 5 correspond to an EC Habitats Directive Annex I habitat. These factors combined ensure that location 5 will be most important for the proposed SDZ in terms of the impacts of the development on the hydrogeology - ecology interaction of the area.

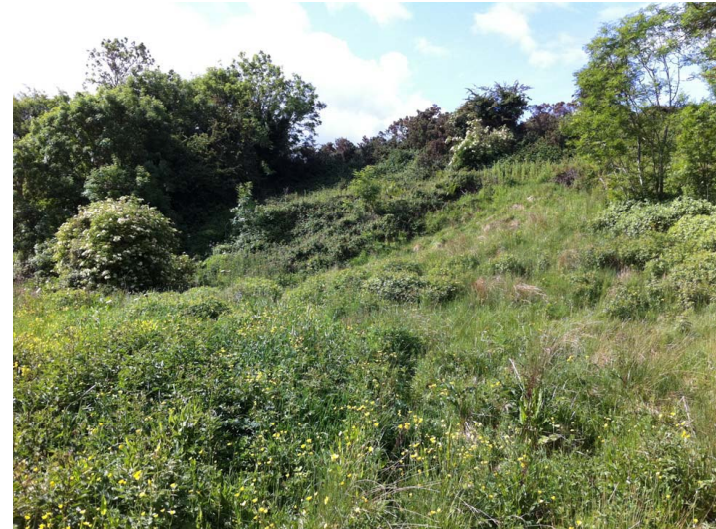
Photograph 4 – Distant view of tuffa spring (heavily overgrown area to the left of trees) located along southwest bank of valley at location 5 (refer to Figure 3).

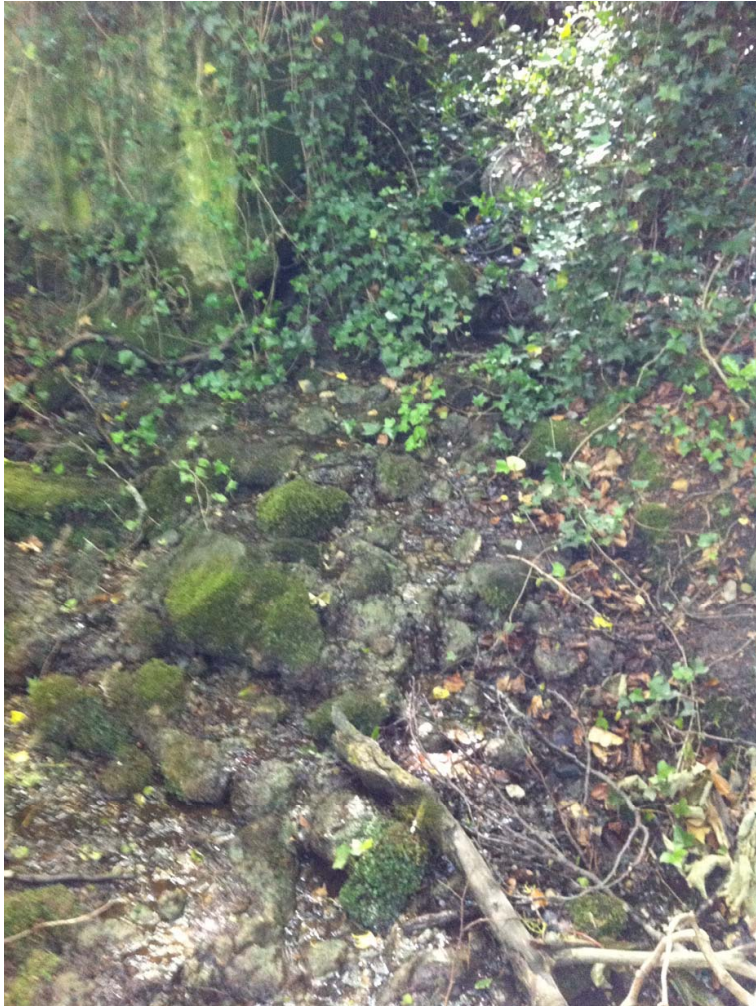
Photograph 5 –Tuffa formation along drainage stream from spring emergence at location 11. Concrete water holding tank visible at top left corner of image.

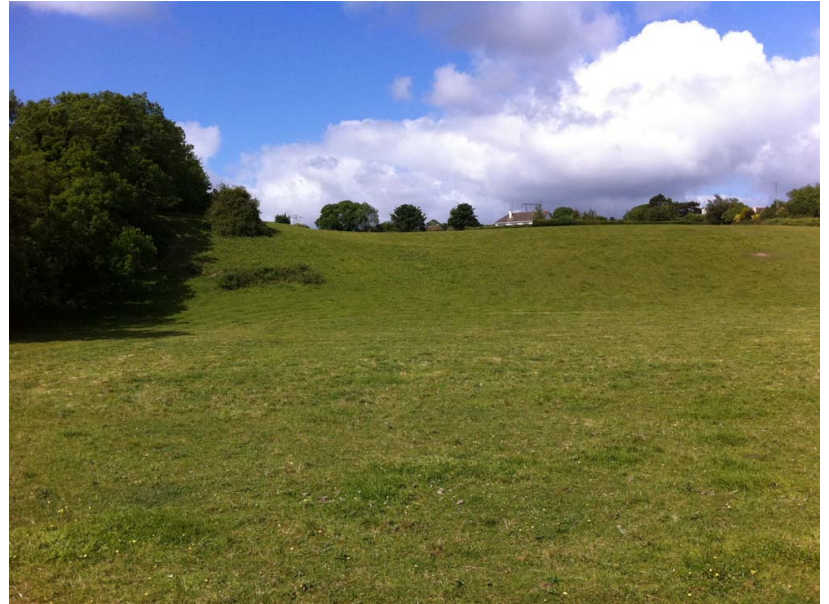
Photograph 6 – Dry well drained land without spring or tuffa emergence along western bank of River valley, refer to location 6 on Figure 3.

The absence of extensive tuffa spring formations along the southwest side of the river valley indicates that the groundwater flow systems supporting these formations are relatively limited in aerial extent. Photograph 6 (Appendix A) illustrates the nature of a well drained slope without any spring emergence 100m to the northwest of the large tuffa springs observed at location 5.

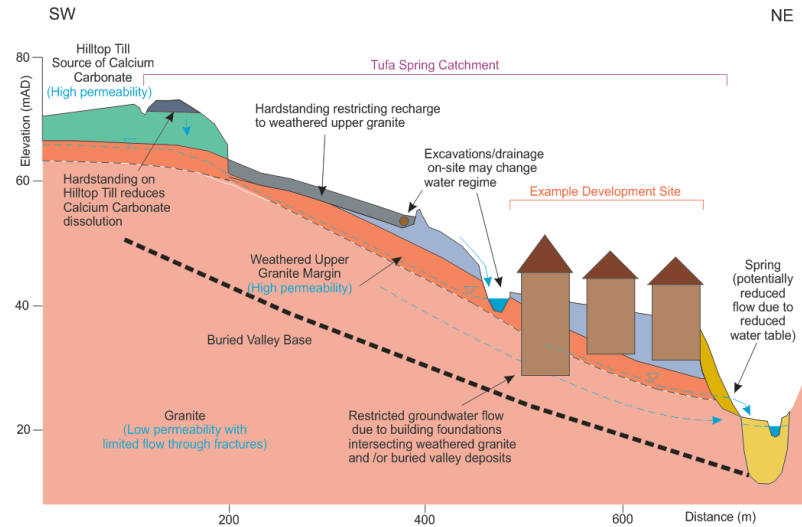
Figure 4-2: Impact Conceptual Model

The potential impact mechanisms caused by future development can be divided into three broad categories (see table below). These are based on three key elements of the groundwater conceptual model which explains the functioning of the tufa spring.

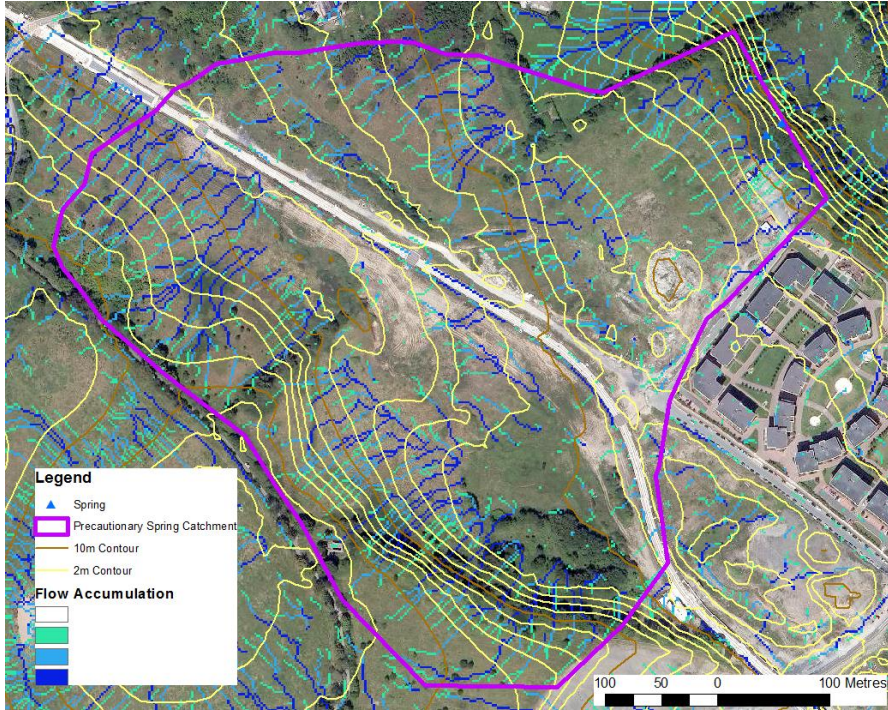
Figure 5-1: Precautionary Catchment Area

A Precautionary Catchment Area is shown in Figure 5-1. It is likely to be slightly larger than the true spring groundwater catchment and its extent has been defined based on the following:

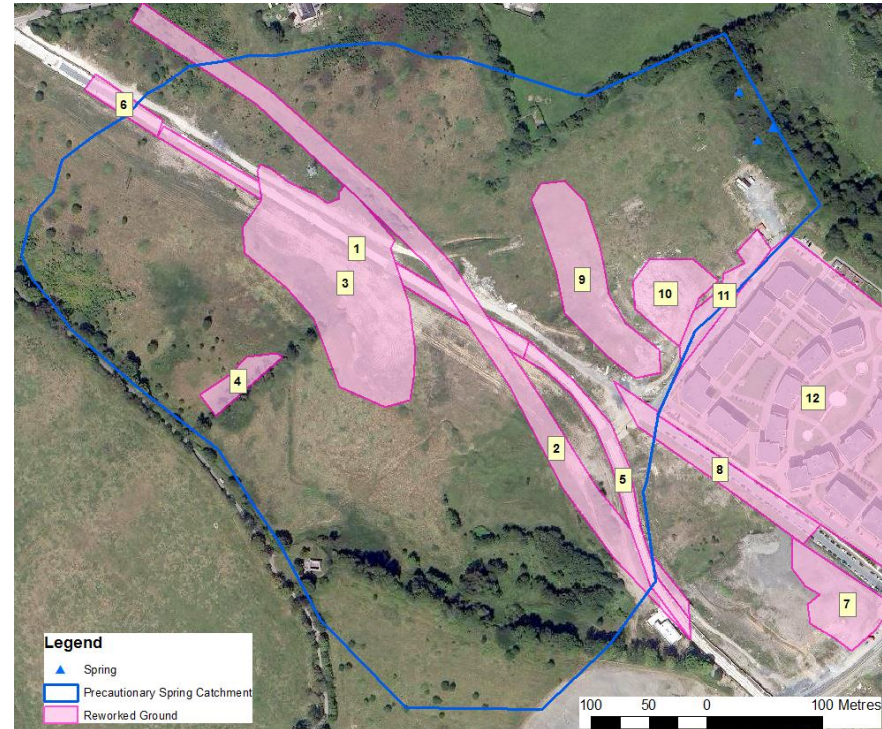
Figure 5-6: Reworked Ground

An analysis of the SI information, LIDAR, Historic Mapping and Aerial photographs have been used to identify areas of reworked, or made ground. This includes areas of cutting and stockpiling. They are shown in Figure 5-6 and described in Table 5-1.

Number	Description
1	Railway line – cut section
2	Historic line of railway line
3	Area of earth stockpile (Domville St, LIDAR and aerial photographs)
4	Historic gravel pit – 1837-42 map
5	Railway line – raised section
6	Railway line – limited cut
7	Earth stockpile
8	Road
