Dublin Bay Bathing Waters

Report by the Bathing Water Task Force

June 2023

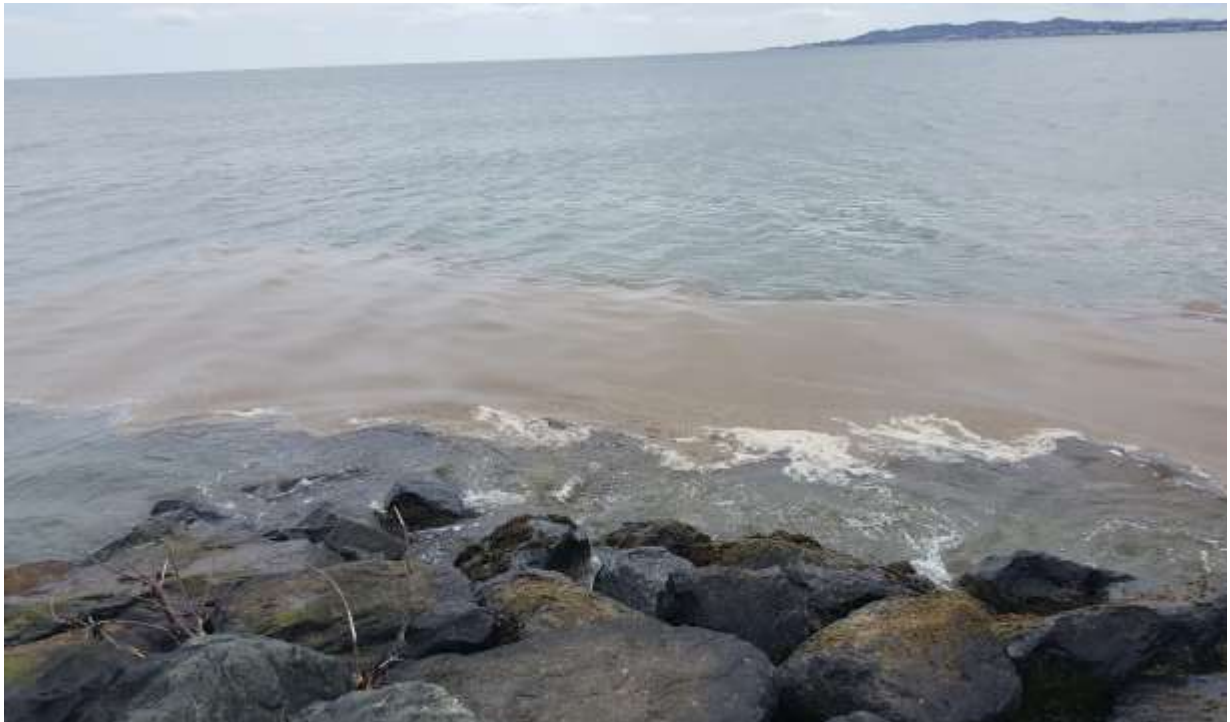
Shelly Banks – Brown ectocarpus washing ashore in the seawater, (Sept. 2019)

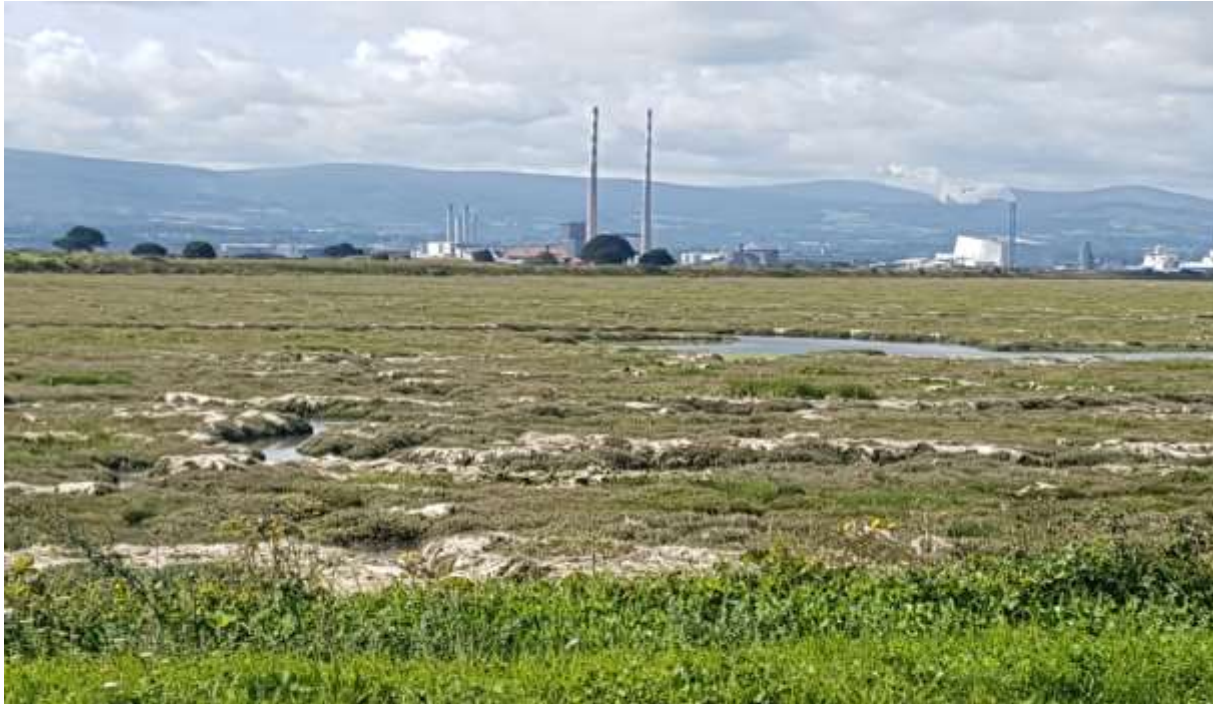
Bull Island – (Light brown) Dried ectocarpus resting on top of the marshes once high tide waters recede, (Sept. 2019).

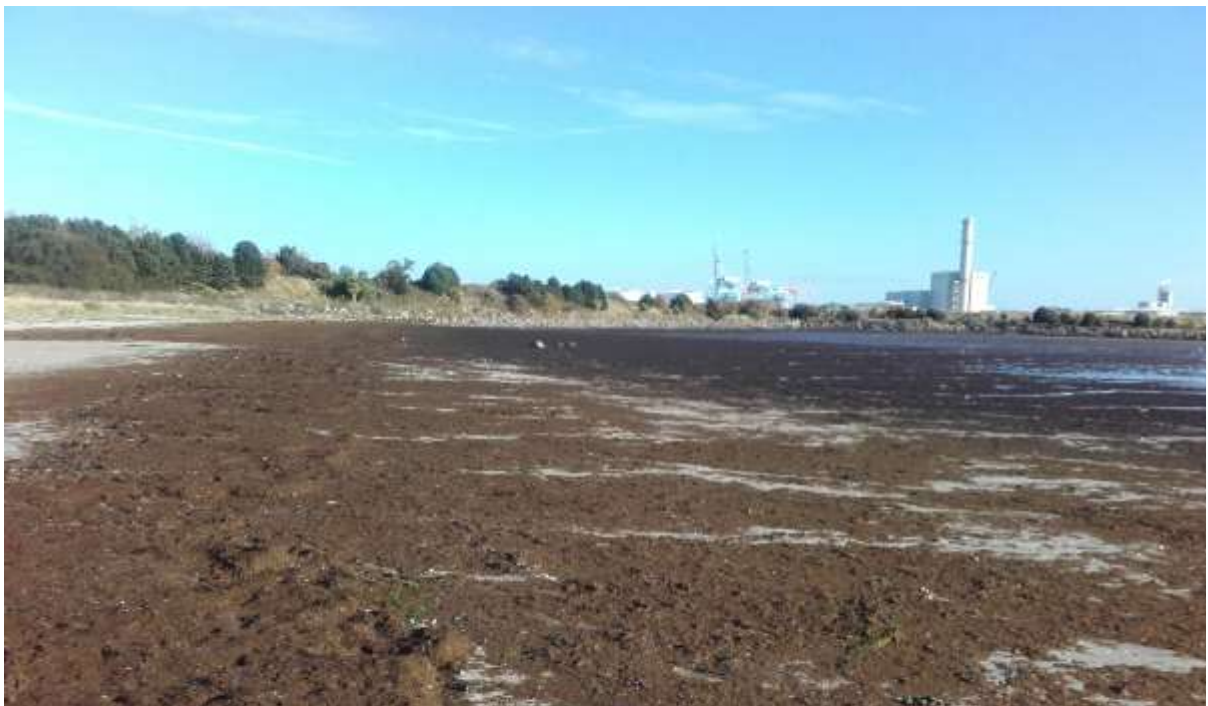
Sandymount Beach – Ectocarpus at various stages of decay, (Oct. 2016).
