Sash Window & Fabric Upgrade
Harbour Masters Lodge
Dun Laoghaire
Co Dublin

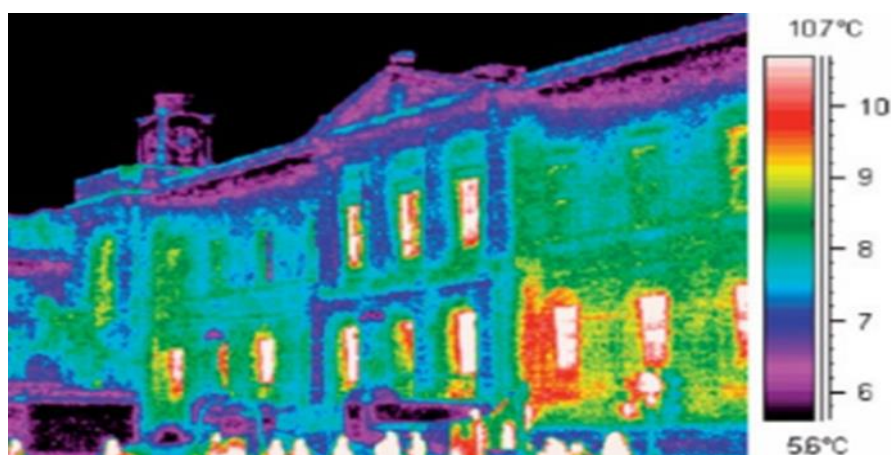
Figure 1 A graphic illustration of heat loss from a building in Edinburgh: most of the windows are single-glazed and are emitting more heat than the thermal imaging camera can record (the white areas); six windows on the top floor (the green areas) have secondary glazing and are cool.

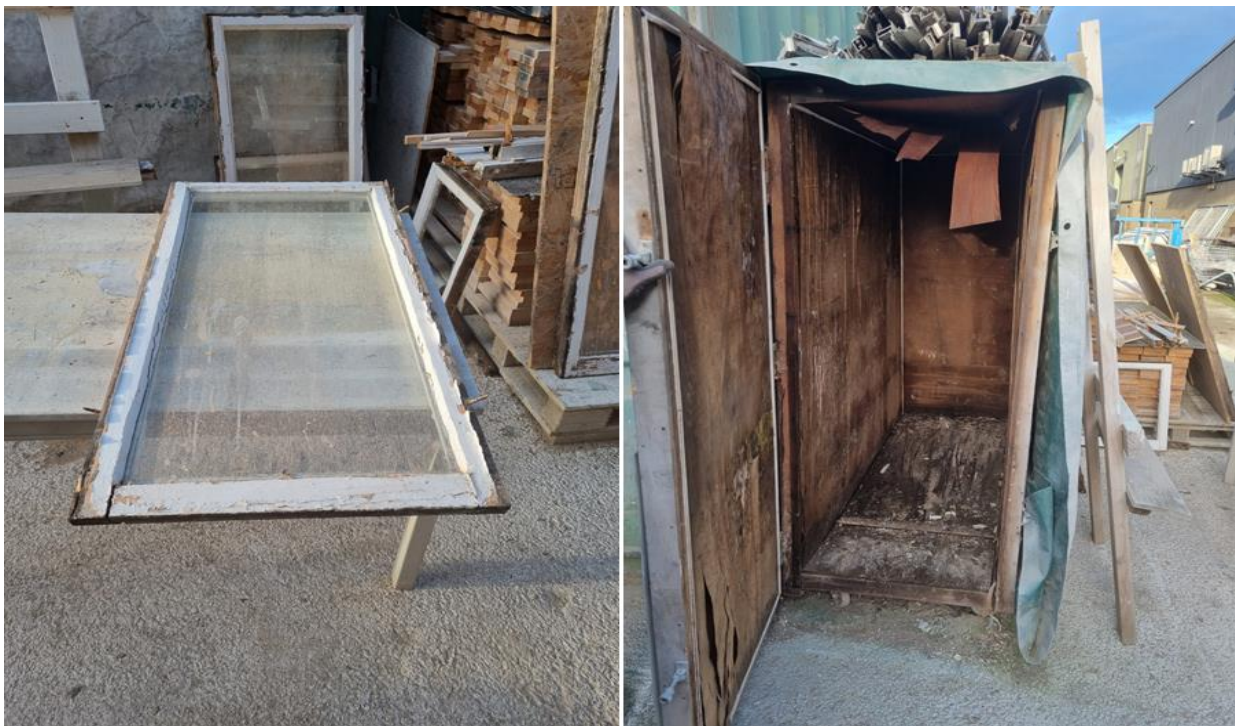
- Windows arrive in the workshop and are inspected for any visible rot and general condition.
- The frames are then placed into a steaming box for 7 minutes. The purpose of this is to soften the putty that holds the original glass in position.

Figure 2 Window for refurbishment & steaming box

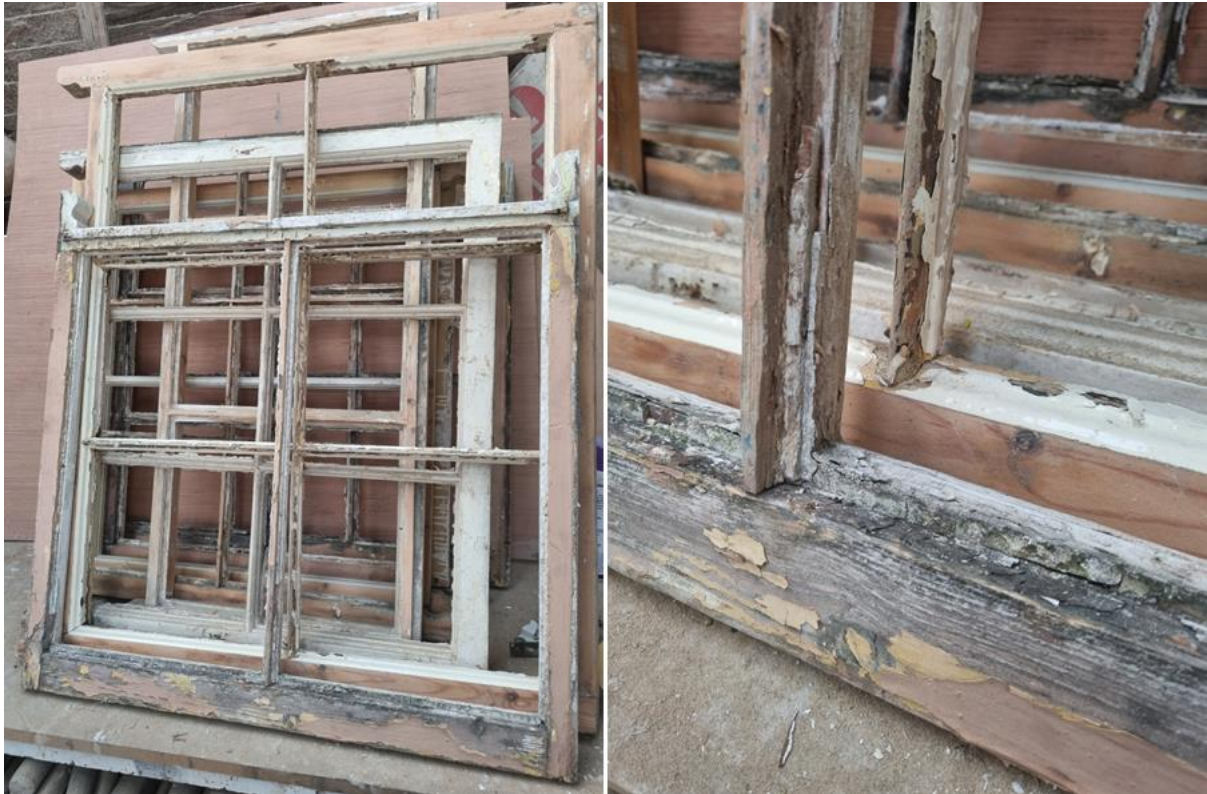
- The softened putty is then carefully scraped out so the glass can be removed. Extra care must be given at this point as the original glass can be 2mm thick or less in places and easily broken.
- Once the glass is removed, the layers of paint are removed with a heat gun and scraper. Great care must be given again at this point as to not damage the moulded profiles of the glazing bars.

Figure 3 Frames cleared of putty and original glass

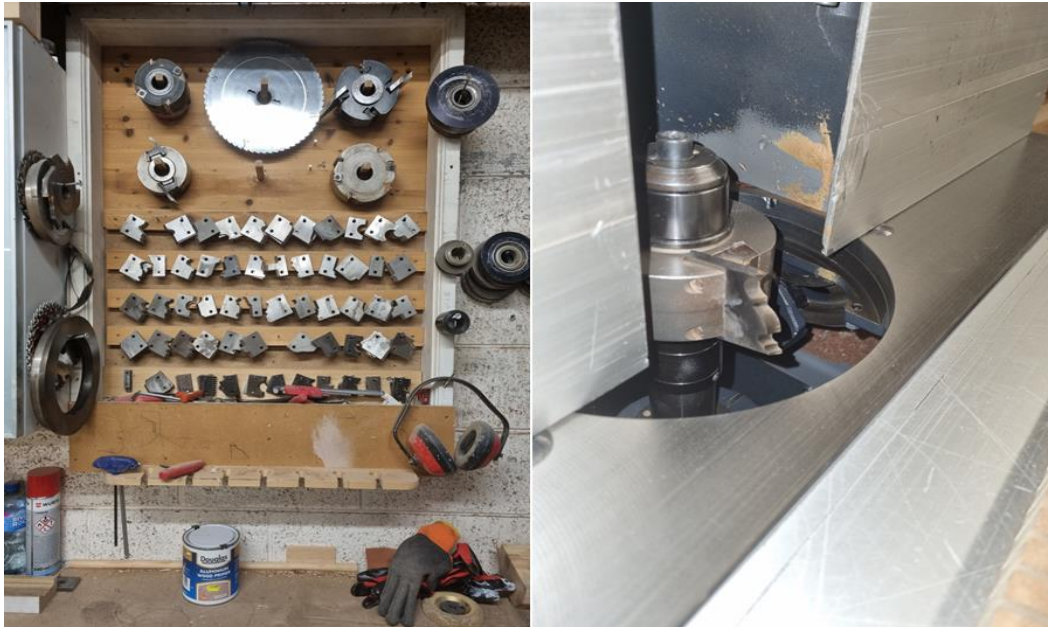
- If the glazing bars need to be replaced and have an old obsolete profile, a bespoke router bit must be manufactured by a specialist steel manufacturing contractor to match the existing glazing bars.

Figure 5 Routing machine with various profile bits

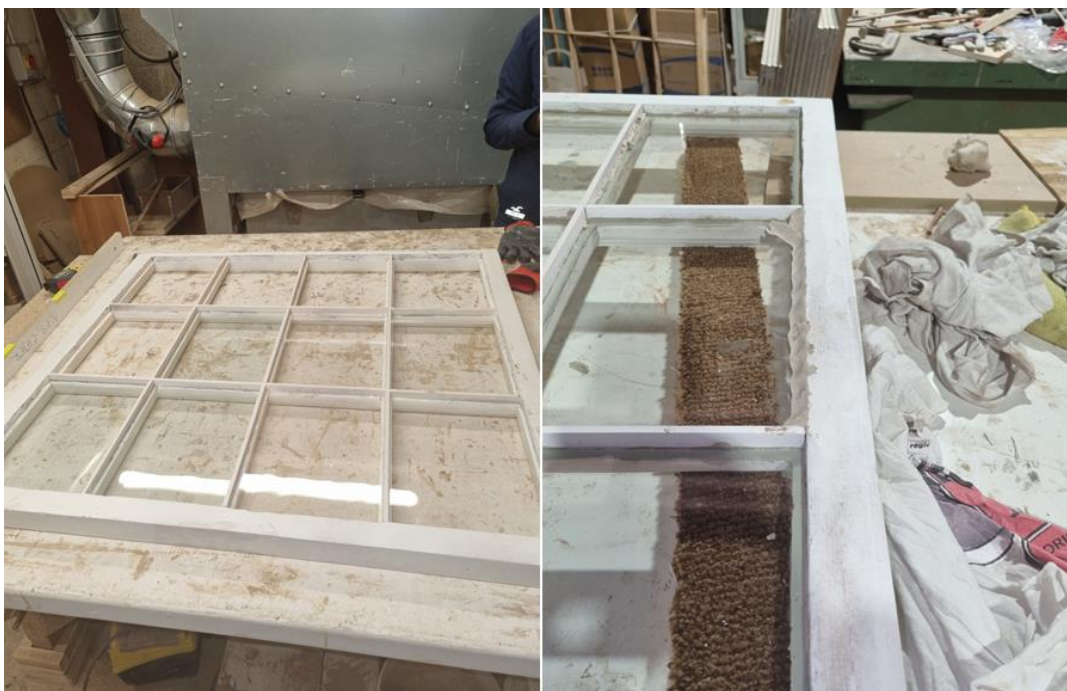
- Windows can be sanded and inspected for further repairs, fame, joints etc. and repaired with Mahogany.
- The frames can be painted without the glass installed.

Figure 6 Frames painted & ready for glazing

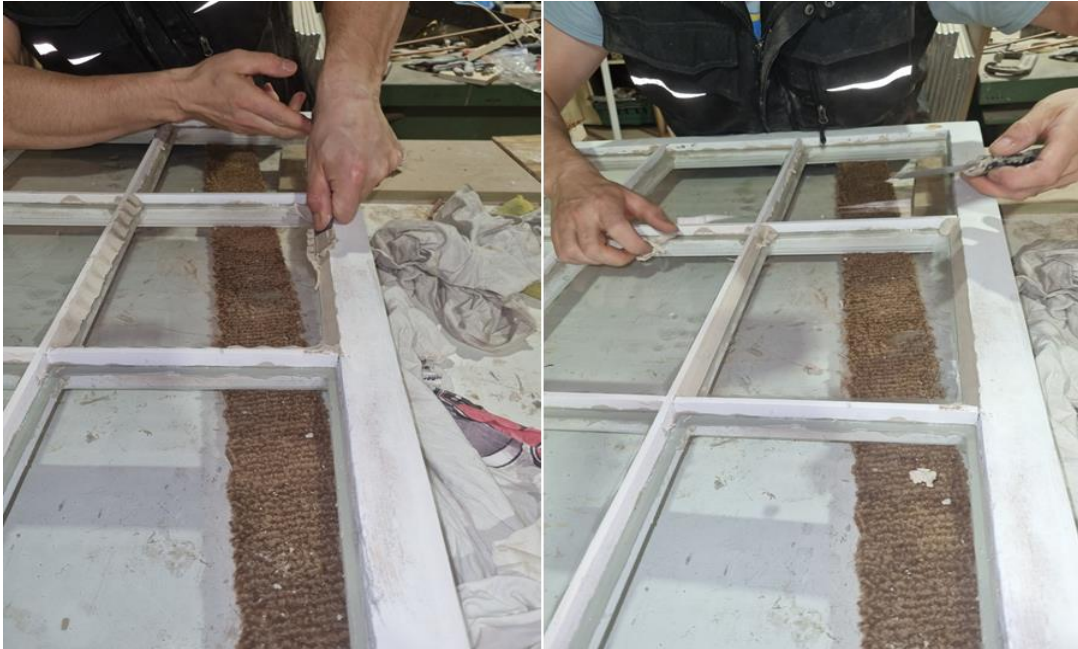
- The frames are ready to be reglazed with the original glass if possible. Linseed based putty is used to secure the glass into the frames and make an airtight and watertight seal. The putty takes approximately six weeks to cure before being painted.

Figure 7 Glazing installed with linseed putty

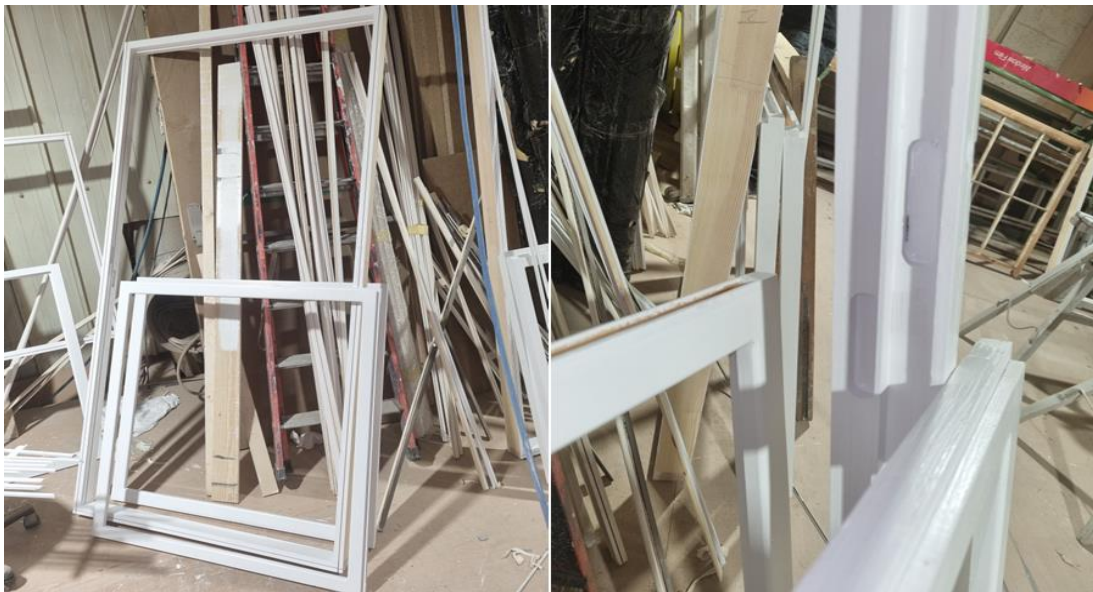
- The completed windows are weighed to determine the counterweights to balance each side of the sash for smooth opening and closing.
- The secondary glazing is manufactured from Poplar timber. The sash windows will have a spring tension balance to match the weight of the new windows.

Figure 8 Secondary glazing frames - unfinished

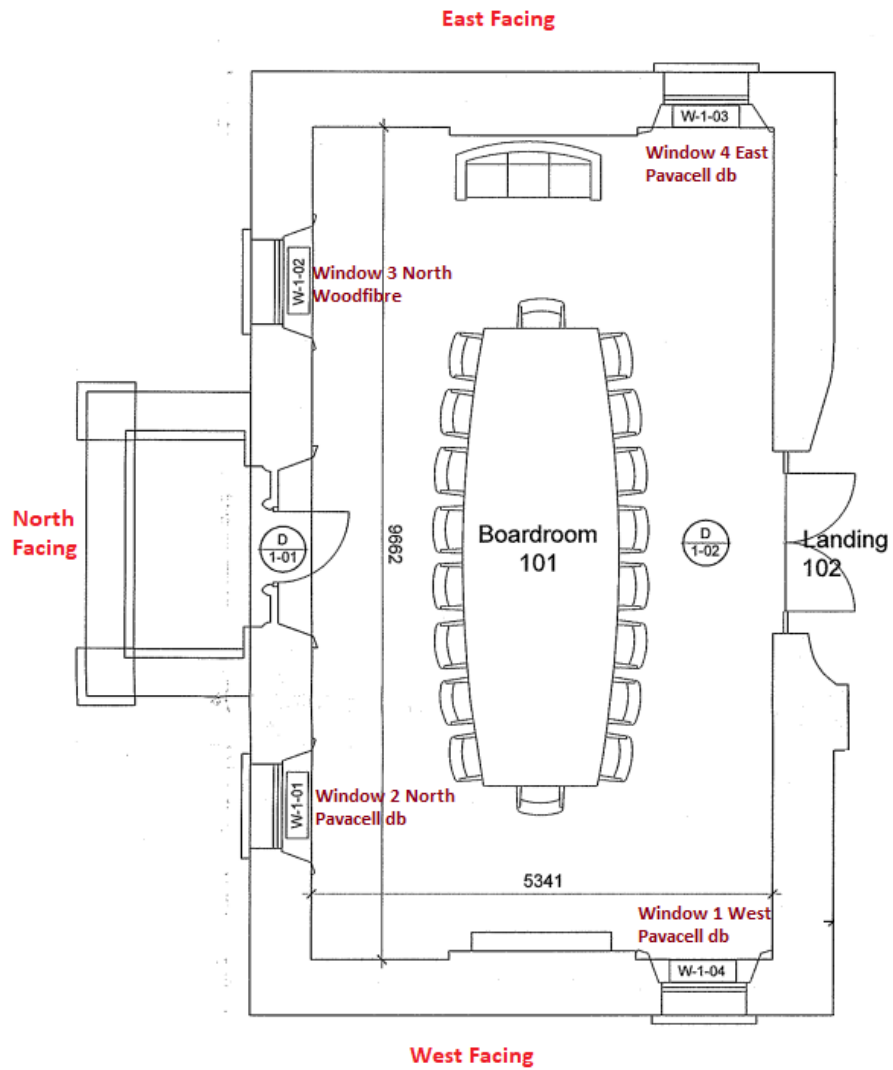
Insulation installed behind the radiators and side panels. Insulation type, Woodfibre and Pavacell db which were supplied by Soprema.

Figure 11 Boardroom window numbers with insulation types

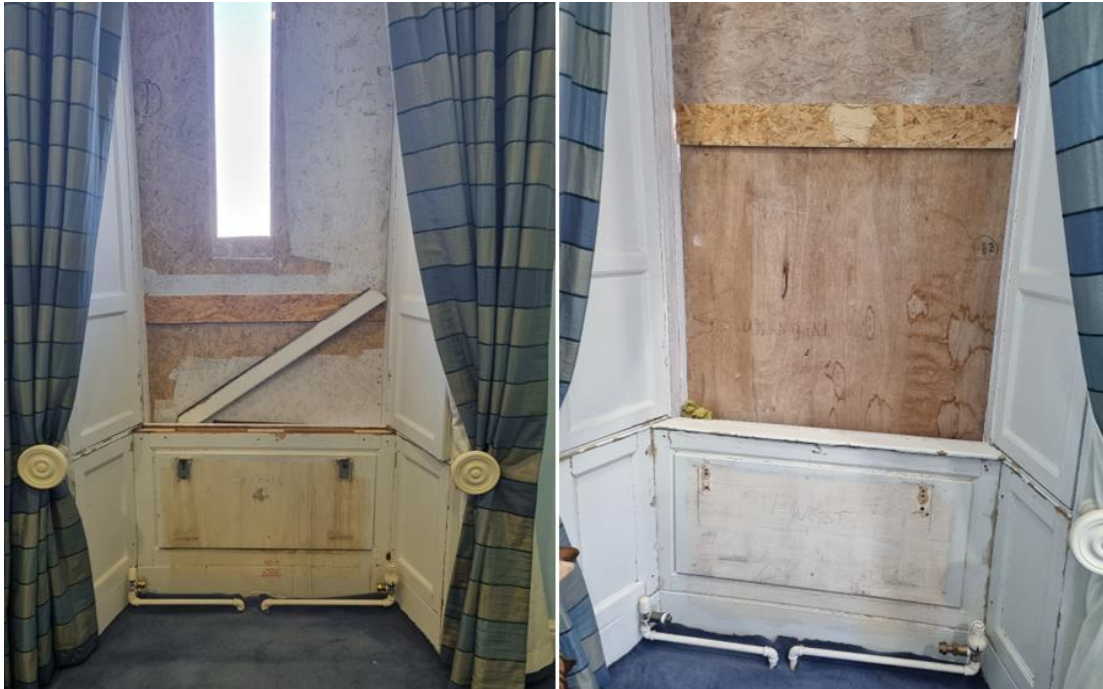
Maclyn staff are not required on site. All planned works in the boardroom have been implemented while the windows are being refurbished in their workshop. All of the window have been identified and openings secured with 20mm ply wood.

Figure 16 Window openings secured with ply

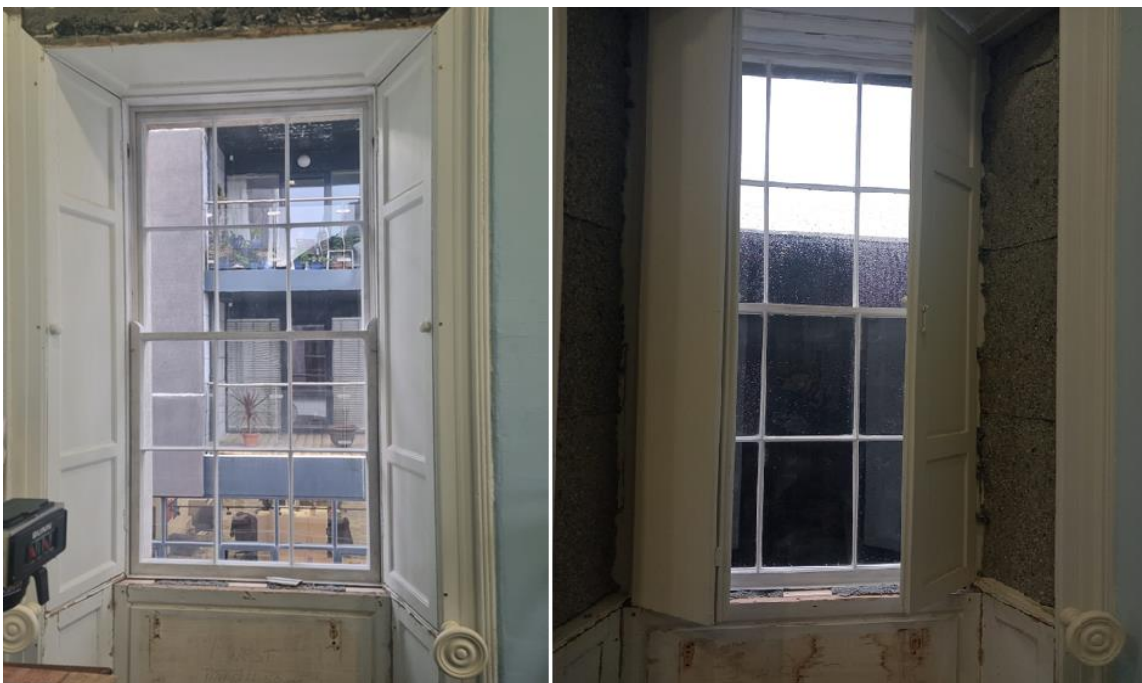
Original refurbished windows are being reinstalled as they arrive on site and painted.

Figure 17 Original refurbished windows reinstalled in the boardroom

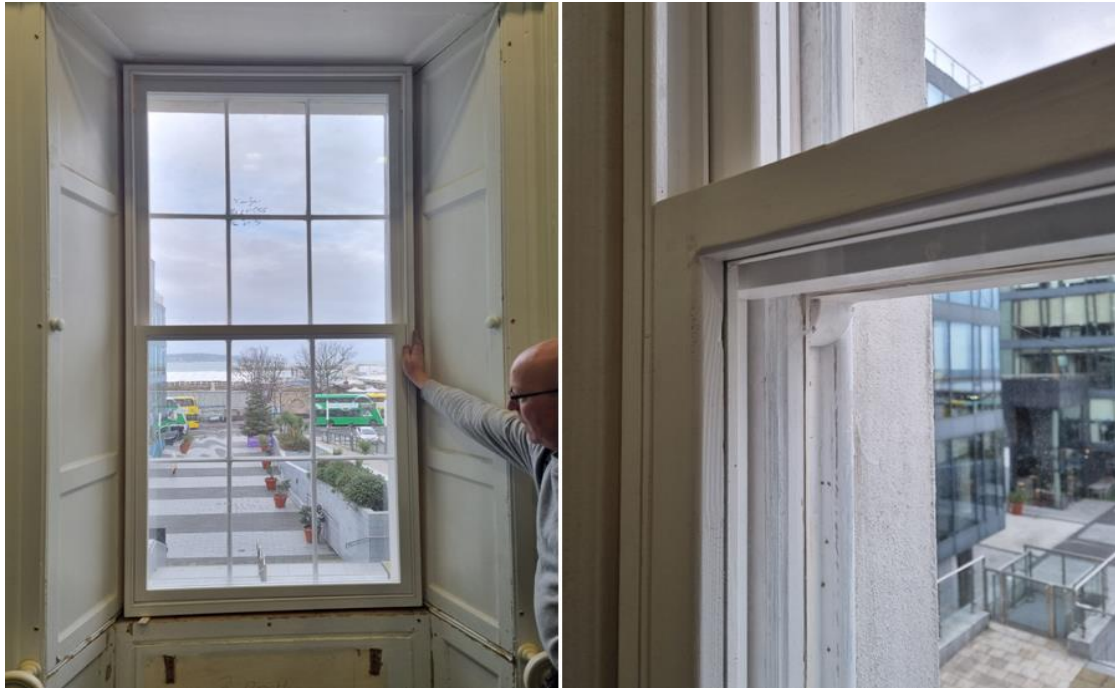
Figure 18 Mock-up of the secondary glazing for visual purposes

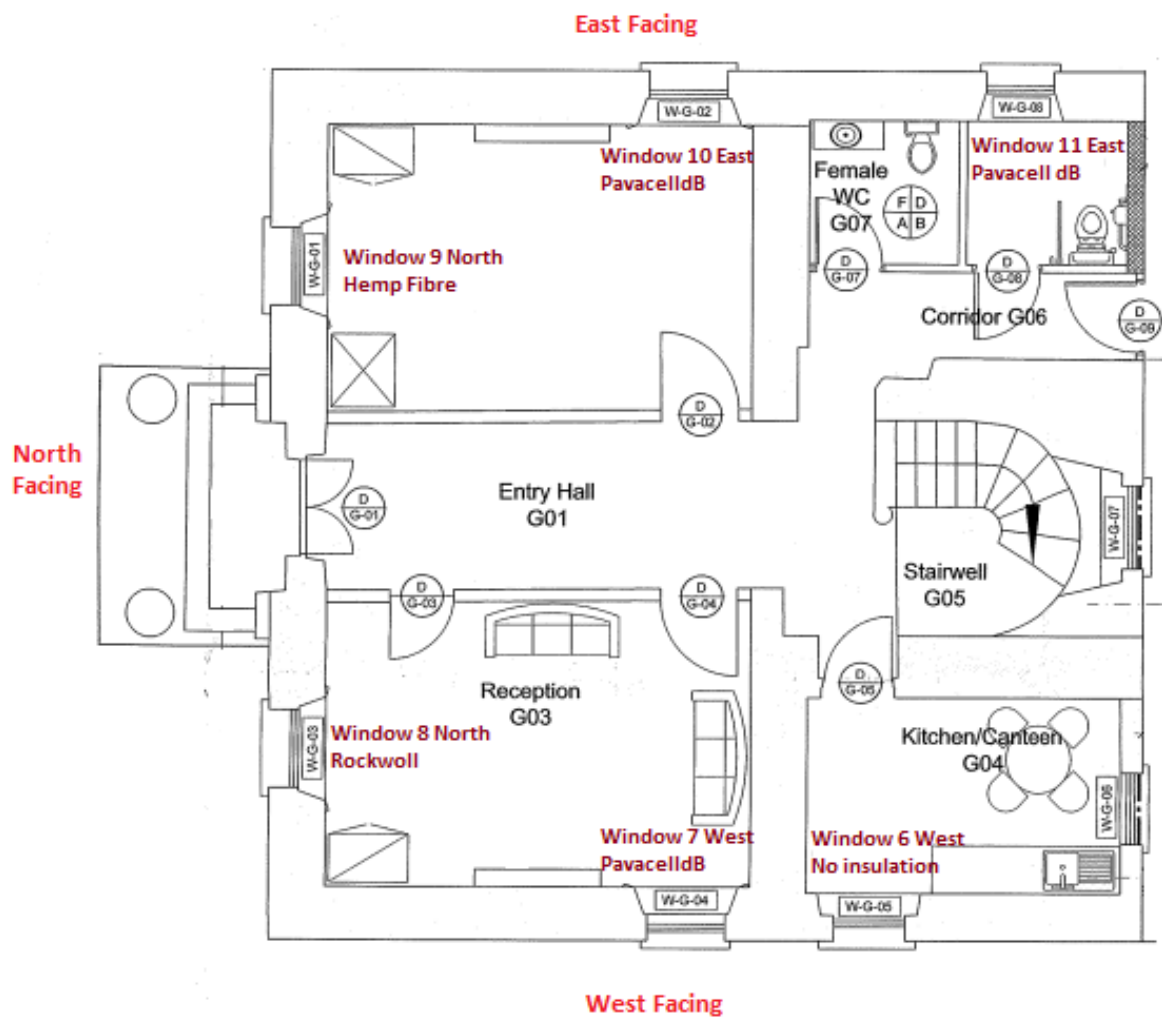
All window bay areas have been insulated in the downstairs areas and panelling reinstated. Pavacell dB has been used in the shutter box in all areas and behind radiator panels in the east and west facing windows, approximately 80mm of insulation. The downstairs north facing window bays which are to be u-value tested by the UCD team have hemp fibre insulation and rockwool both within the region of 70mm thickness behind the radiator panels. Windows outlined below. All the refurbished original sash windows have now been reinstated.

Figure 20 Ground floor window numbers with insulation types

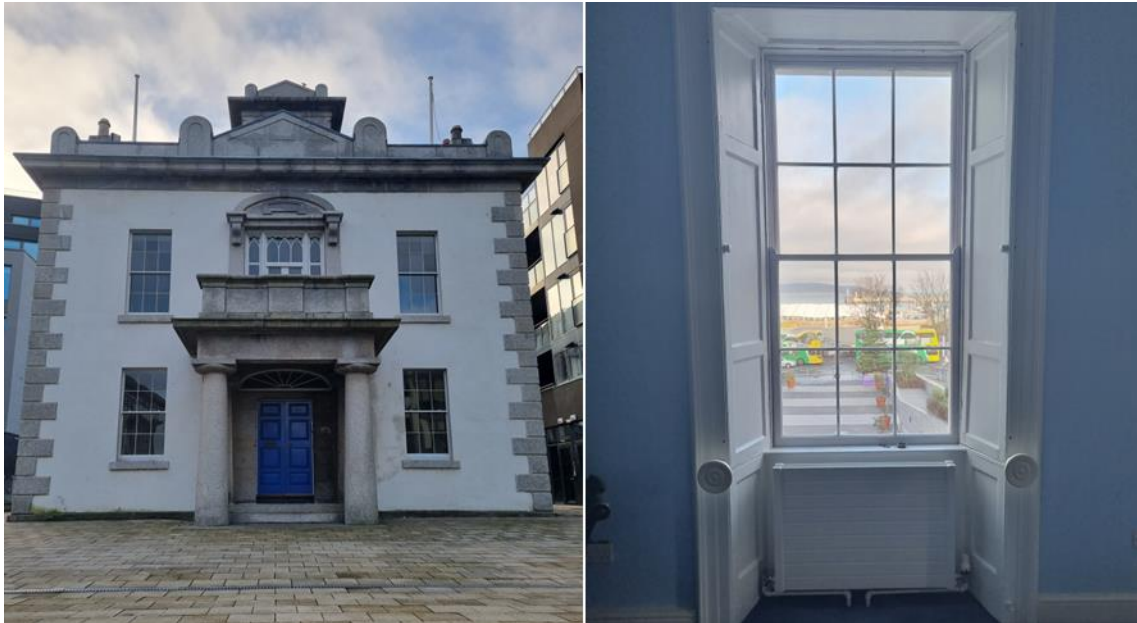
Figure 21 View of original refurbished windows - inside & out

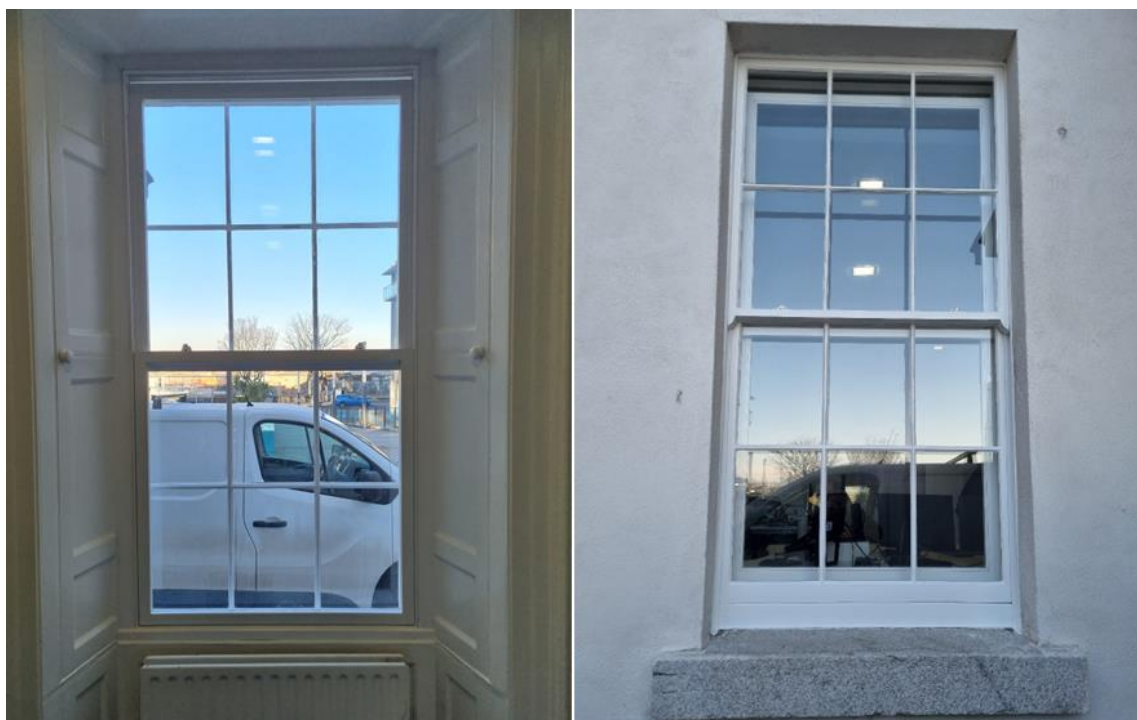
Secondary glazing installed in the downstairs offices. Window locks and handles to be changed to suit the new configuration of opening and closing the double sash setup.

Figure 23 Inside & outside view of secondary glazing complete on ground floor office

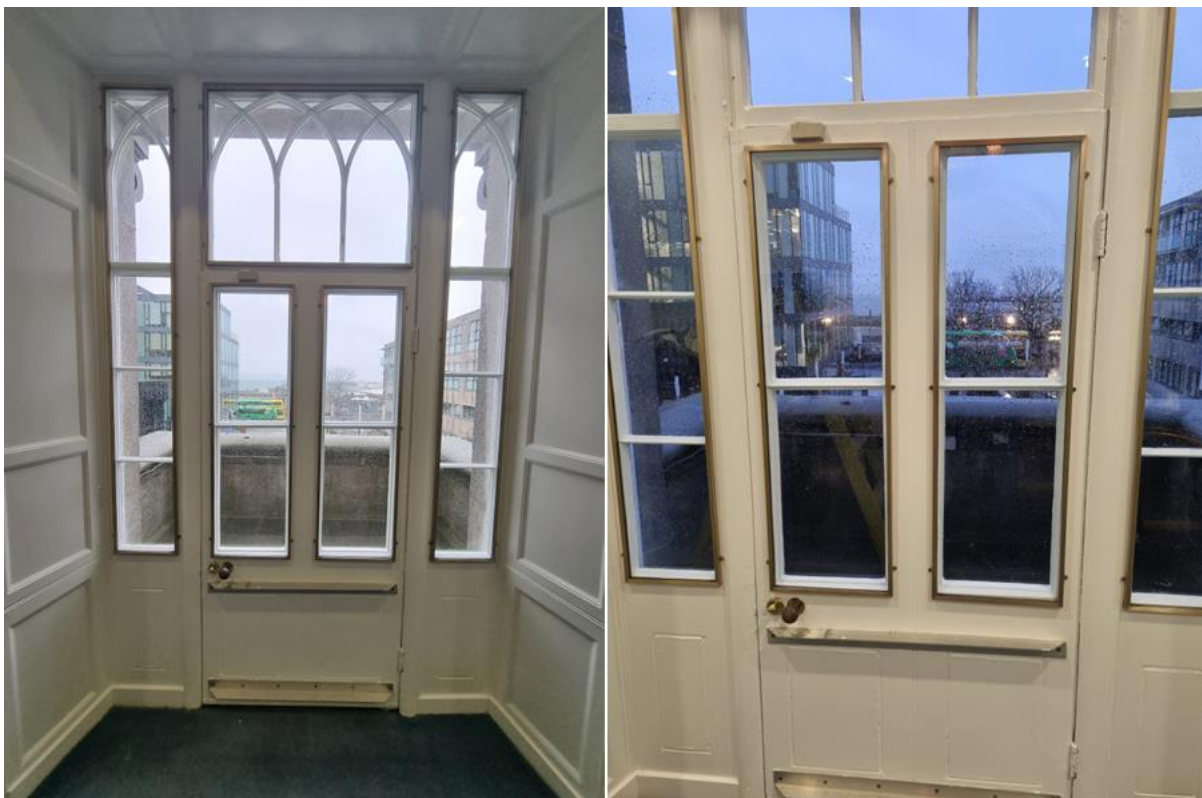
Painting the sash windows will continue through week eight and nine. The ironmongery is installed to the original and secondary sash windows, handles and locking mechanisms. The balcony doors to have bespoke brass framed double glazing panels fitted over the exposed existing single glass panels.

Figure 27 Laminate glass glazing panels on balcony doors
