**PATENT SLIP AT
DUN LAOGHAIRE HARBOUR**

**ARCHITECTURAL HERITAGE
REPORT**

10th July 2023

**Historic Building Consultants
Old Bawn
Old Connaught
Bray**

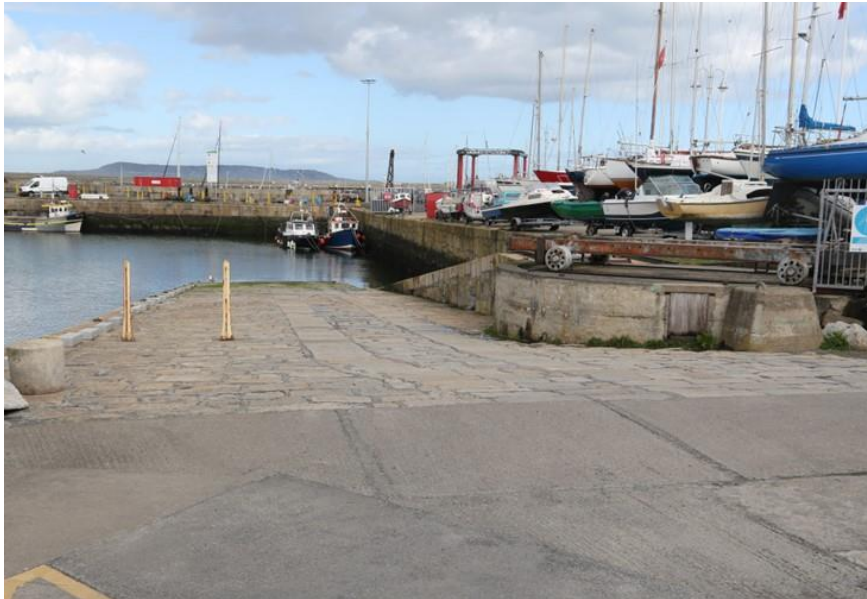
Plate 1: View of slip from landward side, looking north, with patent slip at right

The patent slip is located in the inner harbour of Dun Laoghaire Harbour, adjacent to and to the west of the boatyard that lies between the Coal Quay and Traders' Wharf. The original slipway is paved with granite flags, with two lines of flags aligned along the length of the slip to provide an even surface for the hauling of wheeled carriages carrying boats up and down the slip. Along the eastern side of the slip is the patent slip, located about 1.4 metres from the edge of the quay.

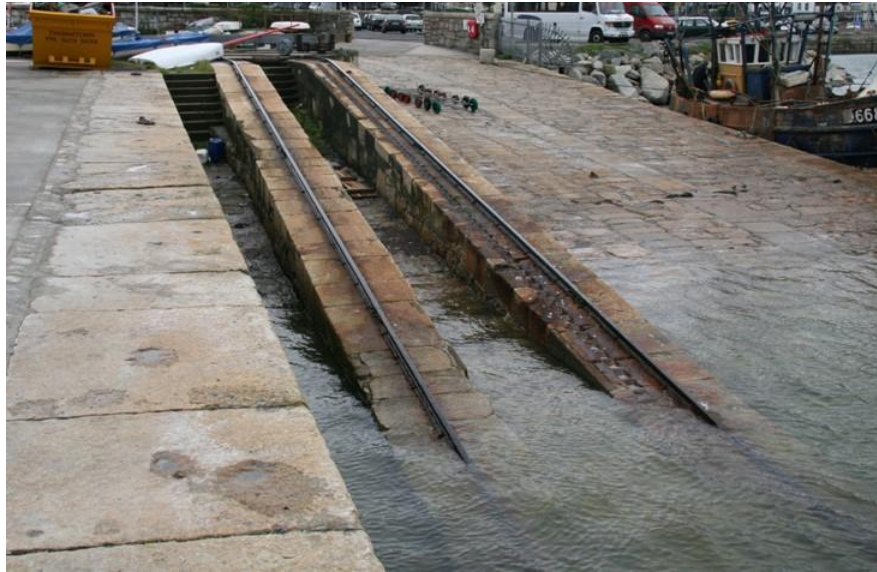
Plate 3: Patent slip, seen from the quayside at the boatyard in 2006

The patent slip consists of a pair of masonry ramps, each with a rail fixed to the top surface, while the western ramp also has an iron rack of cogs set into its upper surface. The ramps run northward down the slip at a steeper angle than the slipway, such that they gradually descend toward the surface of the slip, ultimately running below the level of the slip at the northern end.

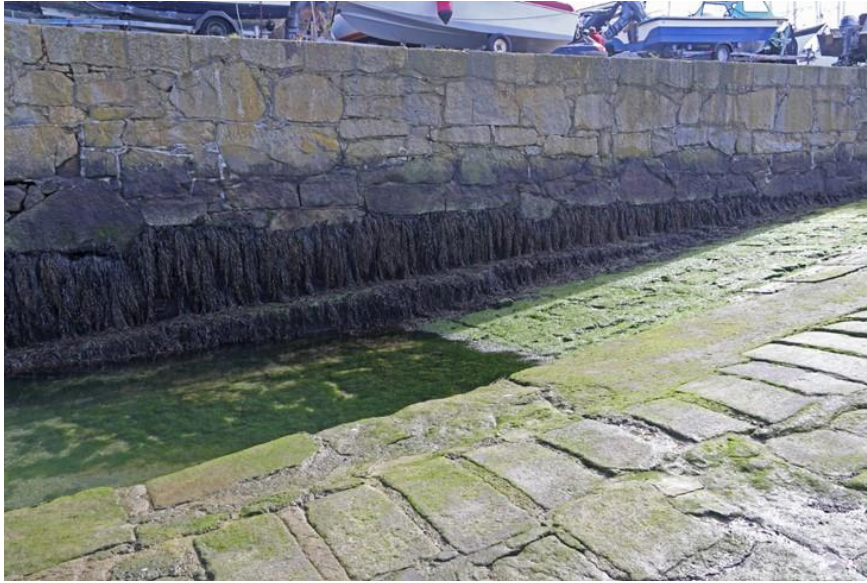
Plate 7: Lower end of patent slip, seen from main slipway

As noted above, the patent slip runs at a steeper angle than the main slipway and at its lower end, to the north, it runs below the level of the adjacent slipway, as seen in the photograph above. The photograph also shows that there is a shelf of masonry alongside the quay wall that is at the same level as the main slipway, suggesting that this section was left in place when the patent slip was constructed, and that the construction of the patent slip involved removal of part of the original slipway. The photograph below shows the lowest level of the patent slip, as seen below water level at low tide. Two lines of granite flagstones are seen, aligned with the two ramps on the patent slip, while flanking the two lines and between them the surface is of loose sand. It is not known whether there is stonework below the sand.

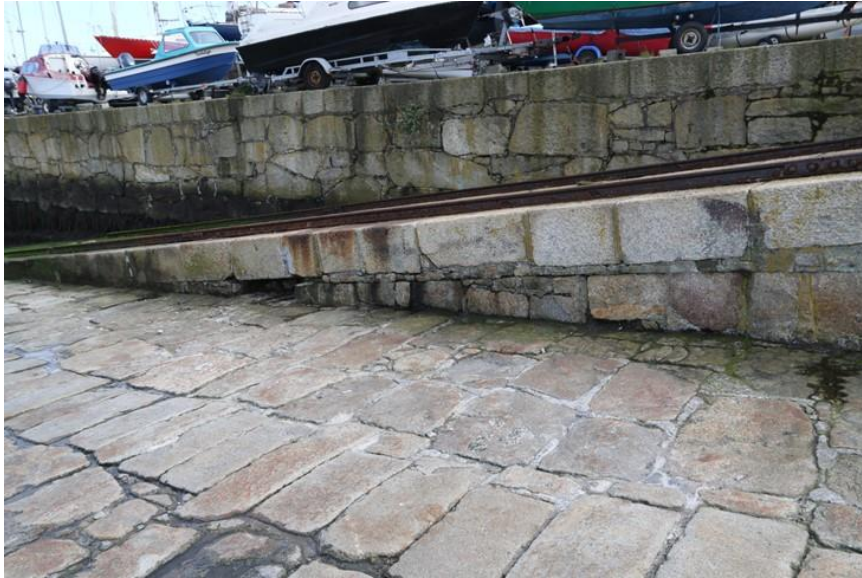
Plate 11: Western side of the lower part of the western ramp

The western side of the western ramp is faced with granite below the level of the upper stones, the stones in the masonry in the lower level varying in size, progressively smaller toward the lower end to fill the space allotted. Toward the upper end of the ramp the wall is of mass Portland cement concrete, with a smooth face, though with traces of the shuttering and lifts. The concrete facing runs along a distance of approximately 8.7 metres from the junction with the turntable. Investigation into the masonry indicates that the ramp was built off the surface of the pre-existing slipway.

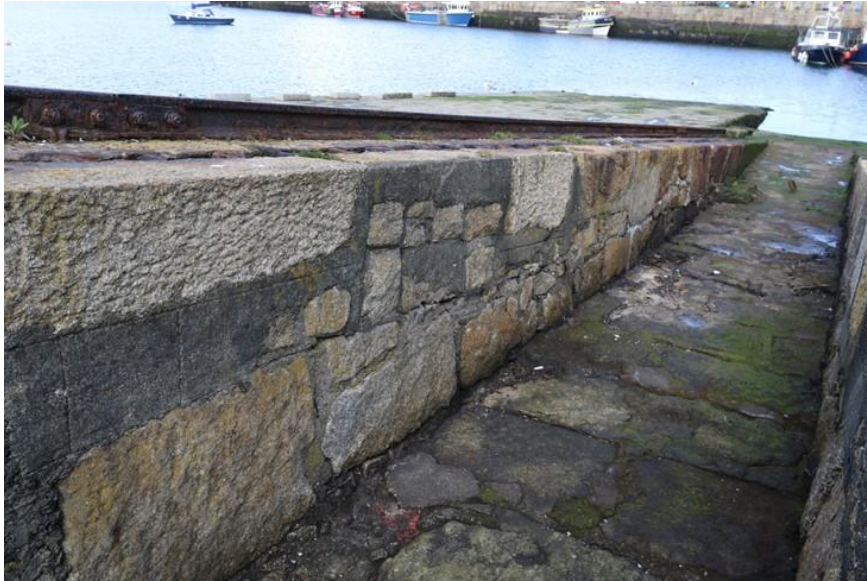
Plate 13: Eastern face of western ramp at lower level

As with the western face of the western ramp, the eastern face is of granite toward the lower end of the ramp, before it runs in the same plane as the space between the ramps. The granite stones in part of this face are large, though most are relatively small to fit the space available as the ramp descends. The upper part of this face of the western ramp is of mass concrete, with traces of the shuttering and lifts. The concrete in the upper section rises to the top surface of the ramp and across part of the top surface, more than half way toward the location of the rack of cogs.

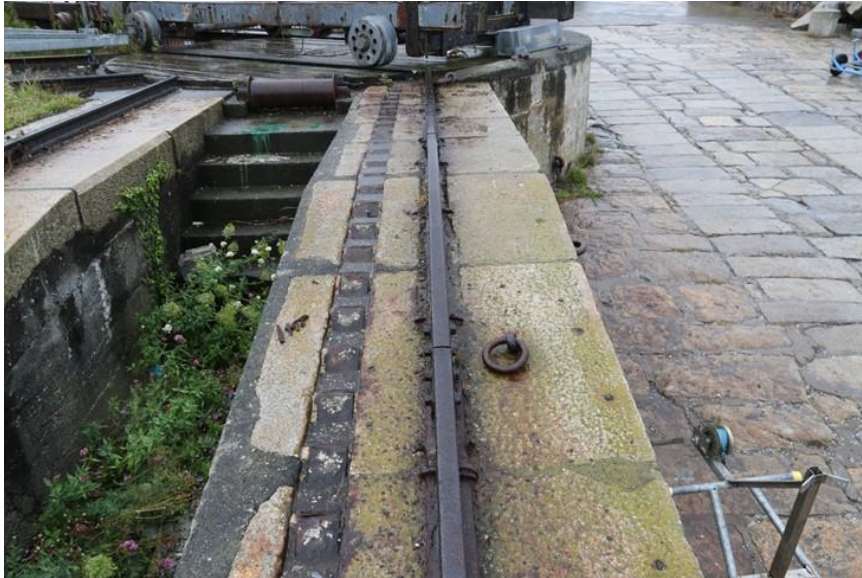
Plate 15: Top of western ramp showing iron rings

Two iron rings are set into the upper surface of the granite of the western ramp. One is located just below the break in slope, to the west of the rail, while the other is fixed on the last granite block, very close to where the ramp meets the turntable. In each case an iron eye is set into the granite, with a ring running through the eye. There are no similar rings on the eastern ramp, though it is noted that there is a similar ring on the edge of the quay near the patent slip.

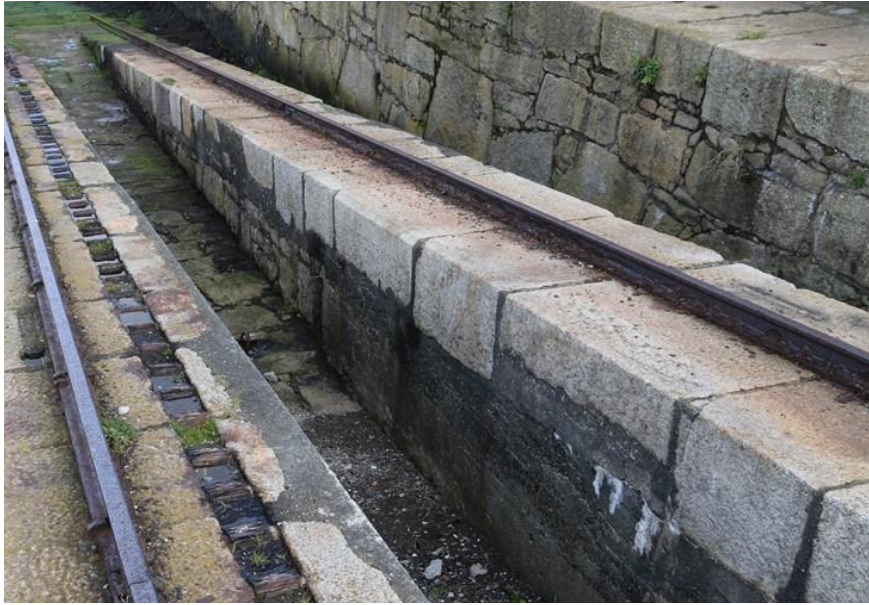
Plate 19: Western face of lower part of eastern ramp

Below the top layer of substantial granite stones the lower part of the eastern ramp is faced with smaller granite stones, while the majority of its length is faced with mass concrete, with traces of the shuttering and lifts.

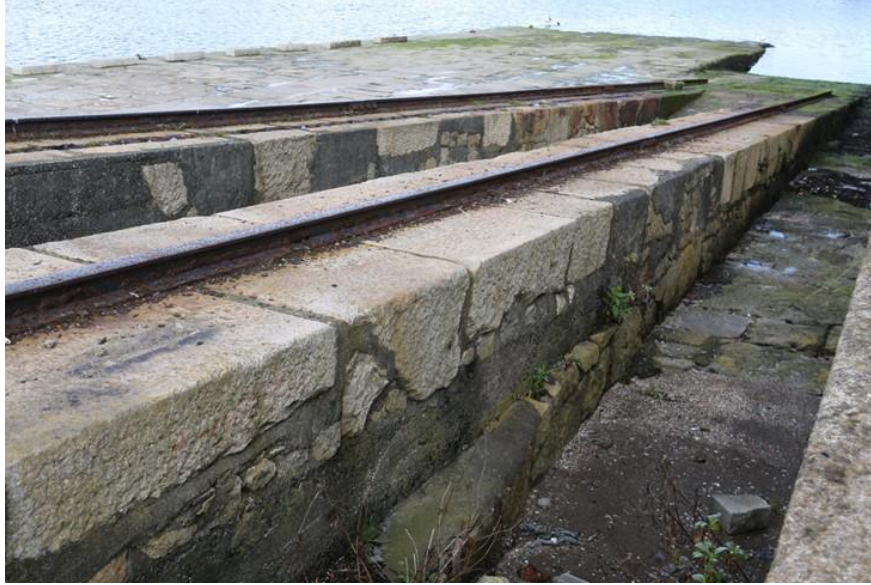
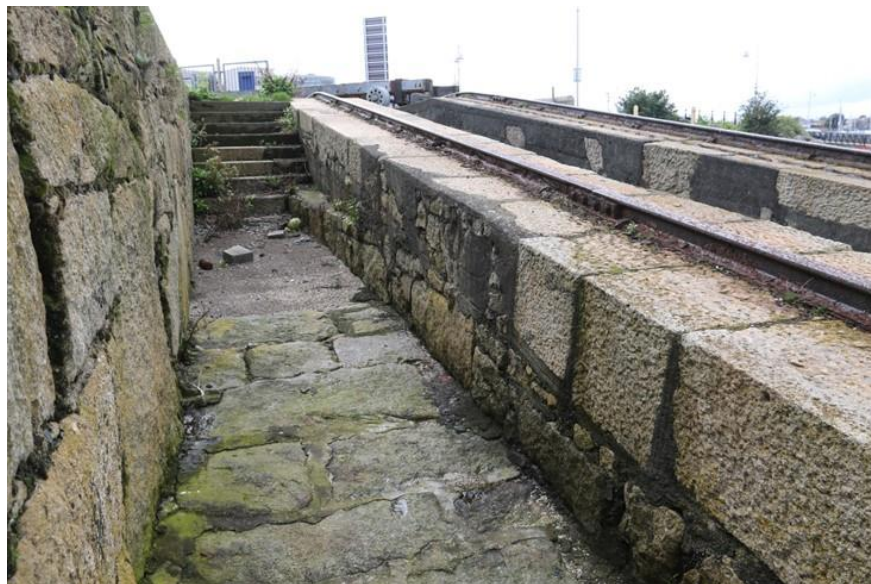
Plate 21: Lower part of eastern face of eastern ramp

At the lowest level of the eastern side of the eastern ramp the facing is mainly of smaller granite stones. In the middle and upper sections of the eastern side the ramp is faced with a mixture of granite stones and mass concrete. The concrete extends to the top surface in some places, including the angle between the top surface and the vertical eastern side. This is seen in places on both photographs, above and below.

Plate 22: Upper part of eastern face of eastern ramp

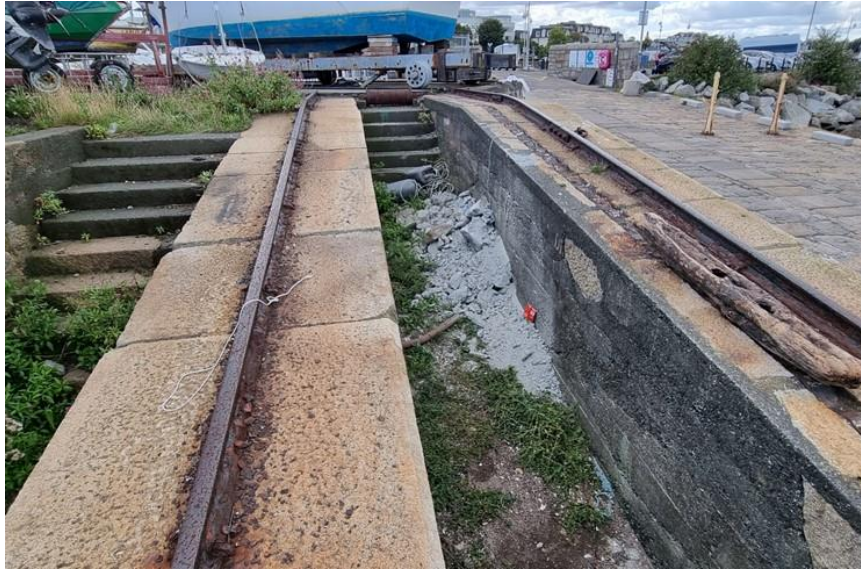
Plate 23: View to top of ramps

At a distance of 3.5 metres from the turntable the slope of the two ramps terminates and there is a break in slope where the top surface of the two ramps becomes horizontal. The two rails and the rack also turn to run horizontally along this section.

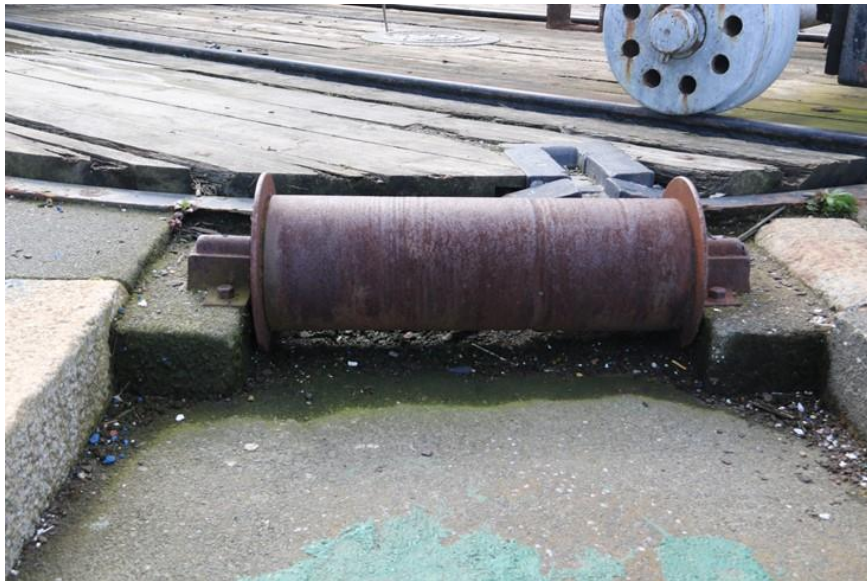
At the upper end of the area between the ramps a flight of six steps leads up to the level of the platform on the turntable. The steps are of mass concrete. At the top of the steps is a short landing of mass concrete at the end of which is a metal roller, the axles of which rest on the lower halves of bearings, the upper halves of which are missing, probably to remove the liners for scrap.

Plate 30: Roller at top of steps

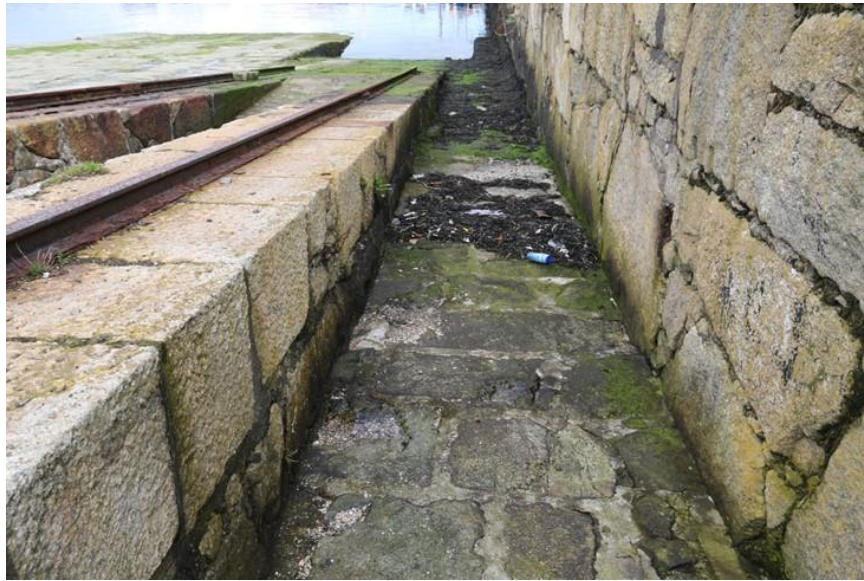
Plate 31: Area between the eastern ramps and the quay wall

The patent slip is located about 1.5 metres from the quay wall at the northern end, reducing to about 1.4 metres at the southern, or upper end. The intervening space between the eastern ramp and the quay wall is paved in a similar way to that on the main slipway and on the area between the two ramps, with roughly rectangular granite flags. Toward the upper end the surface has a covering of sand and the nature of the surface beneath is uncertain

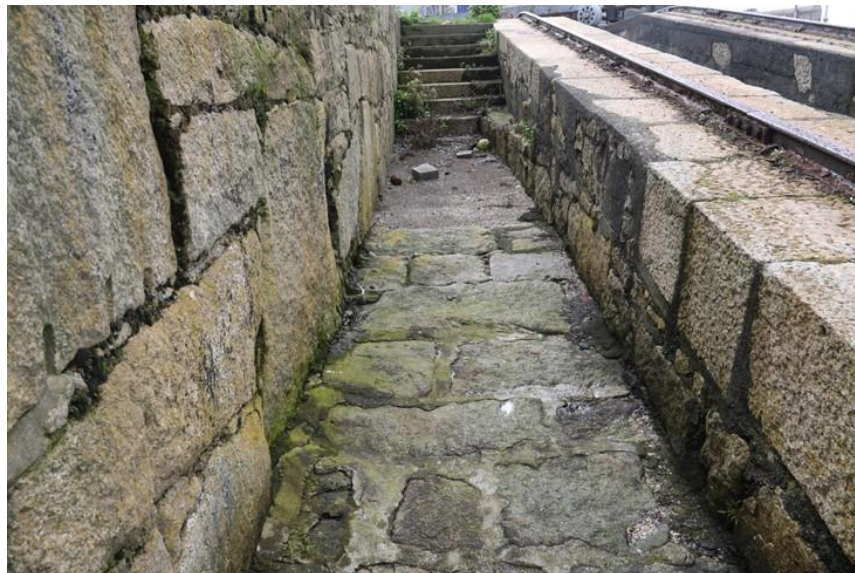
Plate 32: Upper part of the area between the patent slip and the quay

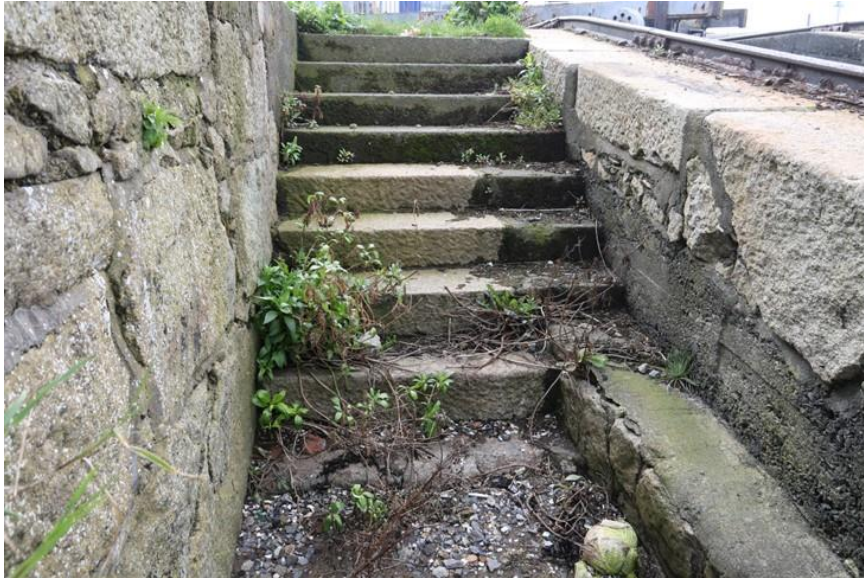
Plate 33: Steps to the east of the top of the eastern ramp

At the top of the slope of the area between the quay and the eastern ramp is a flight of nine steps, the lowest of which is almost buried. The topmost step lies just below the level of the tops of the ramps. The uppermost four steps are of mass concrete, while the lower five steps are of granite, though not across the full width, the section closest to the eastern ramp being of mass concrete. At the base of the eastern ramp a shelf of stonework projects slightly and at an increasing distance from the side of the ramp, meeting the two lowest steps at the end of the granite section. This projecting shelf commences approximately 2.6 metres from the steps. The granite parts of each of the three steps above this shelf are progressively shorter and the width of the concrete part of the steps are correspondingly wider.

The evidence for the rails being raised on ramps in the initial design prior to the addition of the turntable comes from examination of the space between the eastern ramp and the quay wall at the top of the slope. Plate 33 and Plate 34 above show the small shelf that projects from the bottom of the ramp and the granite steps adjacent. This shelf is a remnant of the original alignment of the patent slip, where it began to turn through the curve into the boatyard. The concrete sections of the lower steps follow the line of that curve. This shows that the rail was on a raised ramp and that the five granite steps indicate the original height of that ramp. The concrete at the sides of the steps and the four concrete steps above show the additional height that was added when the turntable was introduced in 1912.

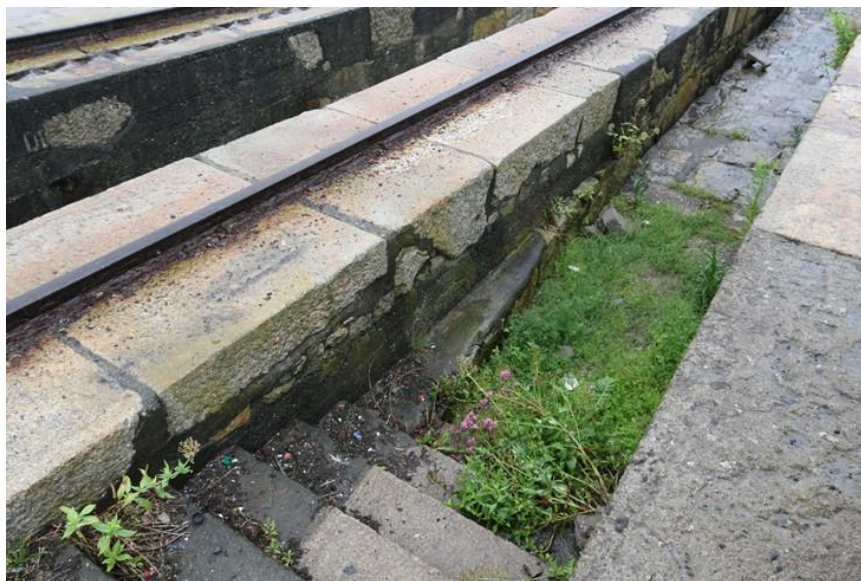
Plate 34: Steps adjacent to eastern ramp

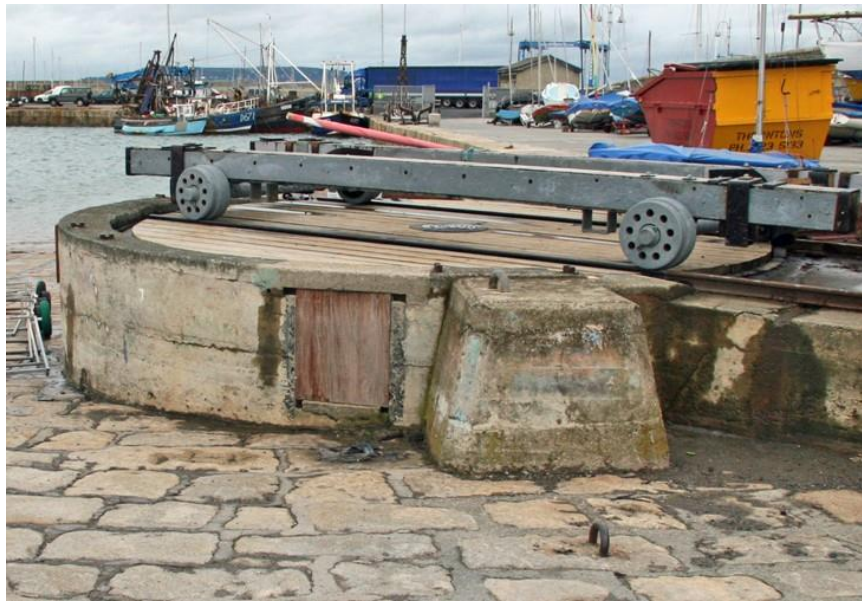
Plate 35: View of turntable from the south

The turntable consists of a cylindrical wall of mass concrete and a circular timber platform. The upper surface of the turntable is horizontal, though the height of the cylinder varies due to the slope of the slipway, the maximum height being approximately 1.4 metres. The overall diameter of the concrete cylinder is 6.7 metres. The greater part of the cylinder is formed with a smooth, fine-grained mass concrete, with the shuttering faintly visible. The top surface is of somewhat coarser concrete and is of a separate pouring, with a plainly visible break between the two sections. This upper part has rounded arrises on the inner and outer margins.

There is a significant amount of damage through rot in the timbers on the surface of the turntable, as seen in the photograph below. It is noted that in the photographs taken on the visit to the site in 2006 the boards looked relatively clean and fresh (see Plate 35 above and Plate 65 below). On this evidence it seems likely that the lifespan of the boarding in the damp conditions is less than twenty years.

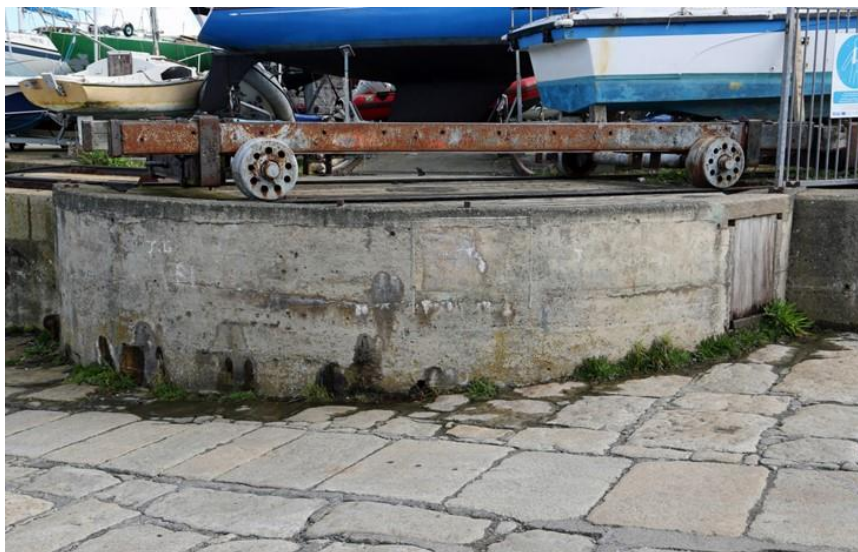
Plate 36: View of turntable from the west

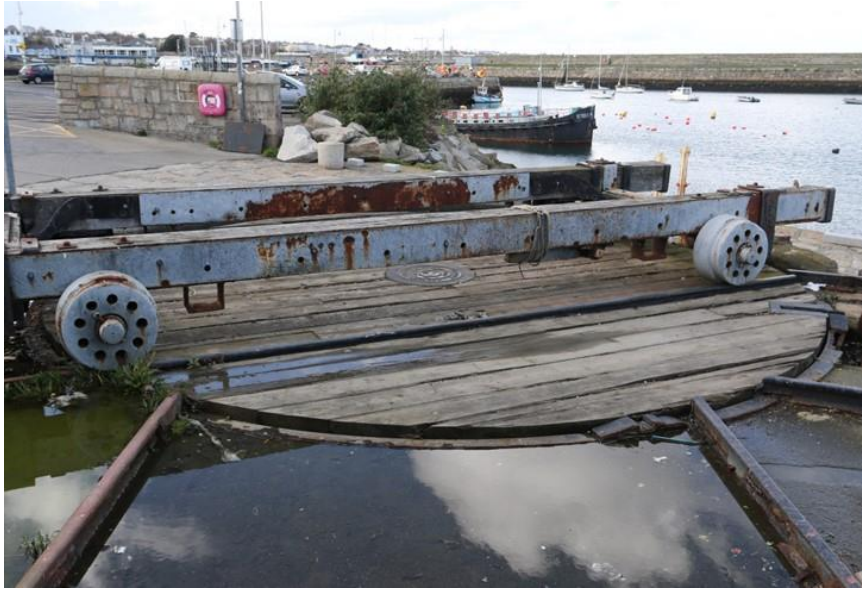
Plate 37: Turntable platform, seen from the south-east

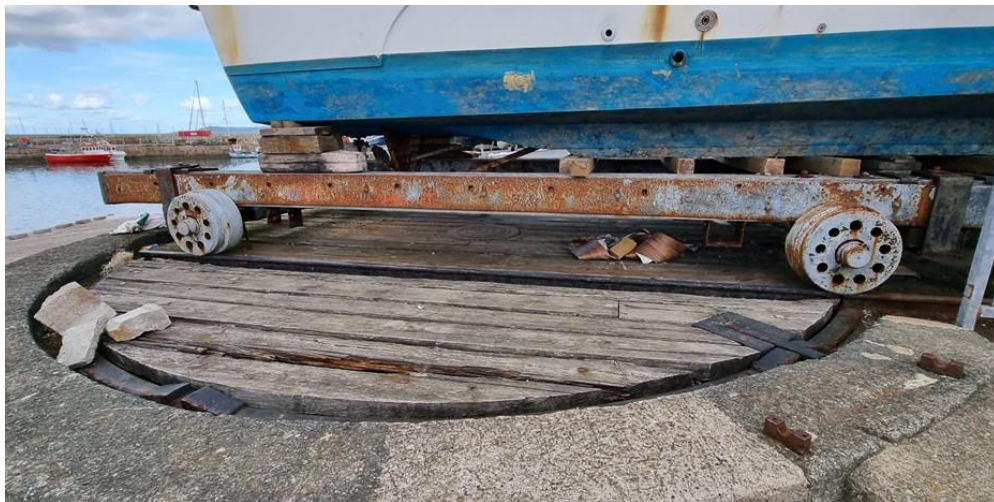
The turntable platform is faced with timber boards set in a ring of iron or steel and not extending to meet the concrete external walls. The inner diameter of the cylinder within the concrete enclosing wall is approximately 5.7 metres. Rail track of the same type as that on the ramps runs across the width of the platform, set symmetrically.

Plate 38: Turntable platform, seen from the south

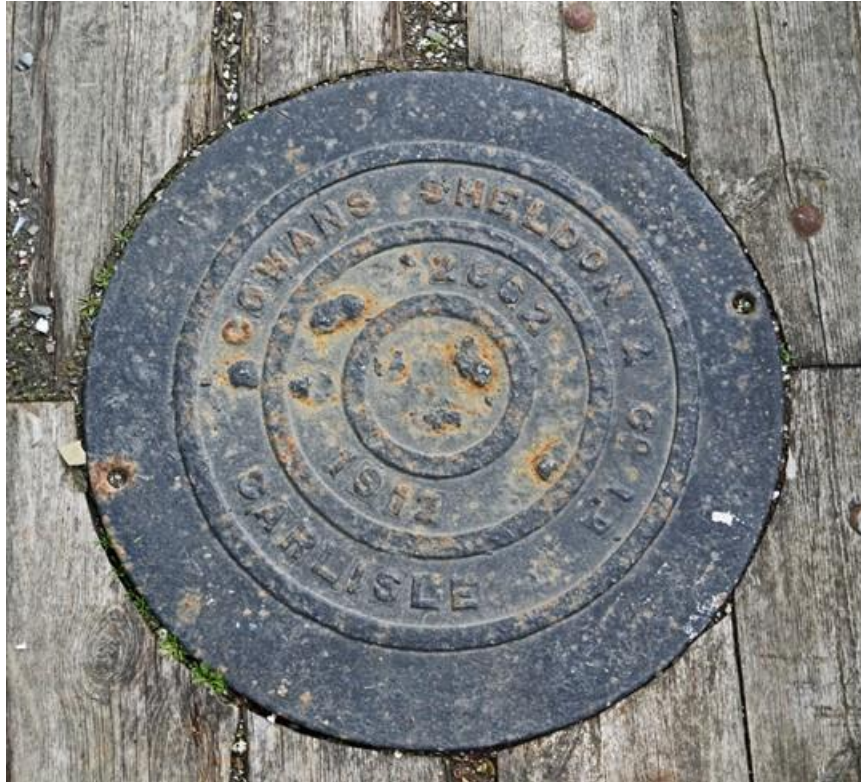
Plate 41: Hub cover in the centre of the platform

In the centre of the platform is a metal plate bearing the maker's name "COWANS SHELDON & C^O. L^D", "CARLISLE", and the numbers "2862" and "1912". The latter number is clearly the date, as this accords with the date of installation of the turntable as given in the annual report of the Board of Public Works. The other number may be a catalogue reference. At six points around the circumference of the turntable there are plates set into the edge of the turntable, each originally having a rectangular bar that pivots at the end furthest from the edge, though in some cases these are missing. These fold down into a receiving plate on the steel surround to lock the turntable in place when necessary.

As has been seen above, the turntable was constructed in 1912 and noted in the annual report of the Commissioners of Public Works for the year ending 31st March 1913. The date on the hub cover in the centre of the turntable platform identifies the manufacturers as Cowans, Sheldon & Co Ltd of Carlisle.

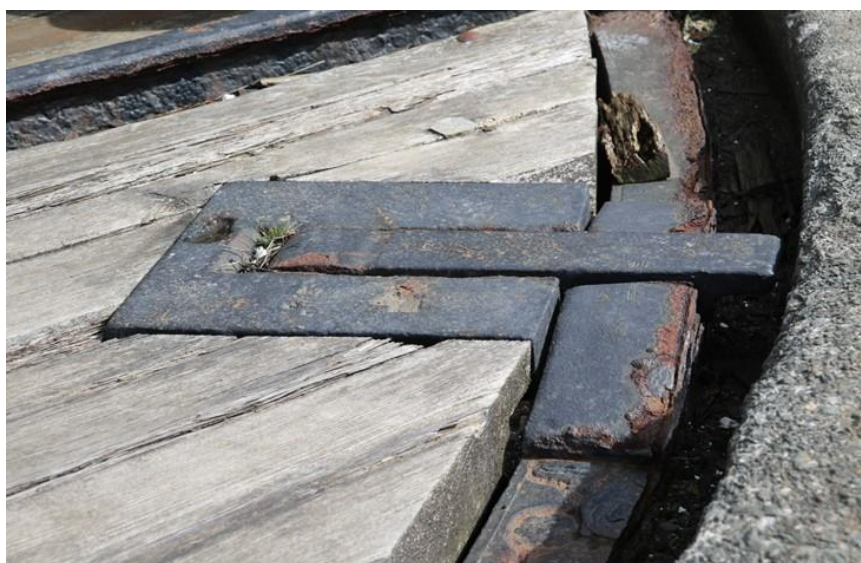
Plate 42: Lock at perimeter of the turntable

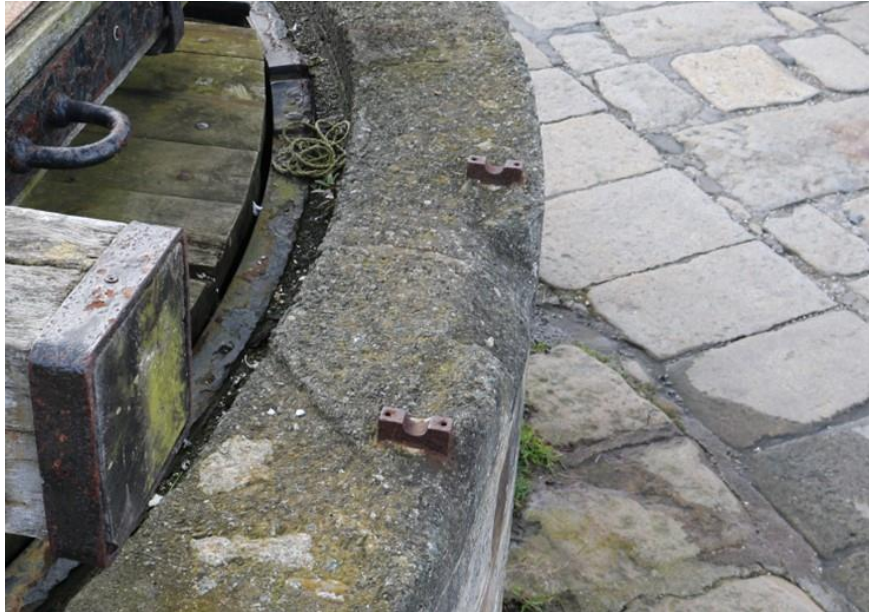
Plate 43: Seatings of bearings at western side of turntable

Three pairs of rails meet the turntable, representing directions in which a boat could be moved. Diagonally opposite each of these there is a pair of seatings for bearings fixed to the upper surface of the concrete surround of the turntable. In each case only the lower seating is present, while the upper seatings, the roller and the bearings themselves are missing. Directly beneath the bearings on the western side of the turntable an iron ring is set into the concrete perimeter, with an iron shackle fixed into the ring.

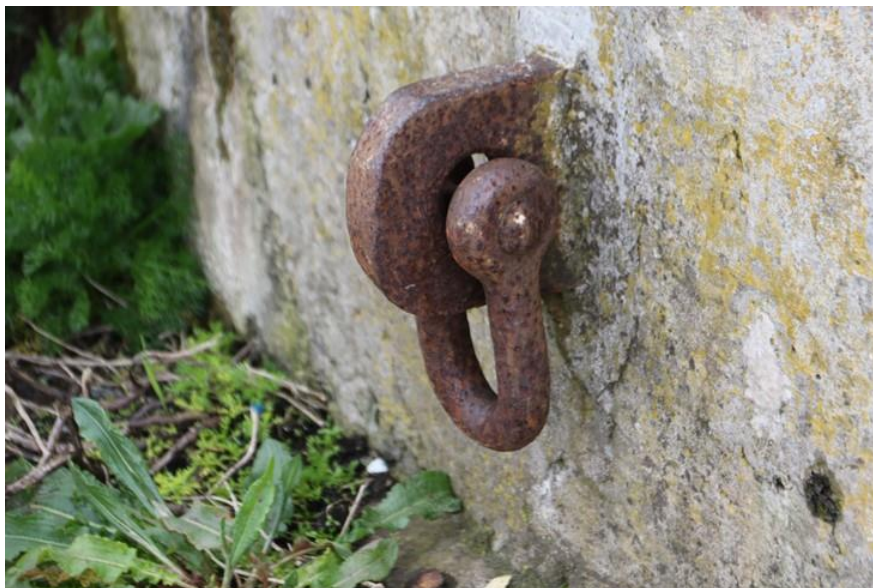
Plate 44: Shackle below bearing on western side of turntable

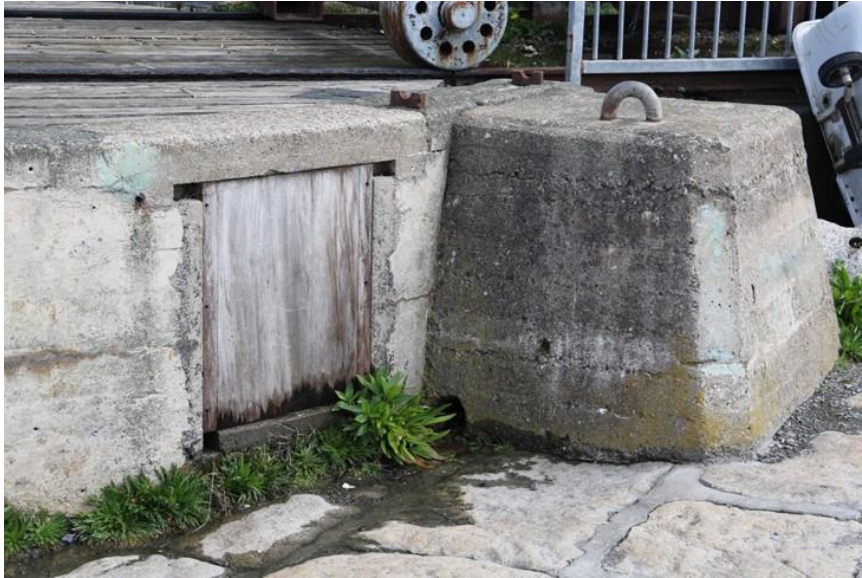
Plate 45: Door and pyramid of concrete on south-western side of turntable

In the side of the concrete surround of the turntable, on the south-western side, is a small wooden doorway. It is presumed that this gives access to the mechanism for turning the turntable. Adjacent to it is a truncated pyramid of mass concrete with chamfered corners on the outer margin. This feature rises to the same height as the concrete surround of the turntable, and it has an iron ring cast into its upper surface. The feature is located adjacent to the pair of seatings of bearings that lie diametrically opposite the slope of the patent slip. The concrete pyramid is of a different consistency than the adjacent turntable and may be a later addition.

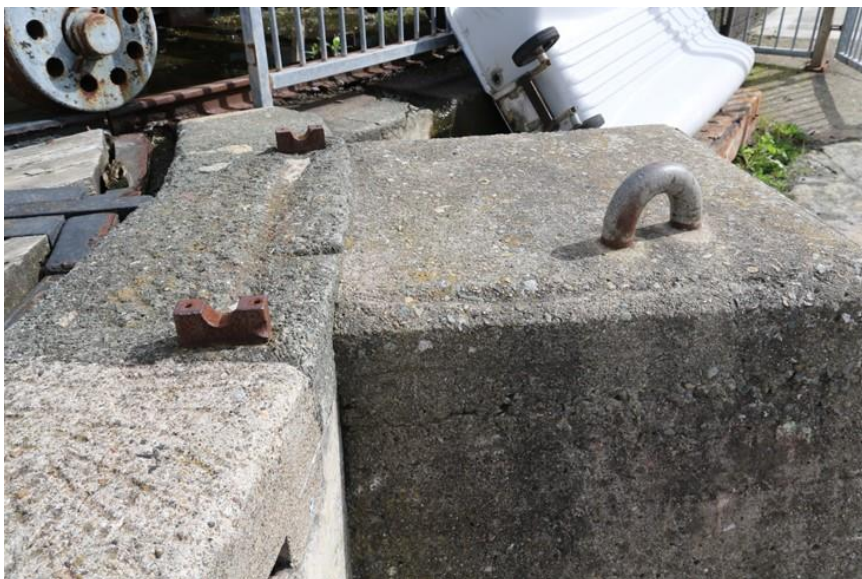
Plate 46: Bearings and ring on south-western side of turntable.

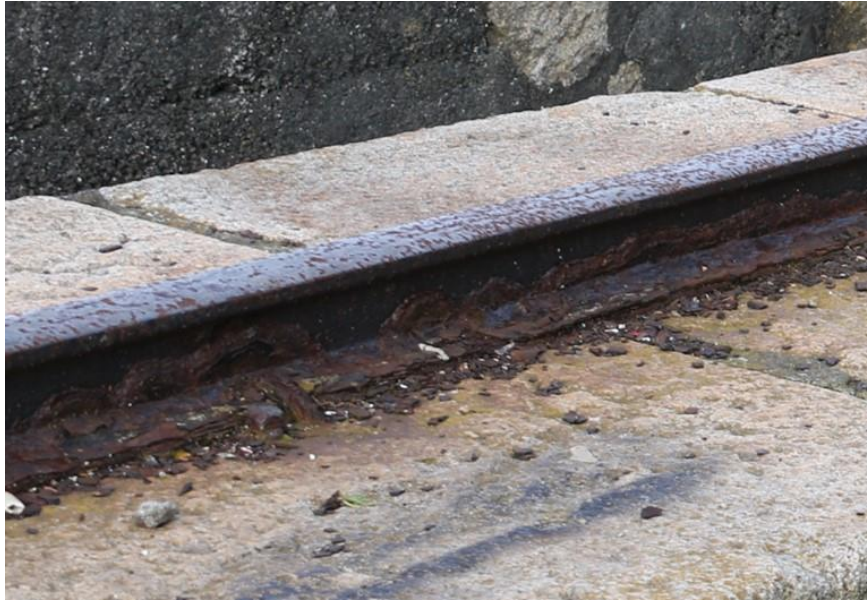
Plate 47: Detail of rail on top of ramp

The rails on each of the ramps are flat-footed, i.e., they have a head on which the wheels run, a spread-out foot that is broader and thinner than the head, with the two connected by a vertical web. The rails are fixed to the granite base by spikes, which are steel rods, bent to a right angle and driven into holes in the granite surface.

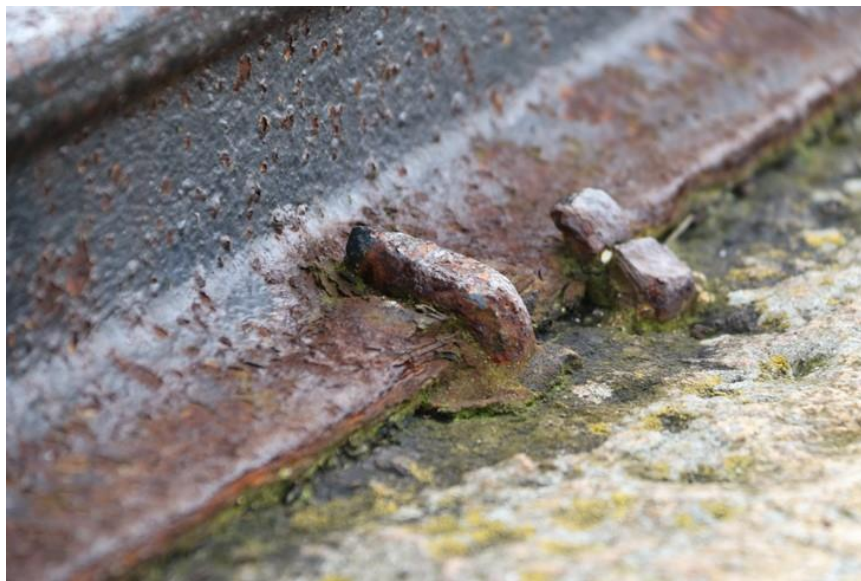
Plate 48: Detail of fixing of rail

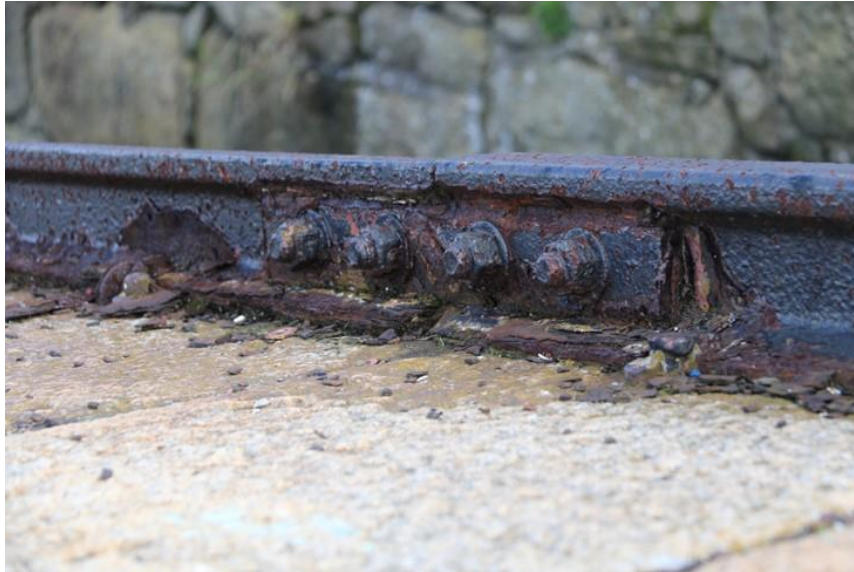
Plate 49: Fishplate joining rails

Where two lengths of rail are joined the rail ends are butted together and joined by metal fishplates set into the web on either side and secured by bolts and nuts run through holes in the rails and fishplates. At each join there are two bolts in each rail.

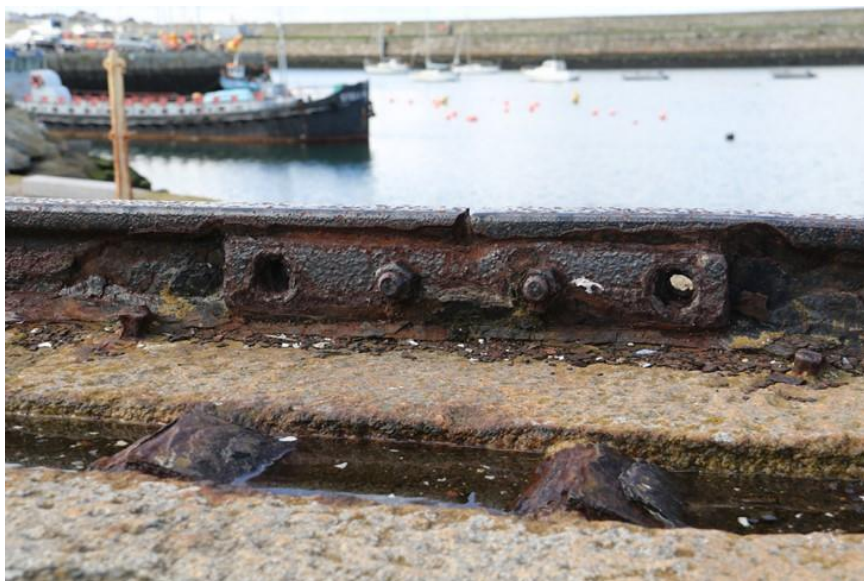
Plate 50: Fishplate joining rails

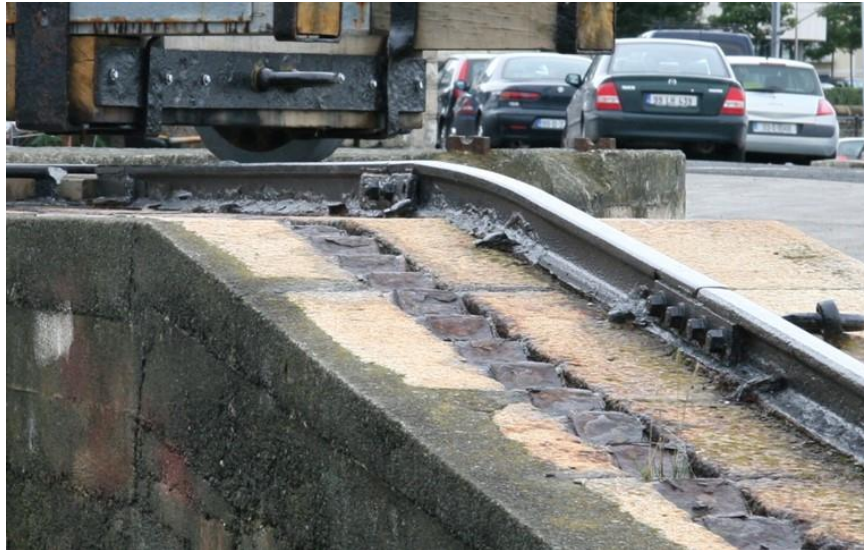
Plate 51: Bend in rail at break in slope

Where the break in slope occurs at the top of each ramp a short length of rail is bent to cross the angle and is joined to straight lengths of rail near to the angle.

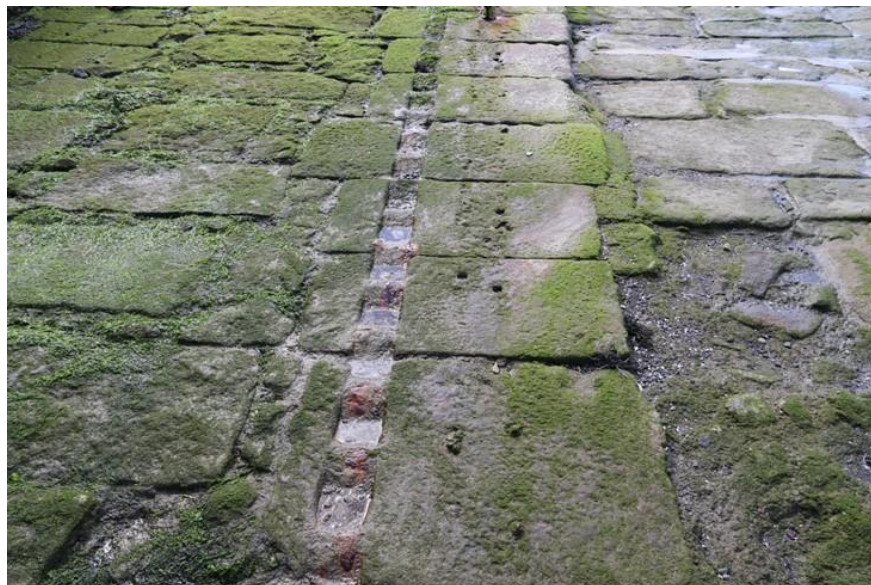
Toward the bottom of the patent slip the rails stop, while the rack continues onward to the bottom. This is not part of the original design, as there were rails along the full length of the patent slip originally, though the rails have either become detached from the base through failure of the fixings or they have been deliberately removed. The holes for the fixings of the rail are visible in the photograph below. The rails are missing from approximately 17.7 metres of the patent slip at the northern or downhill end.

Plate 54: Detail of rack and fixings for rail on lower part of patent slip

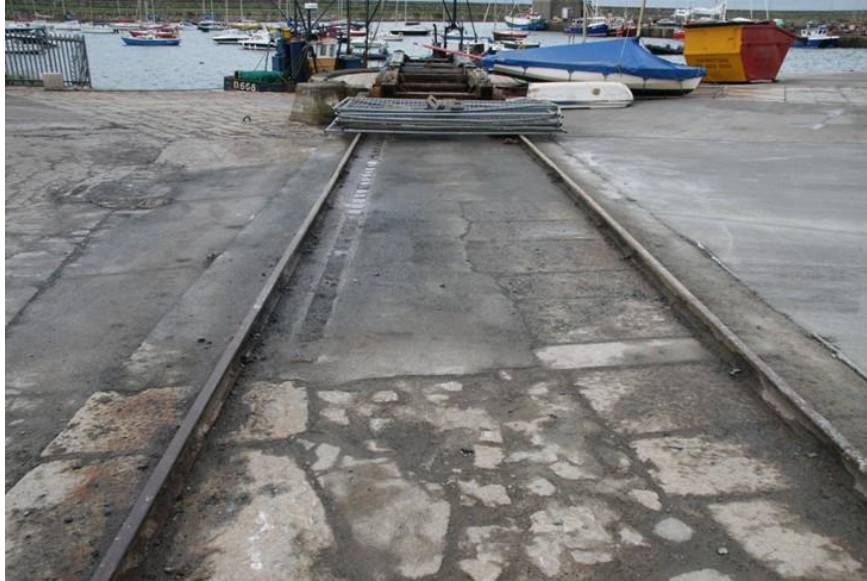
Plate 55: View toward turntable along longer rails in boatyard

Two lines of rail track run away from the turntable into the boatyard. The longer of the two runs to the south-south-east for a distance of 18.5 metres. The cog rack runs only for the first 16.4 metres from the turntable. The part of the rail siding that is nearest to the turntable is set in mass concrete, though there is granite across part of the width near the southern end of the rail, particularly on the eastern side.

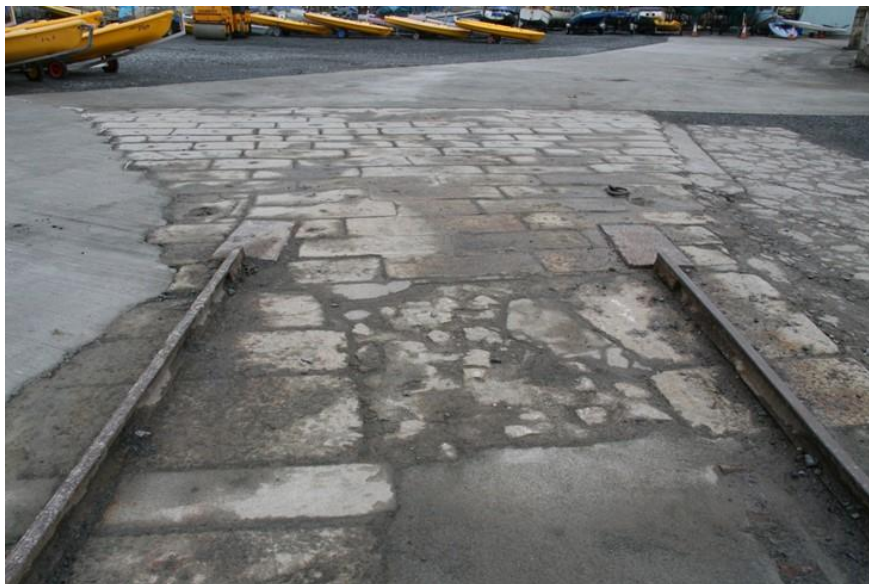
Plate 56: View of end of longer rails in boatyard

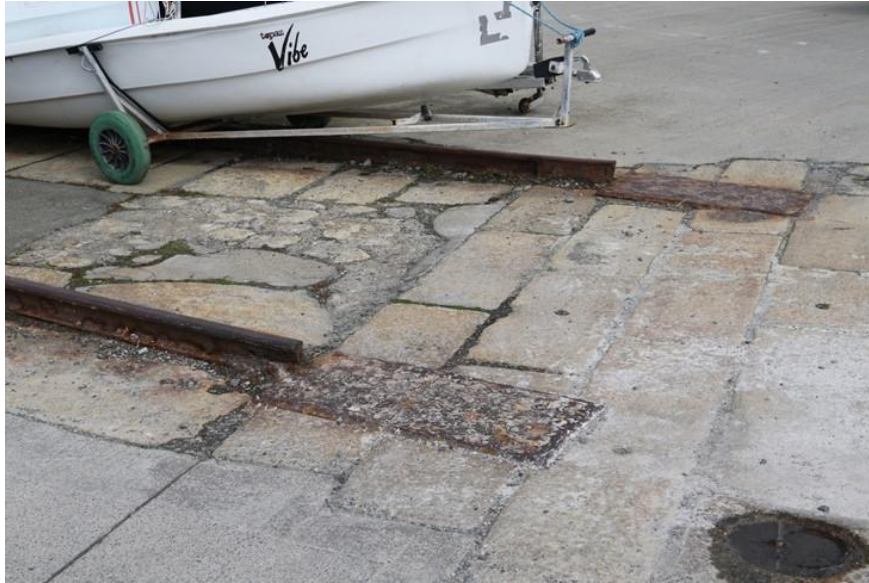
Plate 57: Southern end of rail siding at boatyard

The western rail is slightly shorter than the eastern rail at the southern end of this siding and beyond the ends of each rail is a rectangular metal plate set into the surface of the ground and measuring 0.95 by 0.41 metres. From this point granite paving continues, with flagstones laid in courses that increase in length, the paved area extending to 7.8 metres broad where it terminates some 7.2 metres from the end of the rails.

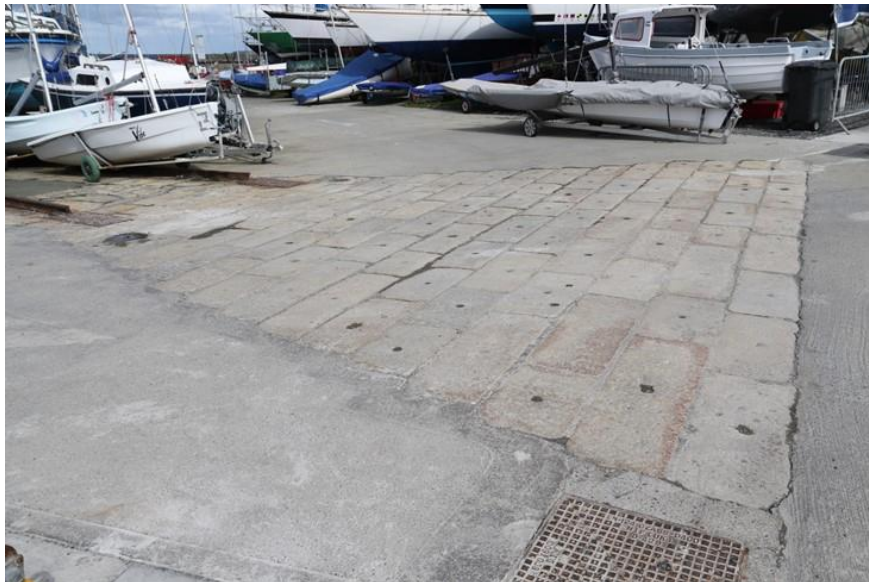
Plate 58: Paved area beyond rail siding in boatyard

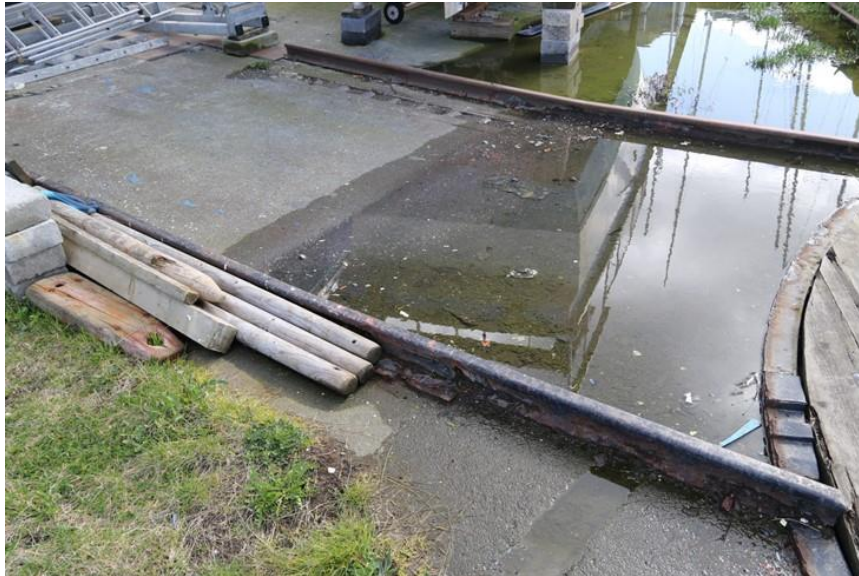
Plate 59: Eastern siding, adjacent to turntable

A second siding runs eastward from the turntable over a shorter distance than the southerly siding. The rails run for a distance of 4.5 metres, while the rack terminates 3.85 metres from the turntable. As with the southerly siding there are rectangular metal plates set into the ground immediately beyond the ends of the rails. The paving along the entire length and width of the siding is of mass concrete.

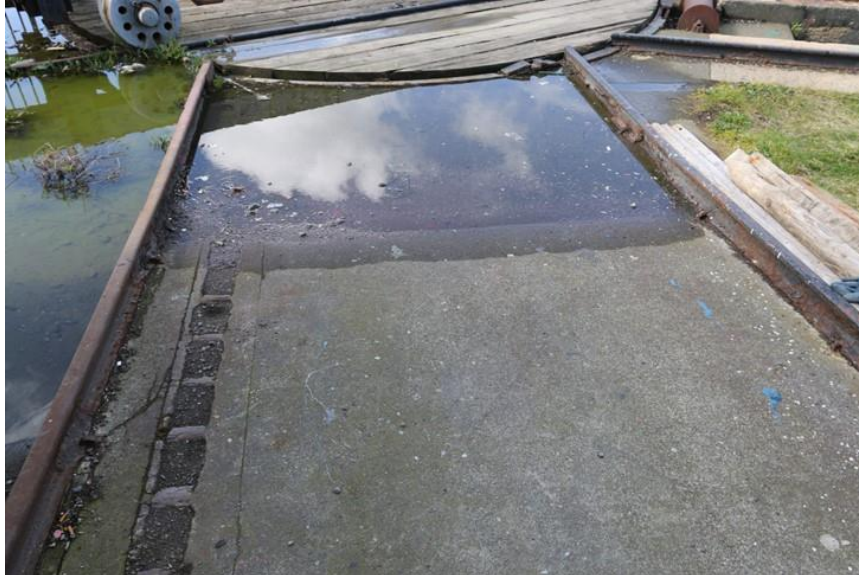
Plate 60: View toward turntable along eastern siding
