**PATENT SLIP AT
DUN LAOGHAIRE HARBOUR**

**ARCHITECTURAL HERITAGE
REPORT**

10th July 2023

**Historic Building Consultants
Old Bawn
Old Connaught
Bray**

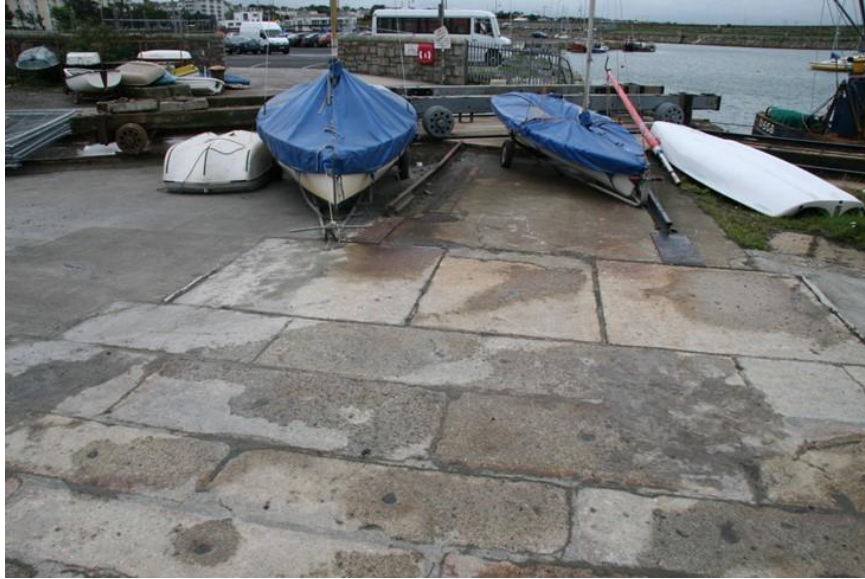
Plate 61: Paving at end of eastern siding

Beyond the ends of the rails of the eastern siding there is an area of granite flagstones, laid in regular courses, and extending 4.1 metres beyond the ends of the rails. This paving increases in width to a maximum of 6.7 metres at the eastern end, within the boatyard. The surface surrounding this paving is of mass concrete.

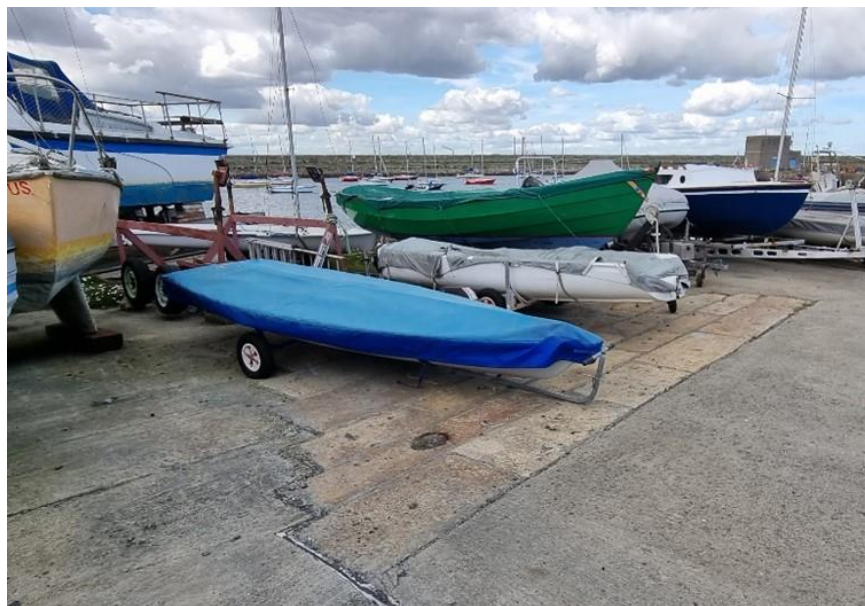
Plate 62: Paving at end of eastern siding

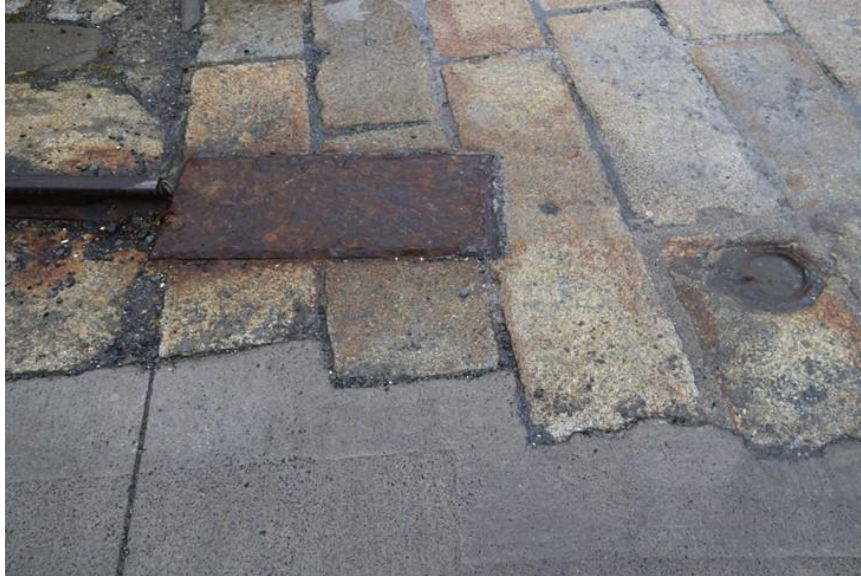
Plate 63: Plate and iron ring at end of rails on southern siding

A short distance beyond the ends of the rails on the southern siding there are iron rings set flush into the granite flagstones. These are similar in type to those near the top of the western ramp, except that they are recessed into the stone. Two rings are located at the southern siding, one close to the end of each rail, while there is one on the paving beyond the eastern siding, near to the eastern end of the paved area. The location of that ring may be seen in Plate 62, just above the nearest granite flag near bottom centre of the photograph.

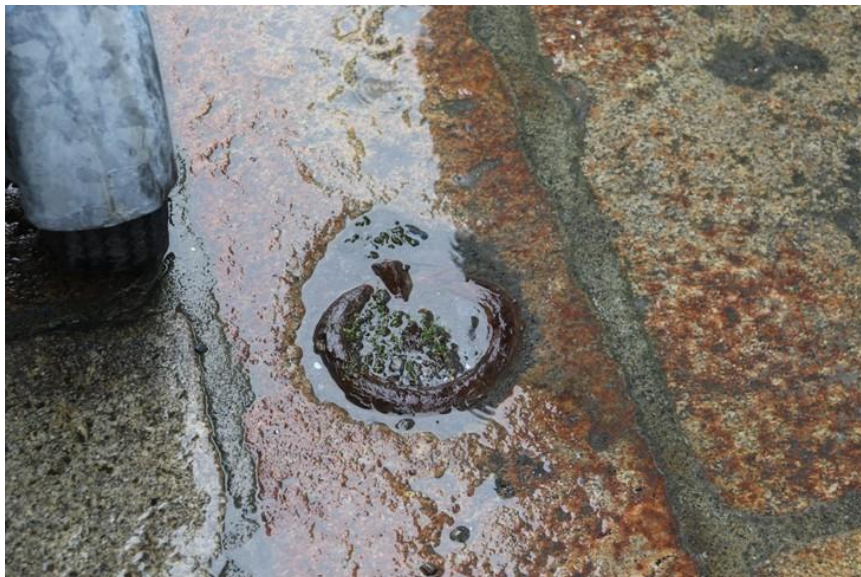
Plate 64: Iron ring at eastern siding

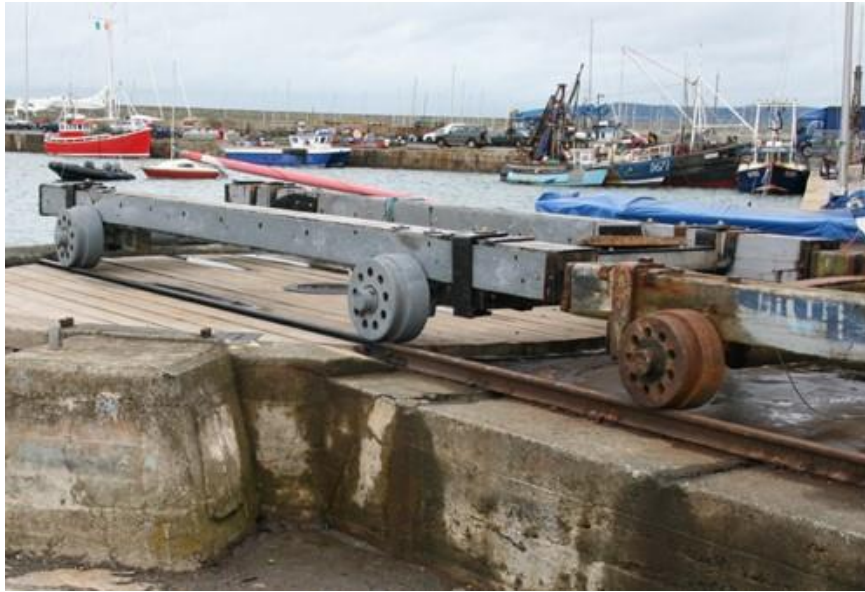
There is a significant amount of damage through rot in the timbers on the surface of the turntable, as seen in the photograph below. It is noted that in the photographs taken on the visit to the site in 2006 the boards looked relatively clean and fresh (see Plate 35 above and Plate 65 below). On this evidence it seems likely that the lifespan of the boarding in the damp conditions is less than twenty years.

Plate 65: Larger carriage on turntable

There are two carriages on the rails at the top of the patent slip. The larger of the two is located on the turntable, while the smaller is on the rails of the southerly siding. The larger carriage consists of two long substantial timber beams 6.75 metres long running lengthways and two beams running below the long beams across the width to form a frame. This carriage has metal plates set on either side of the long beams and the structure is held together by a system of metal straps. This carriage is painted, including the axles and the wheels.

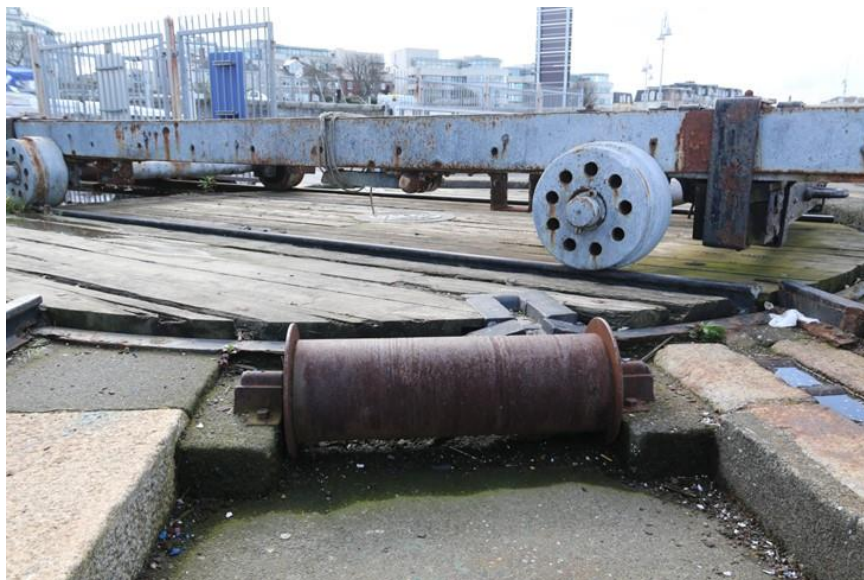
Plate 66: Larger carriage on turntable

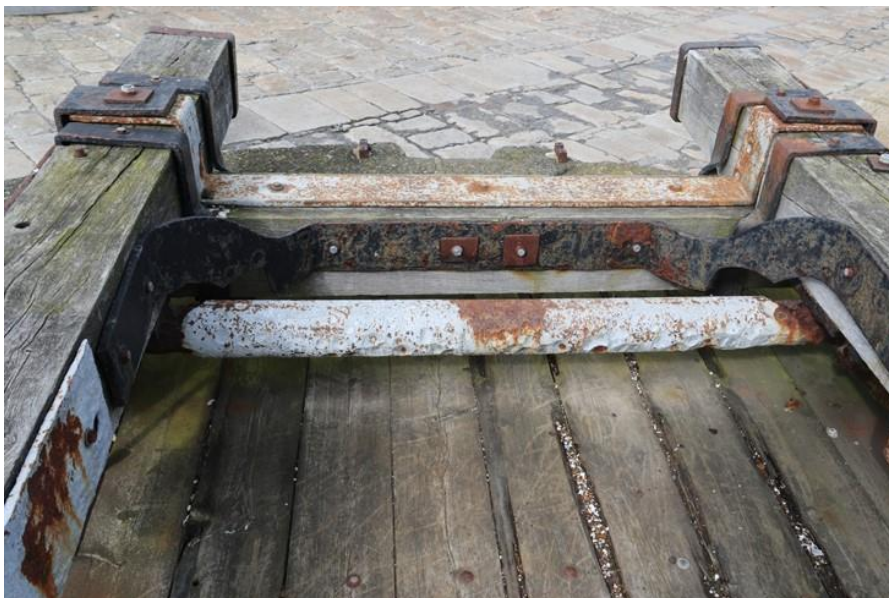
The wheels are broad, with the inner part having a slightly wider diameter than the outer part. The smaller diameter element is the part of the wheel that runs on the rail, while the adjacent area with the wider diameter is also of greater width and would act as the wheel when the carriage is off the rails within the boatyard, while also acting as the flange to keep the wheel on the rails. The wheels are set on a cylindrical axle solid metal and held at the ends of split pins. The outer ends of the wheels are perforated. The axles are heavily pitted due to corrosion.

Plate 68: View from above of end of carriage and axle

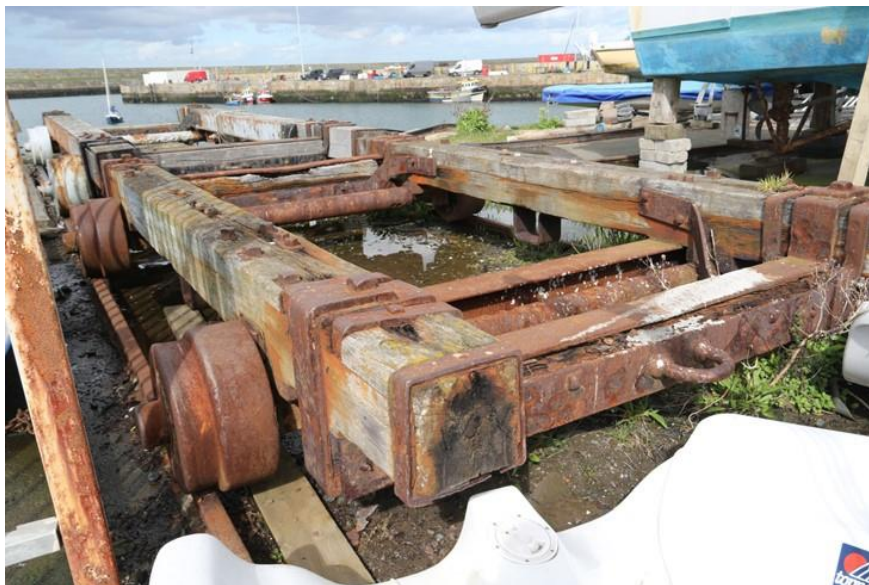
The smaller carriage is similar in construction to the larger carriage, and while it is the same width it is shorter, being only 4.25 metres long. This carriage is not painted, and the timber appears to be older and in poorer condition than that on the larger carriage. There are no metal plates fixed to the sides of the long timber beams. As with the larger carriage, there are towing eyes at either end, set into metal plates that are fixed to the cross beams.

Plate 70: Smaller carriage

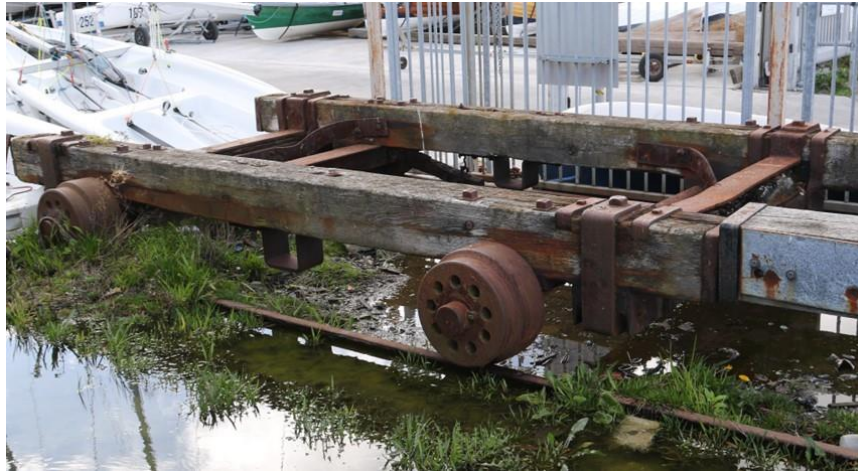
Plate 71: Side view of smaller carriage

The axle of the smaller carriage is more slender than that of the larger carriage and it exhibits the same level of corrosion pitting as on the other carriage.

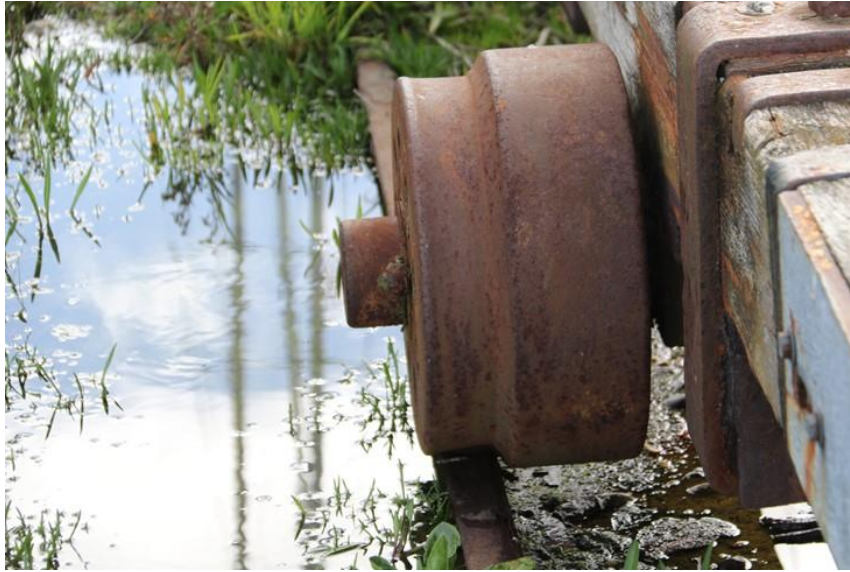
Plate 73: Detail of wheel on smaller carriage

The photograph above shows a wheel resting on a rail, with the broader part of the wheel acting as a flange. The photograph below shows the rear of one of the wheels, where it is hollowed to allow for space for the fixing onto the axle.

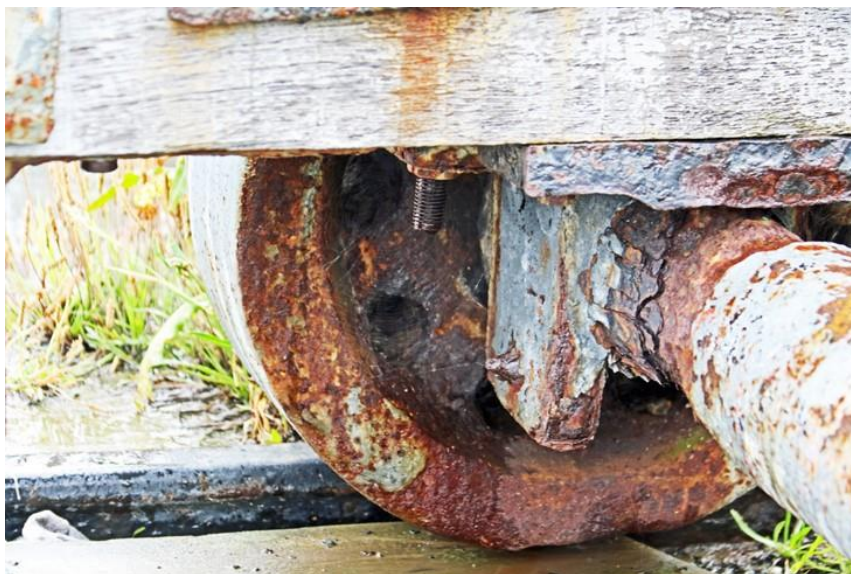
Plate 74: Rear of wheel on larger carriage
