advice series

A GUIDE TO THE REPAIR OF HISTORIC ROOFS

Contents

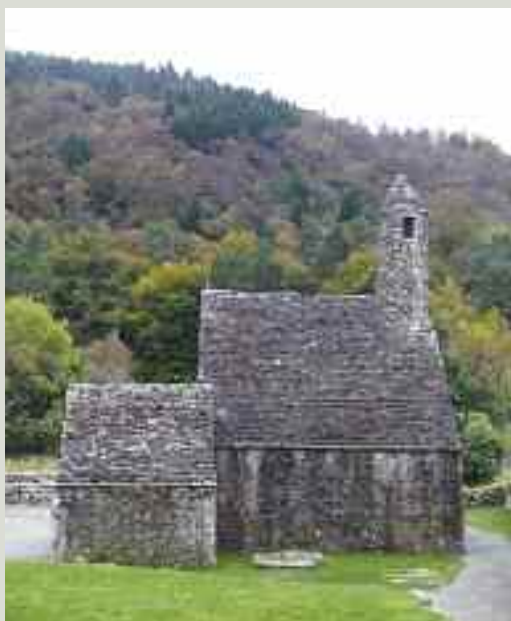
Saint Kevin's Church, Glendalough, County Wicklow. The steeply pitched roof of local stone was built up by corbelling and is supported on walls almost 4 feet (1.2m) thick

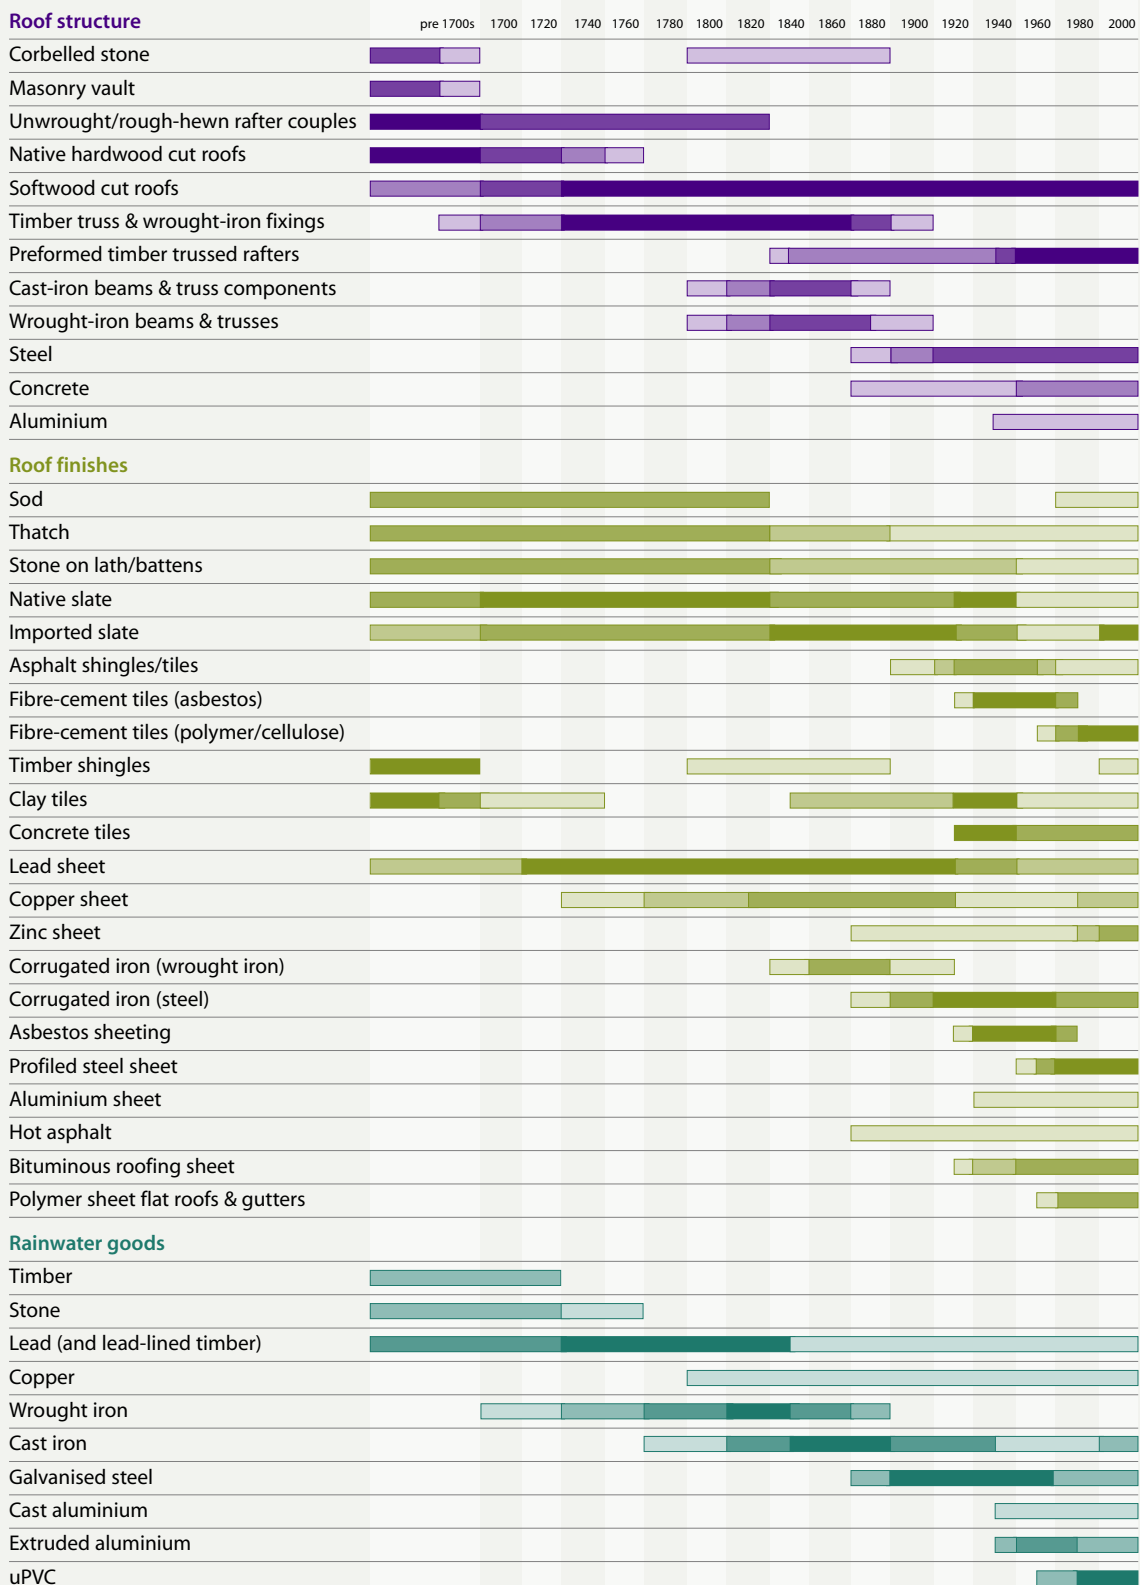
Timeline of availability and use of roofing and guttering materials in Ireland

The degree of shading relates to the extent of use of the roofing material: the darkest shading indicates periods when the material was in widespread use while the lightest shading indicates periods when it has been found in use in isolated examples. In the periods where no shading is shown, there is no evidence of use of the material or it was not yet invented.

This table indicates the approximate date of introduction of different roofing materials into Ireland

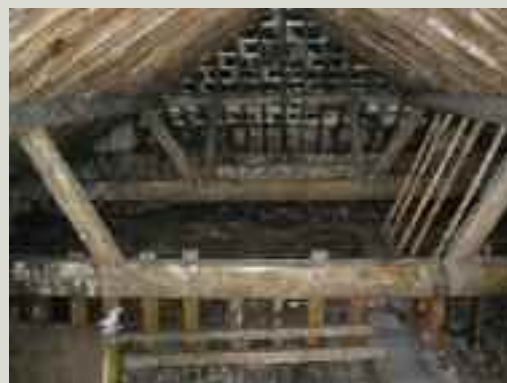
An eighteenth-century re-roofing of a tower house using imported deal

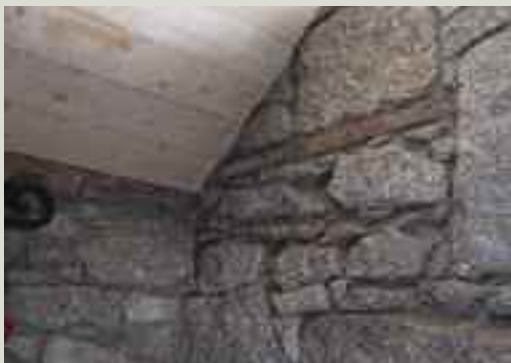
Halved wall plate plus timber strap bedded into a cross wall

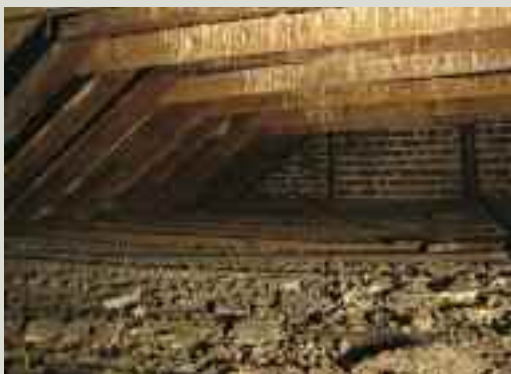
Undersized, long-spanning ceiling joists in this late eighteenth-century roof have become overloaded with pieces of fallen parging and pigeon guano, leading to deflection of the joists

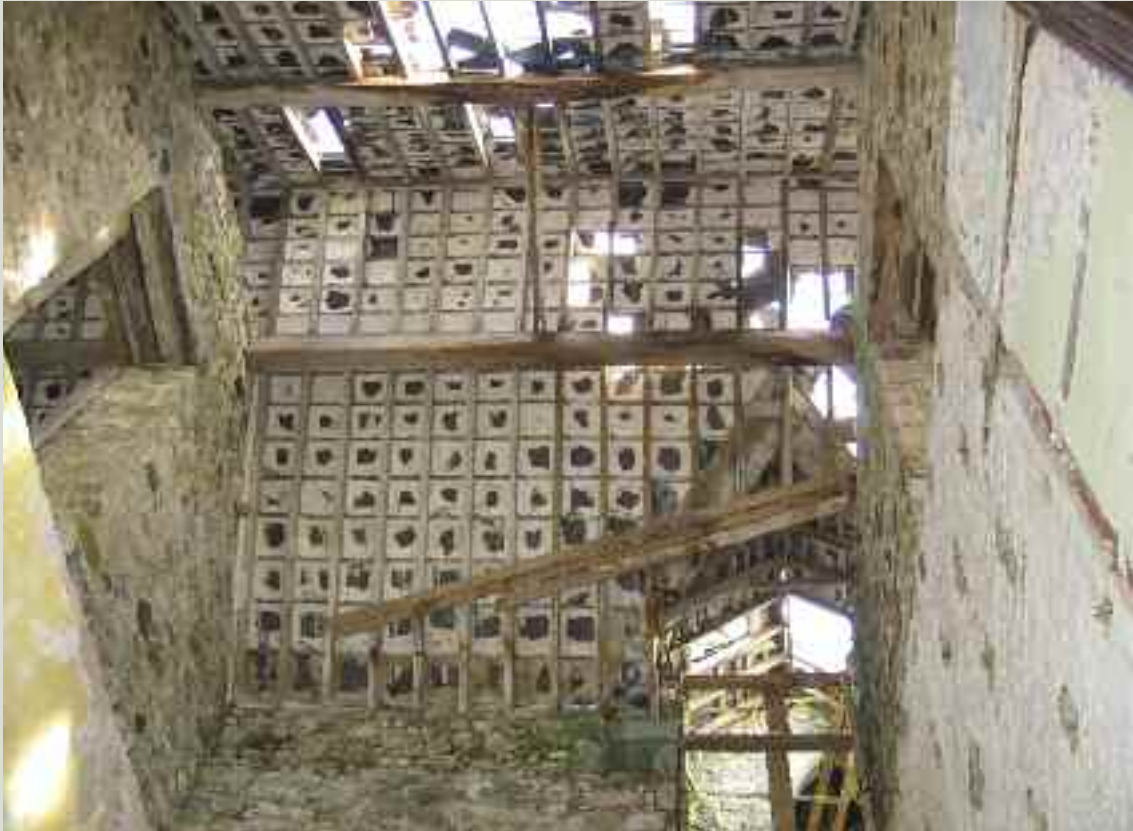
A roof detail particular to Ireland was the practice of continuing the masonry cross walls up into the roof space. Purlins were placed to span between the cross and gable walls to support the common rafters. This proved to be a very economical use of timber and also reduced the amount of skilled carpentry work required

Builders often used timber economically, developing techniques that reduced the need for large or long beams and skilled carpentry. Masonry cross walls were continued into the roof space, allowing for the use of shorter purlins supported between the cross and gable walls. From the early-eighteenth century onwards, ceiling and floor construction was also simplified by using clear spanning joists. The advantage of this long joist form of construction was that it provided a particularly efficient and continuous tie between structural walls. The downside of these long spans coupled with the rather small sizes of joist chosen by many builders is that they tend to result in larger-than-satisfactory ceiling deflections.

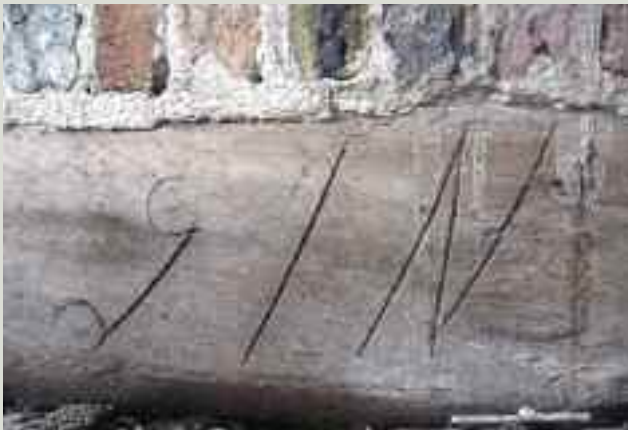
Merchant mark 'g I N' on this bay bressummer was exposed during works to repair this beam and the bay roof. Timber marks, where found, should be recorded and preserved and repair works should avoid concealment

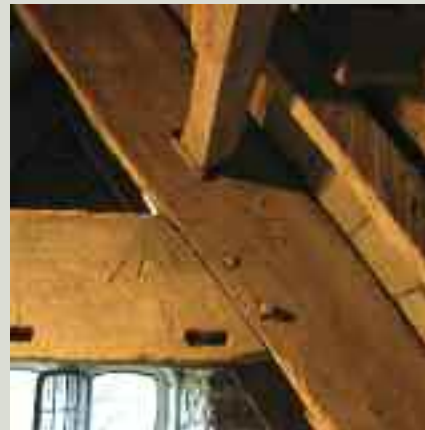
A survey of the timber structural elements of a roof often reveals merchant, religious or assembly marks on the historic timbers. These assembly marks on the oak timbers helped the carpenter to assemble the frame once on the roof. Note the pegged joints and the housing of purlins into frames. This is how roofs were constructed before nails and other metal fixings became readily available

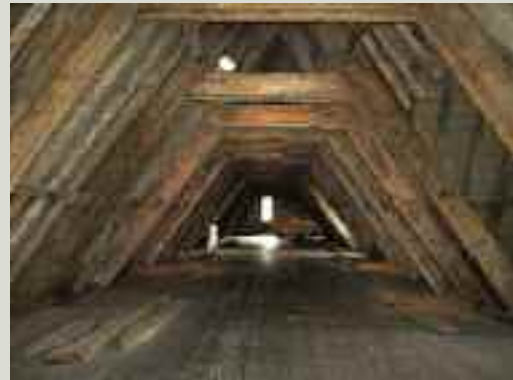
A late sixteenth-century oak roof over a large hall at Ormond Castle, County Tipperary

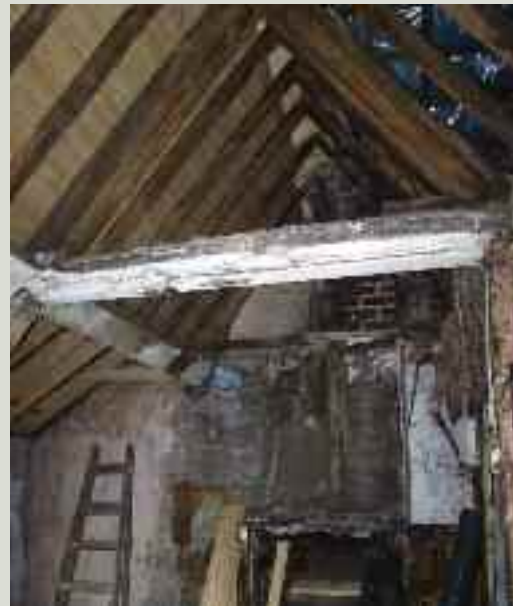
An early-seventeenth century roof showing the original principal roof structure and rafters with replacement sarking boards above (Image courtesy of Tom McGimsey, Mesh Architects)

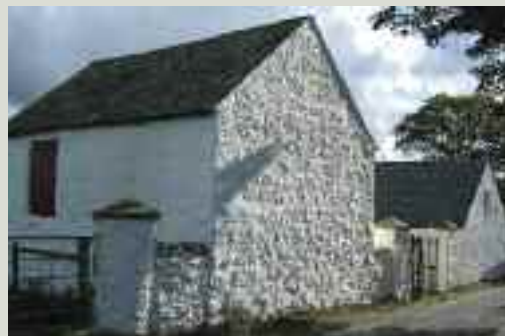
The flush verge detail, as seen in this example, is vulnerable to the extremes of weather; the reconstruction of the detail using lime mortar is of particular importance to ensure that there is sufficient tolerance and flexibility for the slates to move

The verge is the edge of a pitched roof where it meets the gable wall. Up to and during the eighteenth century, roofs were commonly pitched and gable-ended with gable chimneystacks in buildings of all sizes and in both detached and terraced structures. The most common verge type in Ireland was the flush verge, where the roof covering continued across the top of the masonry gable and the slate or tile covering was fitted tightly to the masonry by bedding the outer slates in a lime mortar. A flush verge has no overhang and in most cases no bargeboard, although there may be a stone corbel in some cases.

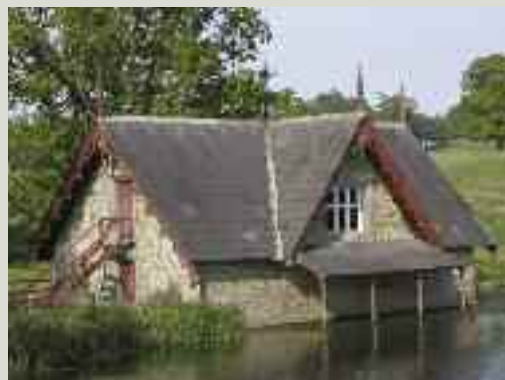
The overhanging gable detail comprised an extended roof to protect the masonry gable and was finished with bargeboards which could be decorated and painted

Where there is an overhanging verge, the roof extends over the gable to give it further protection and is finished with a bargeboard, which could be decorated – often with fretwork – and painted. On some nineteenth-century suburban houses in Dublin, square terracotta tiles are used at the verges of the roof. Another version of this detail consisted of the gable built above the roofline with the slate flashed against it.

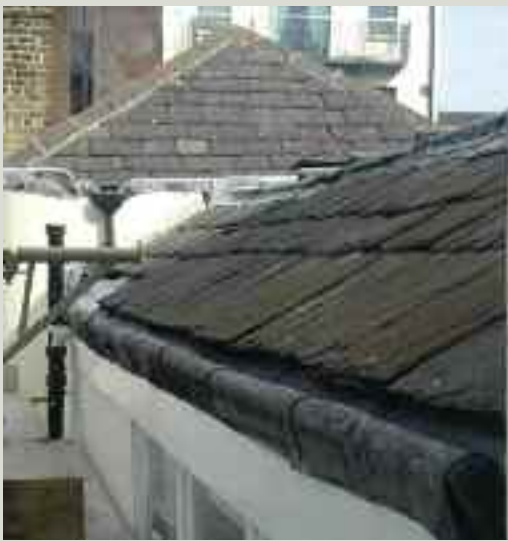
In this flush eaves detail, lead is used to form a conduit for carrying rainwater along the eaves of the roof to the downpipe

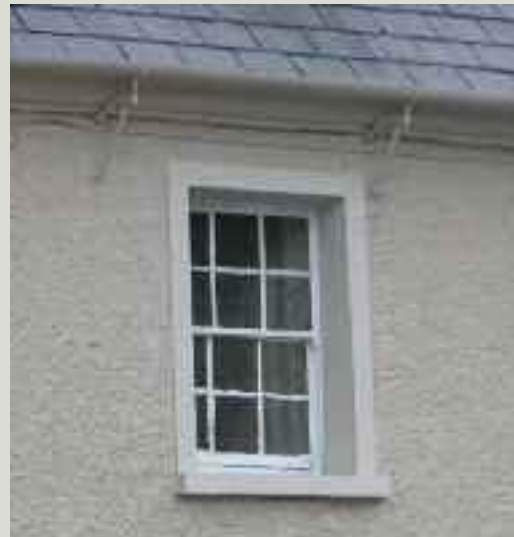
In a common construction detail of the late-eighteenth and early nineteenth centuries, a horizontal course of eaves stones was used to project from the top of the wall while a wrought-iron bracket supported the gutter

In the late eighteenth and early nineteenth centuries, overhanging eaves came back into popularity. A horizontal course of eaves stones or slabs was often fitted overhanging the top of the wall. Timber eaves brackets in this period tended to be deep in section, curved in design and had two points for fixing. This style of bracket was later superseded by driven-in wrought-iron brackets that supported the guttering. The eaves of Victorian and Edwardian structures were robust in profile, overhanging the masonry walls and often picked out in painted timberwork. There was sometimes a timber soffit to the underside of the over-sailing rafters although in most cases the rafter ends were left exposed. Projecting decorative stone or timber corbels were often used to support cast-iron gutters.

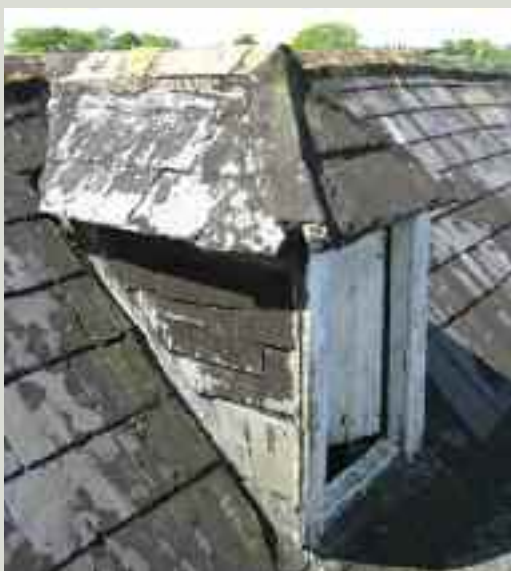
Pitch-roofed hatches, similar to dormers, were used to provide access to the roof for maintenance purposes. They were generally located in the central valleys, constructed of timber and finished with a cladding of slate or lead. By the end of the nineteenth century they had gradually been replaced by hinged cast-iron rooflights, which provided both daylight and roof access

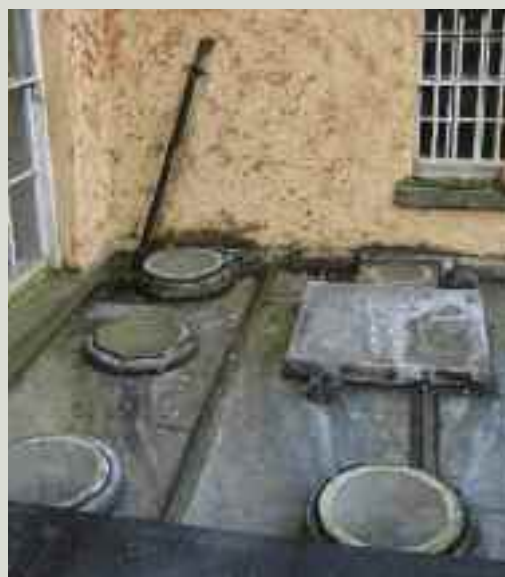
Glazed lanterns of circular and oval form were inserted into roofs as a means of bringing natural daylight into internal spaces such as landings and stairwells. Frequently these lanterns were poorly maintained because of difficulties of access and they were often replaced or covered over with a replacement roof covering. These circular glass rooflights are part of a nineteenth-century alteration

Glazed circular, oval, or occasionally rectangular lanterns were used as a means of bringing natural daylight into stairwells or anterooms. Many were glazed with decorated ribbed members and coloured glass.

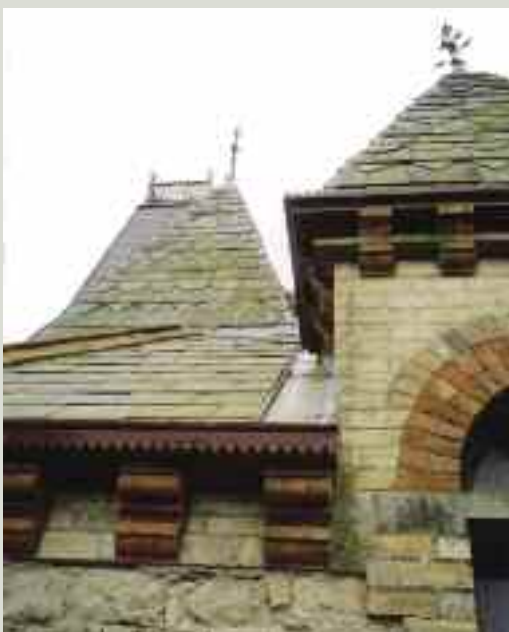
Decorative finials and ridge tiles were added for decorative effect and contrast. However, sometimes the use was also functional, for example when concealing a vent to the roof space

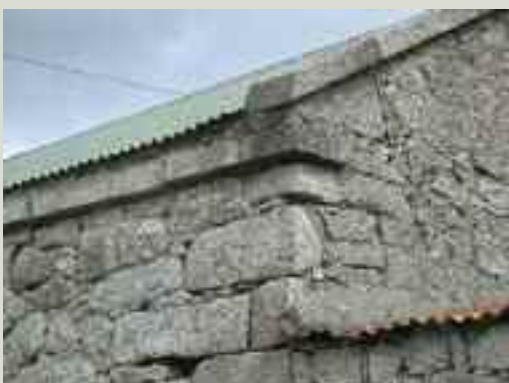
At Ballyknockan, the historic stonemasons' village in County Wicklow, dressed eaves and gable coping stones can be seen incorporated into the construction of even the most modest of structures. The use of these architectural details was the result both of an increased awareness of building detailing and also because of surplus rejected stone samples supplied to building projects around the country reverting back to the quarry village

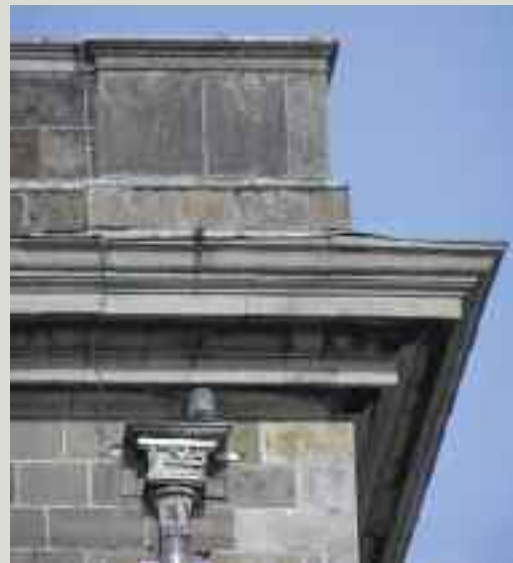
A rare example of a surviving lead hopper head with an embossed date of 1725

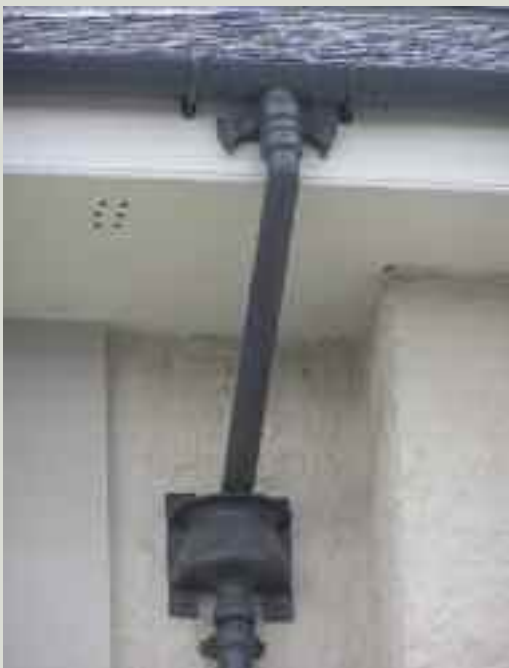
Cast-iron rainwater systems often copied the design of leadwork, but the stronger nature of cast iron enabled the use of shallow collars and two-point fixings rather than the deep collars needed to support lead rainwater goods

During the nineteenth century, cast iron replaced lead as the most common material used for rainwater goods. Gutters are held with wrought-iron or cast-iron brackets while downpipes are fixed to masonry with cast-iron brackets. Eighteenth-century wrought-iron brackets tend to be deep and curved with two fixing points while later brackets were simpler and were made of both wrought and cast iron, usually with one fixing point or a spike end which was driven into the masonry at eaves level. The weight of iron gutters ensures that they do not lift in severe weather conditions. In the later Victorian period, hopper heads became more decorative and a feature of elevations. Rainwater downpipes and guttering of larger square profiles were used, no longer painted in lead grey or black, but highlighted in greens or blues as part of the co-ordinated decoration of the structure.

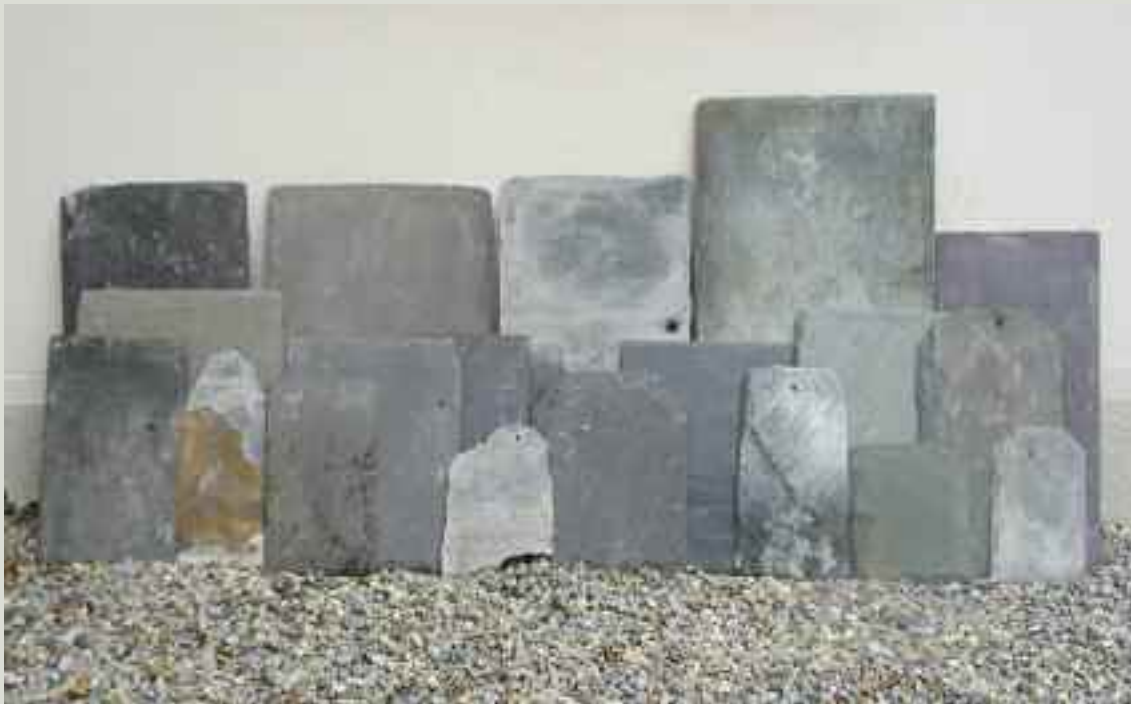
A selection of slate, both imported and native, indicating the wide variety of colour, texture and size available

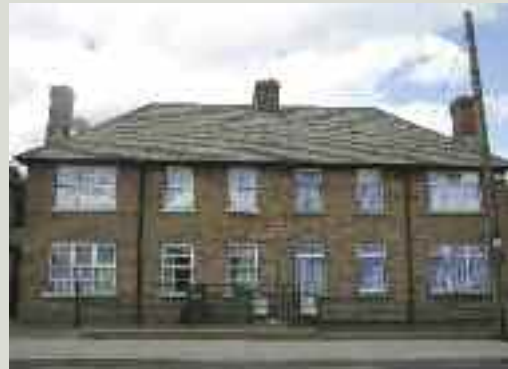
Convoy slate from County Donegal is a grey/black slate; its small size and appearance make it almost similar in appearance to a tile. It was widely used in Dublin during the housing boom in the early part of the twentieth century and can be seen on local authority housing projects, such as buildings in the suburb of Crumlin. Benduff slate from County Cork was also used in some housing schemes of the time

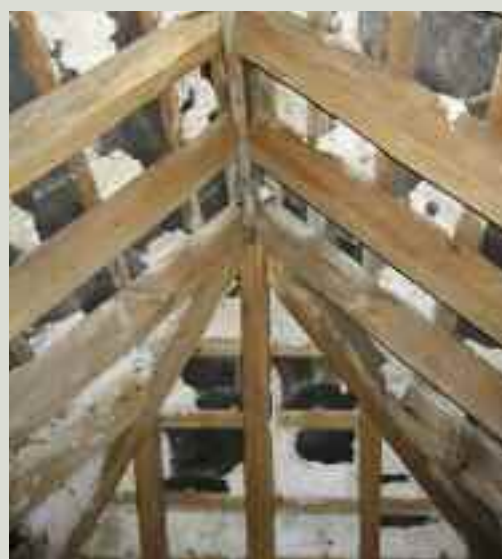
Remnants of parging to the underside of slates

Traditionally, the underside of slates was coated with lime mortar to the interior of the roof space, a form of weathering called lime parging. It was done to counteract wind suction and to give additional security against driving rain, as only a small area of overlap could be achieved between adjoining rows of small, shaped slates or tiles. It also consolidated the slates or tiles and prevented them rattling. Lime parging preceded the technology of roofing membranes to combat draughts and water ingress into the roof space.

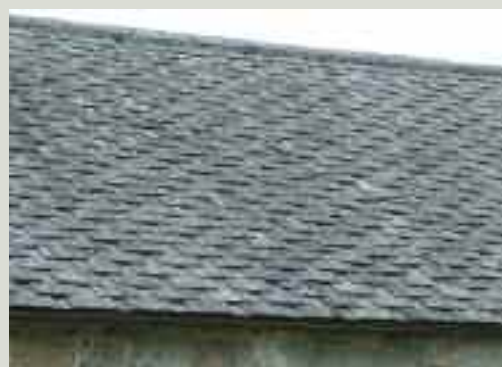
A method of slating sometimes referred to as 'open slating', 'hit-and-miss slating' or 'Scottish cant'. This slating pattern economised on the number of slates used and was primarily used for outbuildings. It is difficult to repair without face-fixing and the amount of exposure of slate surface can make the slates brittle for reuse

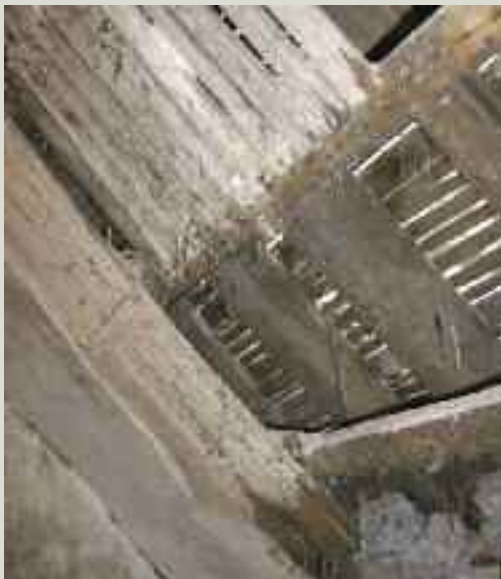
The recent discovery, within a later roof space of part of the former medieval friary in Ennis, of closely spaced riven laths fixed onto covered-over rafters substantiated the presence of an earlier structure within the historic fabric

The setting of slate onto a bed of lime supported by closely spaced riven laths fixed to the upper face of the rafters was a very early eighteenth century detail known as a 'wet roof' construction. The bed of lime was used to accommodate the handcut, irregular, uneven slates generally available from local quarries. There are very few surviving examples of this type, as most roofs on historic buildings tend to be replaced several times over the life of the structure. Occasionally, areas retaining mortar remnants with riven laths and perhaps a few irregularly pegged slates may survive from when the roof was modified or over-roofed. This type of discovery can be a good indicator

of the age and development of the building, and evidence of this nature discovered within a roof should be recorded. A full wet roof existed on Buncrana Castle, County Donegal (1718-19) and this technique was replicated during re-roofing works in the 1990s. Remnants of this type of roofing have also been found on the larger eighteenth-century buildings such as Castletown House, County Kildare.

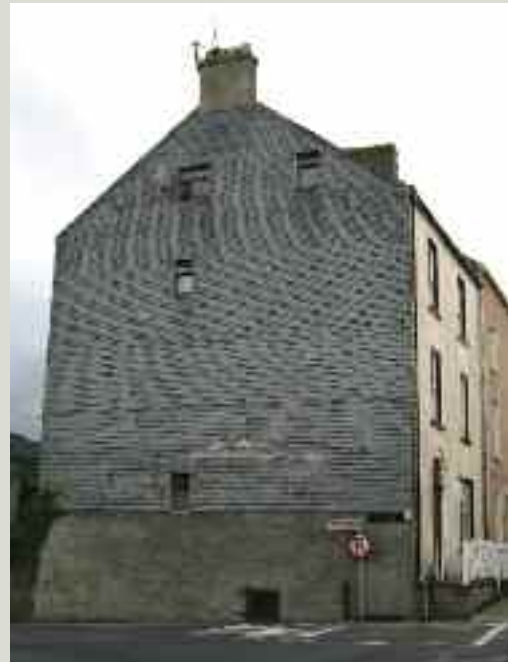
The best surviving examples of native Irish slate are most often found in vertical slate hanging, as it requires less frequent replacement than roofing slate. It is thought that this example of a slated gable is covered in Ahenny slate from the nearby Ormond quarries in the Carrick-on-Suir area

Vertically hung slate is a weathering detail found in exposed elevations. It was frequently used in towns throughout Munster, particularly in coastal areas, but examples can be found countrywide. Vertical slate cladding was often used to cover sandstone rubble masonry where it was difficult to achieve a watertight external render. On some buildings, patterns in clipped slates or contrasting colours were used. Vertical slate hanging was used to protect those parts of buildings that are inaccessible and hard to maintain or are particularly exposed to weather, such as parapets, chimneys and gable walls. Frequently, slate hanging was used to clad the full internal face of parapet walls instead of lead.

Vertical slate hanging was carried out in a similar manner to wet roofing (see above). The wall was plastered with a lime mortar, which was allowed a few days to set. Lime mortar was then applied to the underside of the slates, which were placed in position like wall tiles. The slates were fixed at the head using wrought-iron nails with a thin shank. This fixing curled on fitting, forming a secure fix into the lime mortar. The mortar bedding delayed corrosion of the iron nails.

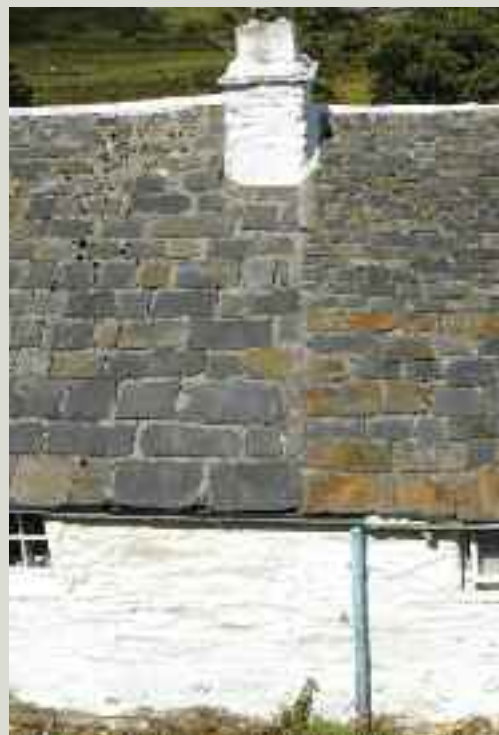
A rare surviving example of a stone slab roof in County Donegal showing a building covered with flags of a local stone

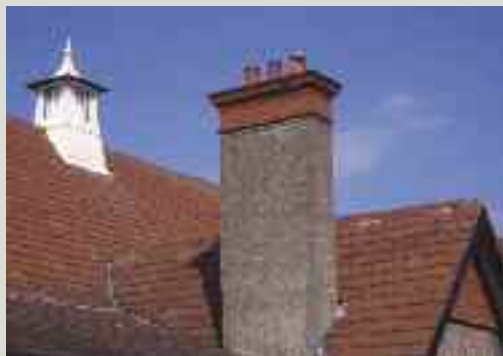
An Arts and Crafts style clay-tiled roof with tile hanging to the upper part of the gable

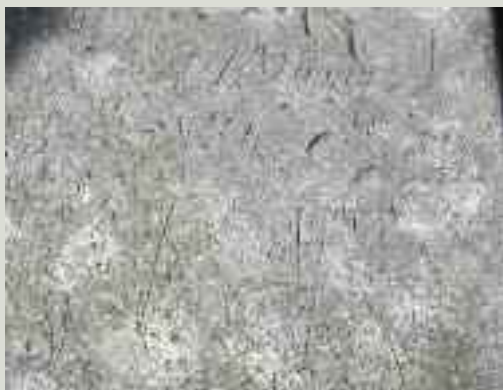
Lead sheet, while very durable, is soft. In this example, the lead sheeting has been etched with graffiti over centuries

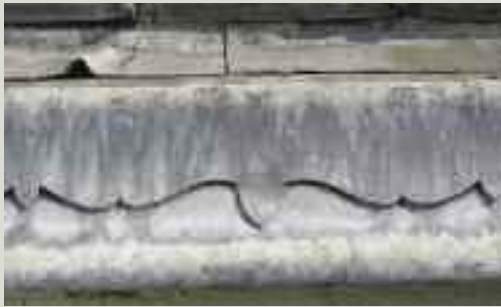
In high-quality work, the visible edges of lead flashings were cut to decorative shapes

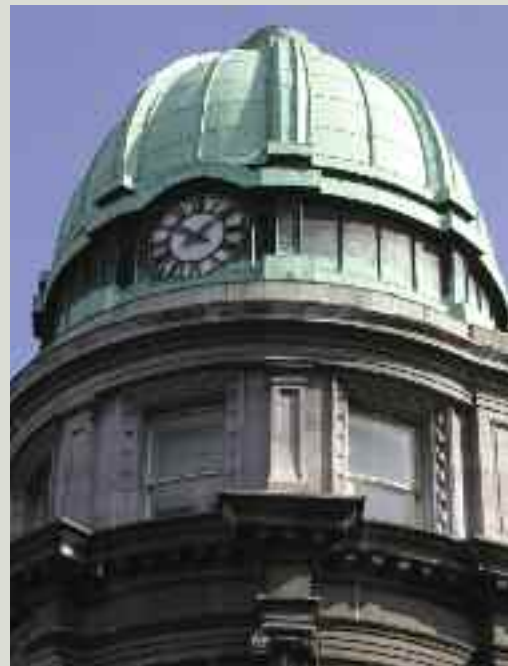
Copper was used to clad eye-catching architectural features on buildings, embellishing elements such as cupolas, domes and steeples

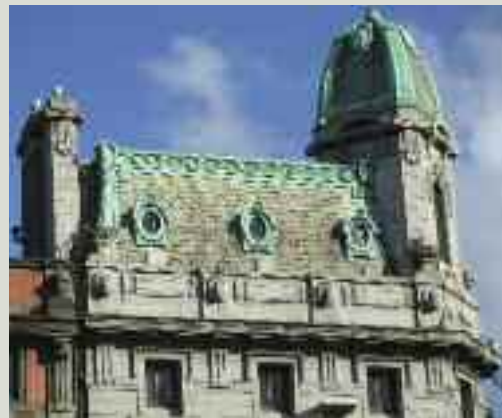
Copper used for the decorative trimming of architectural details on a mansard roof and dome, its green hue complementing the pale grey of the slate and stonework

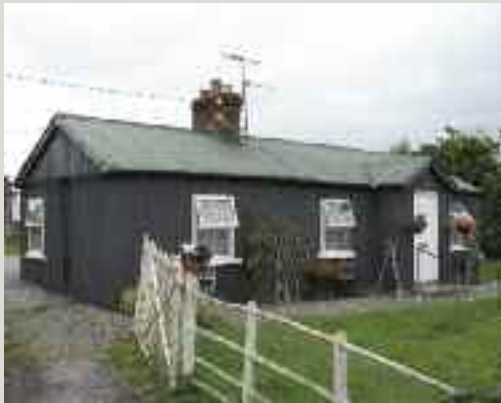
Corrugated buildings often came in kit form from as early as the 1860s, and were used for a variety of different purposes. Corrugated-iron housing was more predominant in the mid-twentieth century. Often seen as temporary, these structures have, in many cases, lasted over 100 years

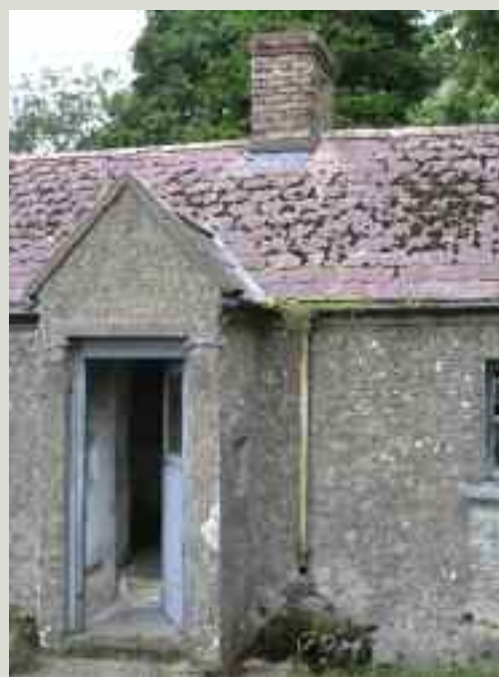
Asphalt shingles were introduced as early as 1890, although their use is more usually associated with buildings dating from the 1930s

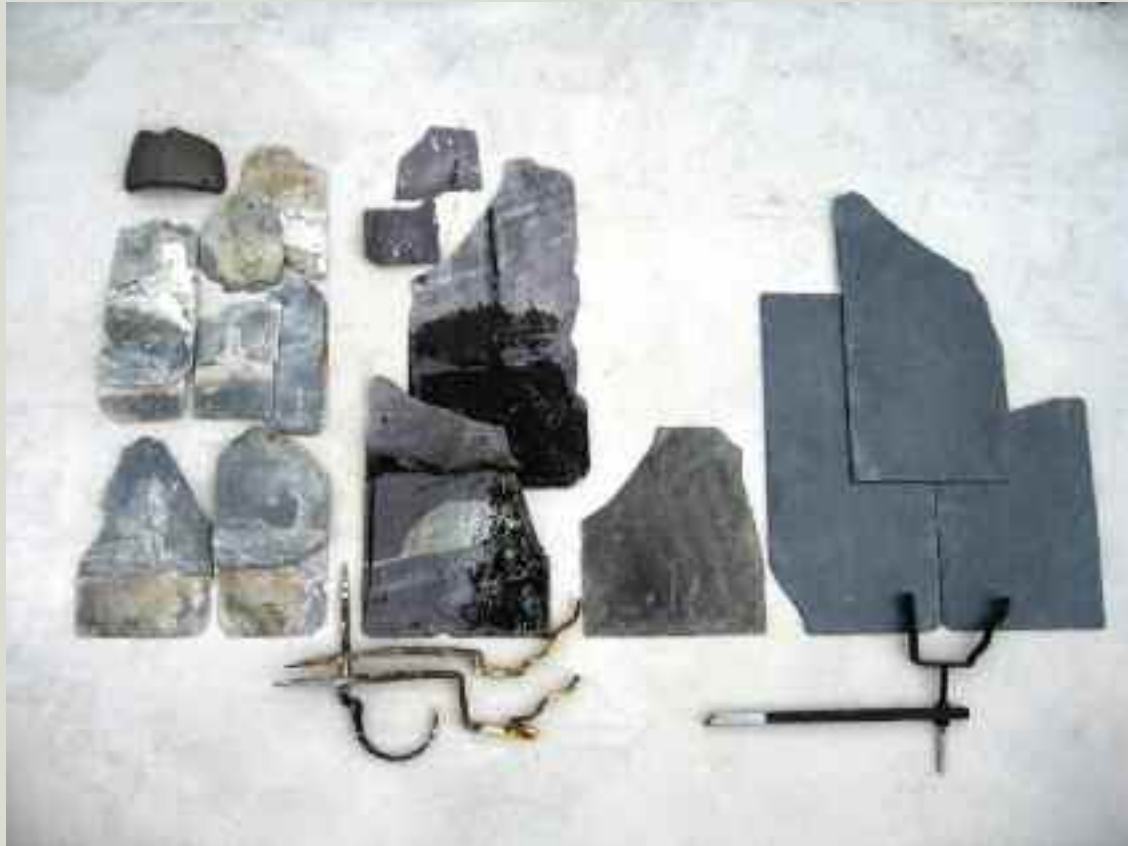
This set of slates indicates a sequence of re-roofing projects, over a period of centuries, on an early eighteenth-century country house. On the left, the small greenish, hand-dressed slates, held in place by pegs fixed into lime mortar, are thought to represent the original roof covering. Clay tiles may have been used to cover the ridge; the fragment shown here (top left) was found in the attic space of the house. An extension to the house in the 1800s appears to have been the impetus for re-cladding the entire roof with a blue-grey slate in a gauged slate pattern, possibly Ahenny slate (second from left). This roof survived until the mid-1960s, when neglect over time had caused serious damage and undermined the roof covering. The roof

was then re-slatted with an artificial fibre-cement tile or 'slate', retaining one section of the 1800s blue-grey slate roof to the central valley. In recent times, the roof has been fully re-clad using a high-quality natural Welsh slate, seen on the right.

This sequence highlights the number of times a historic roof may be altered or replaced over the lifetime of a historic building and how the materials and details change in the process. The original small hand-dressed slate would have provided a very different visual effect in terms of colour, texture and pattern from the recently laid machined and regularly sized Welsh slate

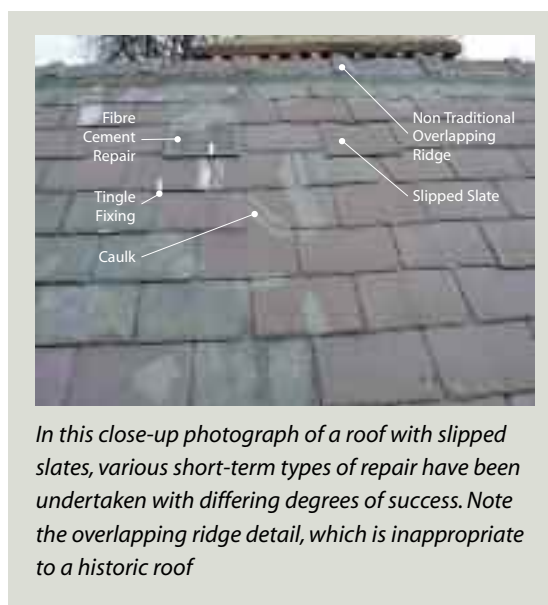
In this close-up photograph of a roof with slipped slates, various short-term types of repair have been undertaken with differing degrees of success. Note the overlapping ridge detail, which is inappropriate to a historic roof

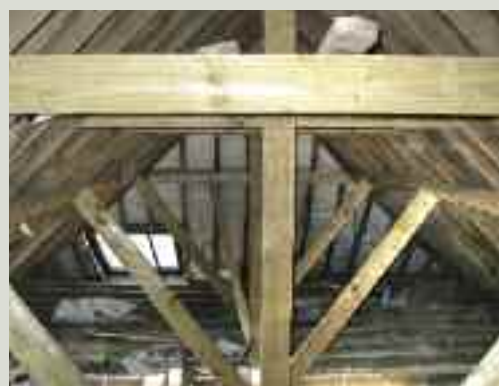
These rafters were originally undersized for their span and had deflected, causing slates to lift or slip, and thus allowing water to enter the roof space. To correct the problem, this additional support structure was added during roof repair works

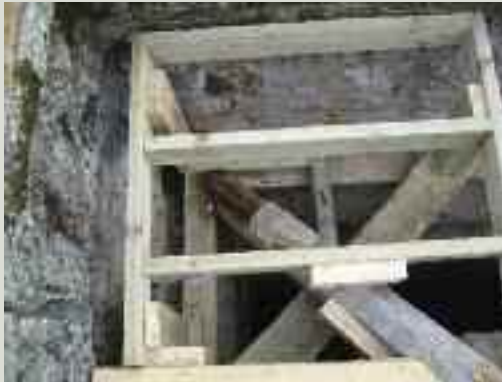
Additional support was added on the diagonal below the truss end, thus avoiding the need for new timber splice and steel connections or the local removal of the rotten timber truss end. The timber that had supported the gutter above had to be fully replaced

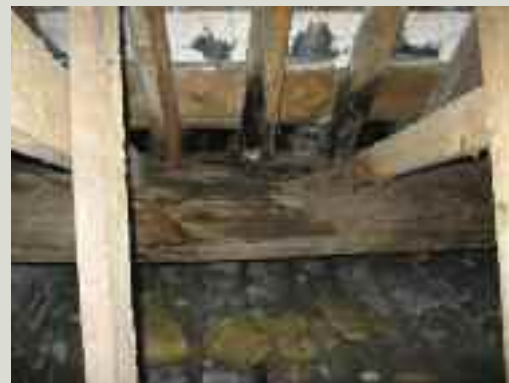
Evidence of wet rot damage to a roof beam and rafters under a tapered valley gutter. Only about ten per cent of the beam section was degraded, so no strengthening works were required to the beam. The rotted rafter ends, however, needed replacement

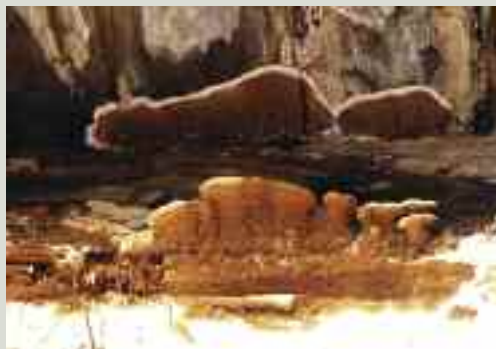
The fruiting bodies of the serpula lacrymans fungus can be identified by their rust or orange colour, usually with a white edging

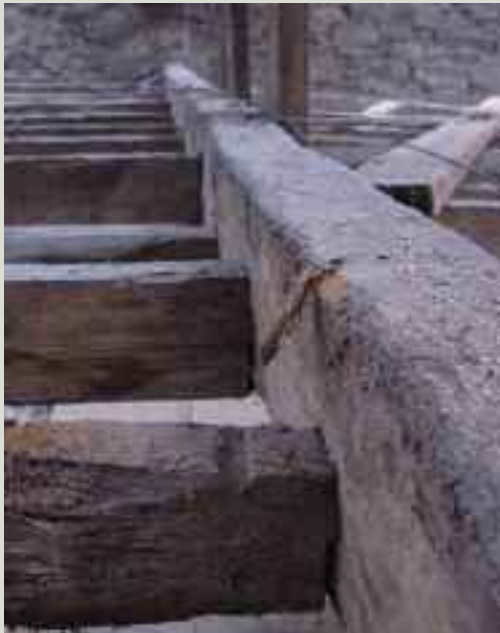
Furniture beetle has damaged only some of the faces of these timbers – these are the sapwood faces of ceiling joists. The slight shrinkage of the joists where they are mortised into the ceiling beam was not seen as problematic in this case but, if the displacement were any greater, it would need thorough investigation

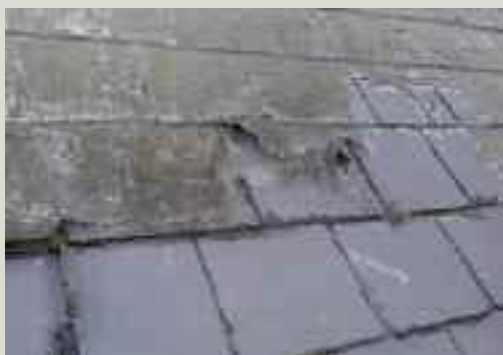
The process of covering a leaking slate roof with a bitumen covering was known as 'turnerising.' It is ineffectual and damaging and should never be carried out on a historic roof. Furthermore, it prevents the slates ever being salvaged for reuse

The external roof slopes may have been painted with a bituminous liquid, either on its own or with a hessian base, as a 'quick fix' to resolve slate slippage and leaks. These types of repair essentially stick the slates together and make it impossible to carry out local repairs. If this treatment, known as 'turnerising', has been applied to a roof and there are further leaks, complete replacement of the slates is the only option. Furthermore, slates subjected to turnerising are not fit to be salvaged and reused.

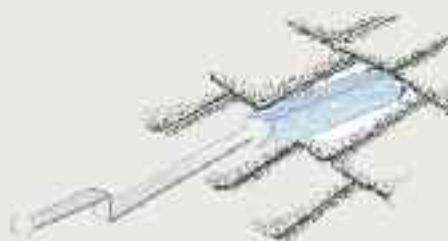
Here, a partially folded metal piece is slid under the upper slate as part of the bib repair. The metal is partially folded to allow the metal to sit above the nail head. The metal used should preferably be a painted aluminium or copper but should be matt in texture

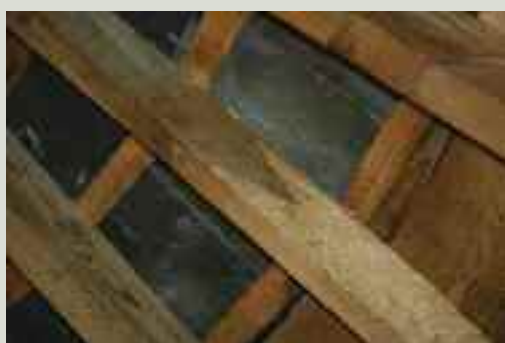
The use of a traditional scarf joint repair to damaged rafter ends is particularly worthwhile where the roof structure is exposed to view (Image courtesy of the Irish Georgian Society)

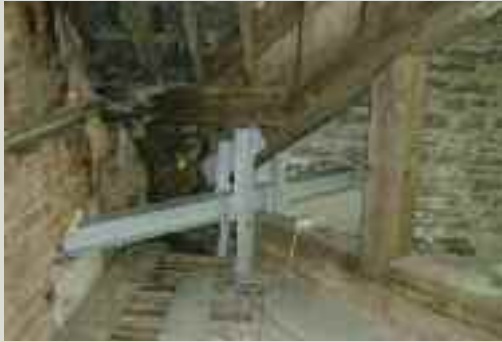
Added support has been given to the main hip roof truss at an internal valley. This repair detail used prefabricated steel elements and tooth plate connectors, but avoided the need to open up the recently repaired valley finishes and does not obscure the original truss details

Where necessary, more extensive repairs can be made using modern mechanical fasteners such as tooth plate connectors, split rings and steel brackets. These can produce a detail whose function is readily apparent and calculable by current engineering standards and which is theoretically reversible. Introducing a new structural member to reinforce the existing historic structure or even supersede it is often a viable option and can usually be designed to avoid the removal of the failed original timber.

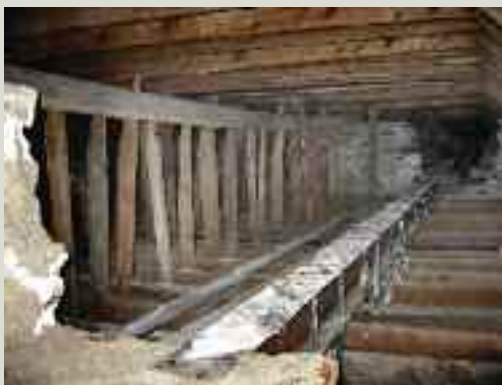
Two consecutive corrective structures to provide additional support to undersized ceiling joists. The first intervention (upper left) occurred early in the roof's history and consisted of the addition of a timber beam and timber hangers to give extra support to the ceiling joists. The new beam itself then deflected. Further corrective measures were taken using a new steel beam (lower right). Note that all original timbers were retained intact and the history of the roof and successive repairs can easily be read

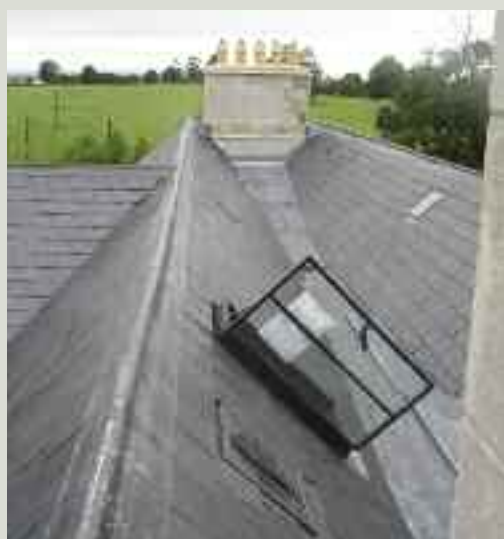
There are several contemporary products available, of which the side-opening rather than top-hung skylight type is possibly the most convenient for providing access for maintenance inspections of the roof

Sometimes single sheets of glass were fixed into the surrounding slate as a means of bringing natural light into the attic space. These glass panels tend to be poor at protecting against water ingress. Fitting a well-detailed, strategically placed, contemporary conservation-type rooflight in a central valley would allow the introduction of natural daylight to the attic space. The installation of new elements should be in

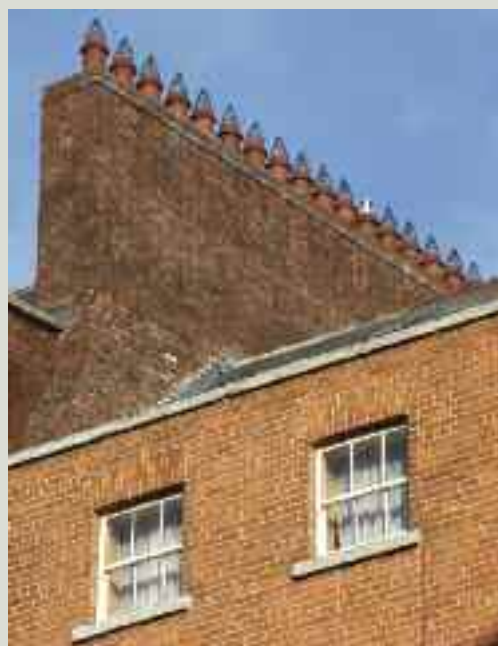
Chimneystacks are prominent features and add considerable character to a historic building. They are integral to the design as well as to the original use of the structure and, even when redundant as vents for fires, play an important role in providing ventilation to the interior of a building

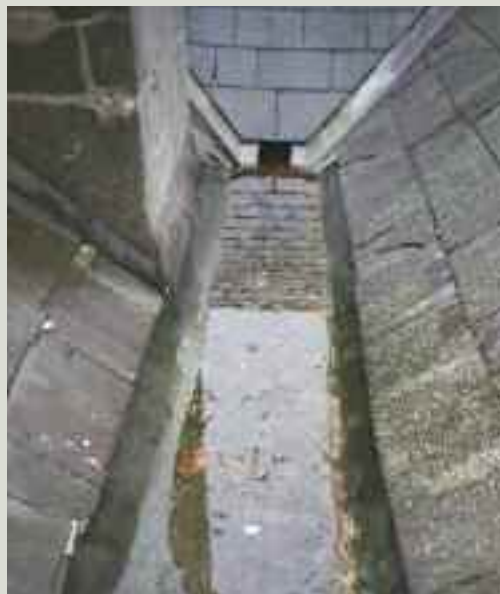
View of a defective valley gutter with a shallow fall that is now holding water. Birds' nests in the outfall of the secret gutter (seen at the top of the image) blocked this roof outlet

Often the parapet gutters and central valleys are too long, constructed with an inadequate fall and/or using inappropriate lead sheet sizes. The timber boards supporting the lead may subside, resulting in water falling back into the valley and causing continuous pooling, which eventually leads to an exacerbated depressed section of gutter. Where previous repairs in parapet gutters and central valleys were executed using poor quality or inferior roofing materials and details, such as torch-on felt or silicone products, it is only a matter of time until water eventually starts to lodge and to leak down into the valley boards and roof structure below.

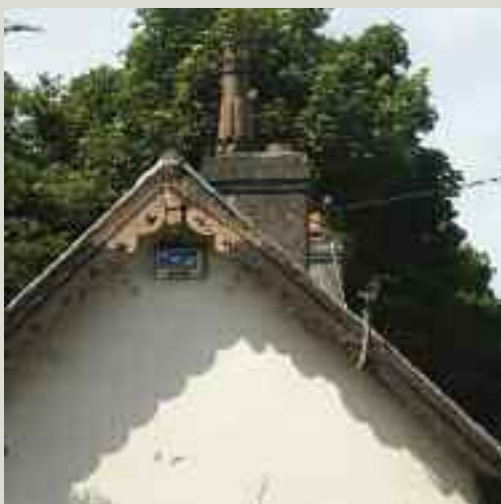
The poor condition of overhanging verges can lead to deterioration of the ends of the purlins as well as the loss of sections of decorative timber bargeboards

Overhanging verges are generally constructed of timber, with a timber or plaster soffit to the underside of the over-sailing rafters and gable purlins, and in some cases a decorative timber bargeboard. If not maintained and painted regularly the timber can deteriorate rapidly. It is important, when scarfing or jointing-in replacement sections to damaged lengths of bargeboard (as with a decorated fascia), to ensure that the grain is similar and correctly orientated to the original timber for the most effective repair. Where entire sections are to be replicated, it is important that the quality, section size and profile of the timber are correct. The patterns for decorative bargeboards are normally repeating, so sections can be made to match a known template.

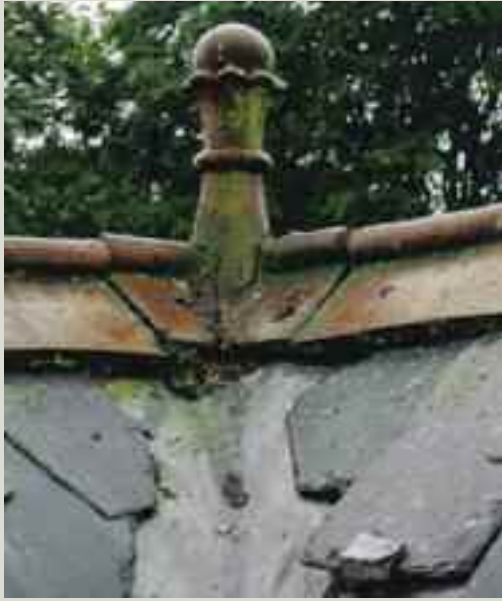
This terracotta ball finial was cracked; as part of a roof repair project it was removed, carefully cleaned and repaired before re-installment

Decorative embellishments of stone, fired clay or ironwork on roofs should be regularly inspected to make sure they are securely attached and are not cracking or corroding. Finials may also function as lightning conductors or as vents. Repairs will sometimes require that the feature be removed from the roof and brought to a workshop. A ceramic or stone conservator or specialist metal worker should be consulted in the case of the respective type of embellishment. Repairs will have to withstand the severe weather conditions of their original location.

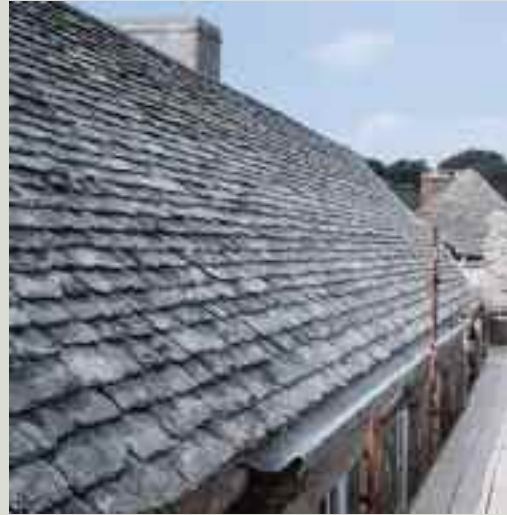
A new flush eaves gutter formed in lead along the top of the wall

The life expectancy of lead is in excess of 200 years, and as the material will not rust painting is not necessary. Where the existing rainwater disposal system is made of lead, there is often a temptation to use less expensive substitutes for repair or replacement. Appropriate high-quality alternative materials to the correct profiles may be justified in some circumstances. If there is a high risk of theft, for example where the lead is easily accessible or in a remote building, steps should be taken to reduce its vulnerability.
