advice series

A GUIDE TO THE REPAIR OF HISTORIC ROOFS

Contents

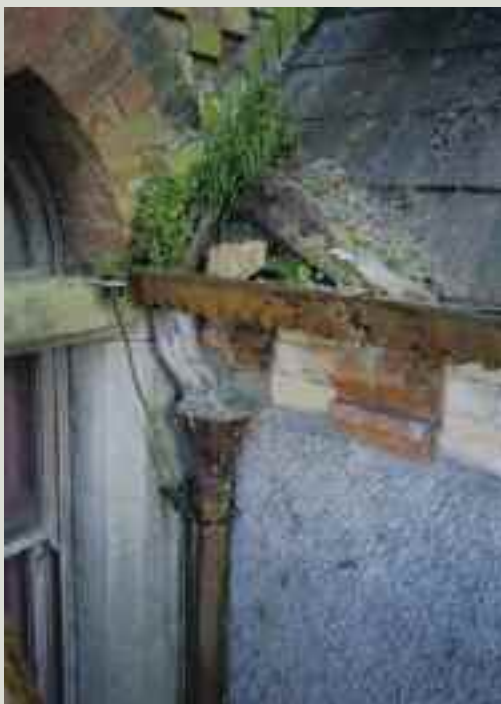
Cracked or broken rainwater goods can be replaced on a like-for-like basis with half round, box or ogee cast-iron gutter profiles which are readily available. Where castings are more decorative, such as in this case, new gutters can be cast to replace the broken sections. Downpipes should be carefully examined, cleaned down and fully refurbished on a regular basis

The condition of eaves gutters can often be superficially assessed from the ground. However, a more detailed assessment should be made on a regular basis from a ladder or scaffold, to check that there are no underlying issues such as cracking to the back of the gutters next to the masonry, and to assess the condition of the brackets and the joints between sections of guttering. The base of the gutters should be checked for soundness, as weak organic acids and salts in a build-up of bird droppings or other corrosive pollutants can attack the metal. The fall of the gutter should be checked to ensure that it directs rainwater down towards the downpipes. The fall can change with time due to distortion in the roof framing or damage to gutter brackets from the weight of debris and water. Damage from ladders, wind pressure or from falling branches off nearby trees can also contribute to the deterioration of rainwater goods. Water sitting in the gutter or a build-up of debris can weaken the gutter supports, leading to breakage in the gutter and water penetration into the roof or wall. Ideally, the outer edge of the gutter should be lower than the inner edge, so water spills away from the wall of the building if blockages occur.

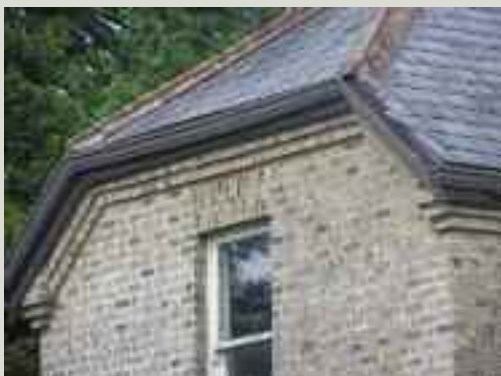
An unusual example of a decorative cast-iron gutter detail following the profile of a half-hipped roof

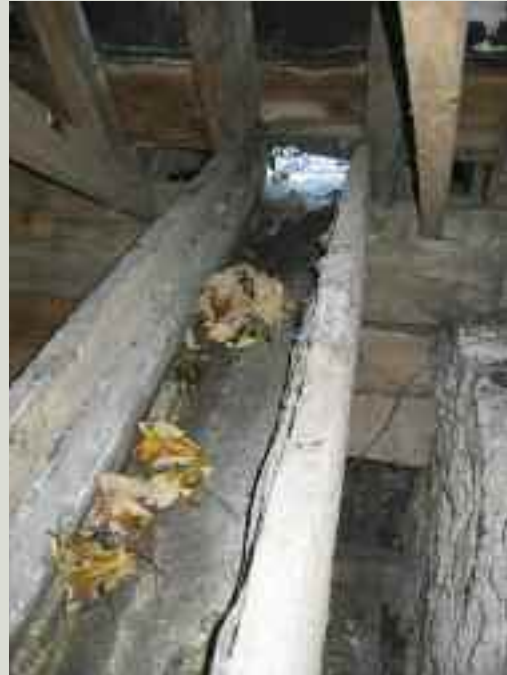
A lead-lined, secret gutter within the roof space used to carry rainwater from an internal roof to outfall at the eaves

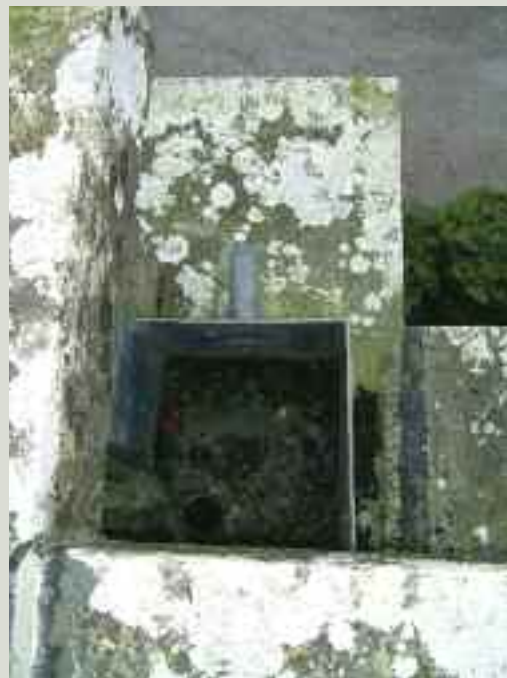
The installation of an early warning system in the form of an overflow pipe will alert the owner that the catchment pit is full and that a blockage in the gutter or hopper head needs to be cleared before excessive damage occurs

Overflow pipes can be fitted to hopper heads and catch pits to alert owners of blockages. Where the gutters are hidden from view, such as secret or valley gutters, this is an especially useful early warning system and should be included when any major roof repair works are undertaken.

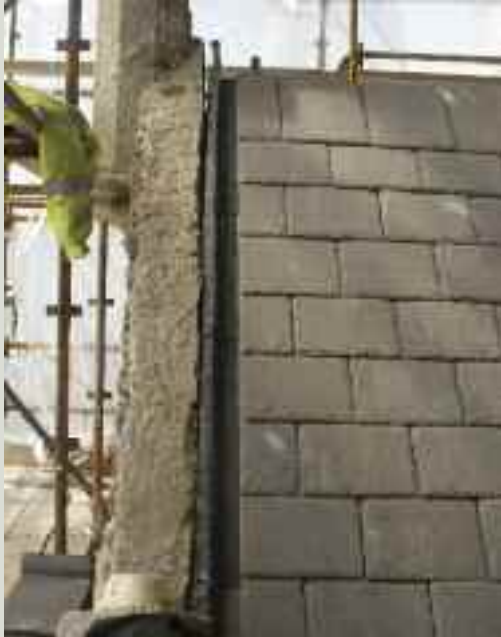
This so-called 'secret gutter' detail is not a traditional one. However, it may be recommended in instances where there is a history of water penetration below lead cover flashings at the junction with abutments, particularly on roofs of a low pitch (Note: in this image the gable capping stones have yet to be replaced)

The term 'secret gutter' is also used to describe a partially concealed gutter to the base of an abutment or gable coping. Where the roof is being re-slatted its profile will most likely be increased in height by the addition of new battens, which are thicker than were formerly used, or counter battens (an additional layer of battens fixed perpendicular to the first layer of battens). The relationship between roof covering and coping upstand may therefore be altered. If there is a risk of water penetration below the lead flashing, a recessed or secret gutter can be formed if the roof is counter-battened, and an appropriate lead upstand formed to the coping. These works may materially affect the character of the roof, and the architectural conservation officer in the local authority should be consulted regarding the necessity of obtaining planning permission.

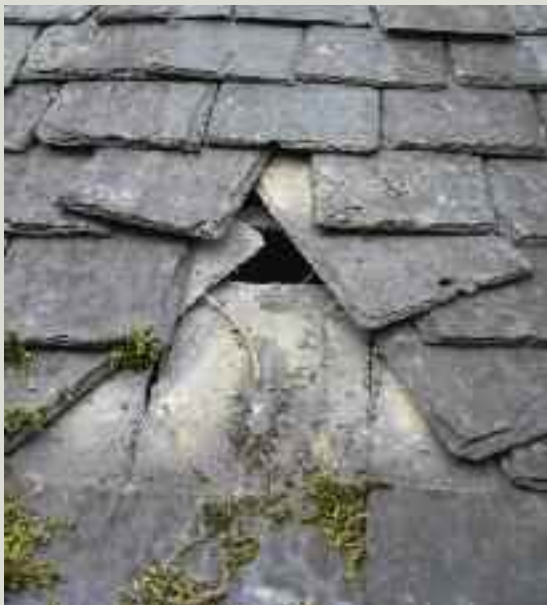
Earlier slate roofs using top-hung, single-nailed slates can easily be repaired by swinging individual slates aside allowing access to replace or re-peg the slates beneath

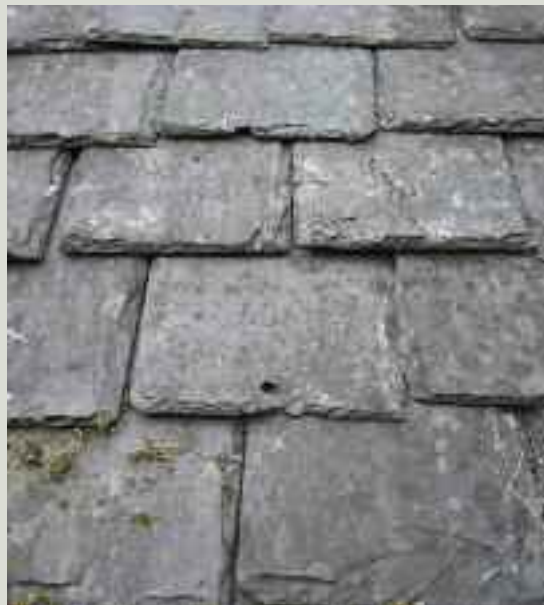
Slates are swung back into place after works

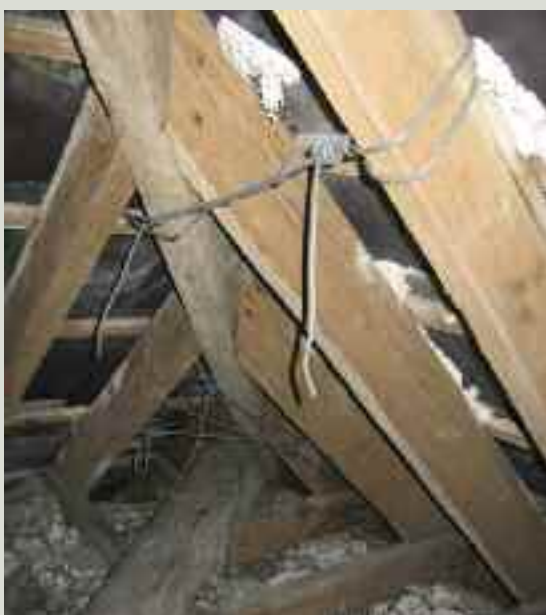
An alternative repair method is to tie the slates within the roof. This is useful where the slates are large or have square shoulders or, for some other reason, cannot be swung aside. A plastic-coated wire such as electrical lighting wire is threaded through the gap from inside the roof and attached to the slate outside. The slate is then carefully pulled back into position and the wire tied back to the timber roof structure

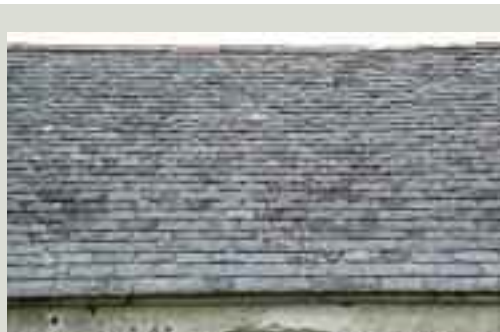
An example of a gauged roof of Ahenny slate, where the sizes of the slate courses gradually get smaller, or diminish, towards the ridge of the roof

Slates are priced according to the amount of labour associated with their production, the most expensive being the thinnest and in the largest sizes. Gauged roofs require a schedule for battening to be set out for the roofing contractor to follow. Diminishing courses may be in 2, 3 or 4 inch increments (50mm, 75mm or 100mm respectively). Graduated or diminishing slate courses cannot be laid where the slate is supplied with pre-drilled nail holes.

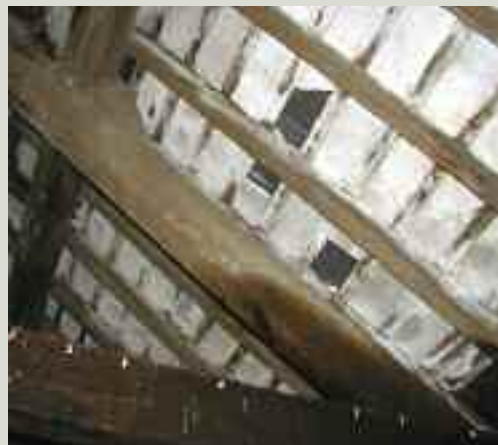
Substantially intact parging to the underside of slates is visible from within the attic space and provides a secondary line of defence against rain and wind entering the interior of the building

The repair of parging may be impractical due to restricted attic space. However, local repairs should be attempted if the roof parging is generally intact. If the parging has become detached and fallen, it should be removed from between the ceiling joists, as it may cause detrimental loading to the ceilings below.

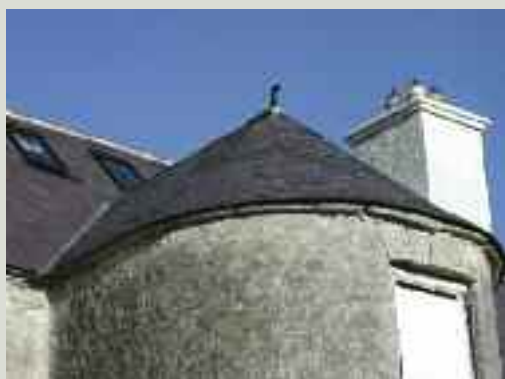
The repair of curved slate roofs is highly specialised work and requires a roofing contractor who has experience and skill in gauged work

The repair of slated circular or half-round shaped roofs is best undertaken by a roofing contractor who has experience and skill in gauged work with conical roofs, supported by the advice of a slating specialist for the cutting and sizing of the replacement natural slate. If the roof needs to be re-slatted, slates should be removed carefully and numbered according to the courses from which they were removed. Replacement slate should be sourced as previously outlined. Where new slating is being considered, it is important to note

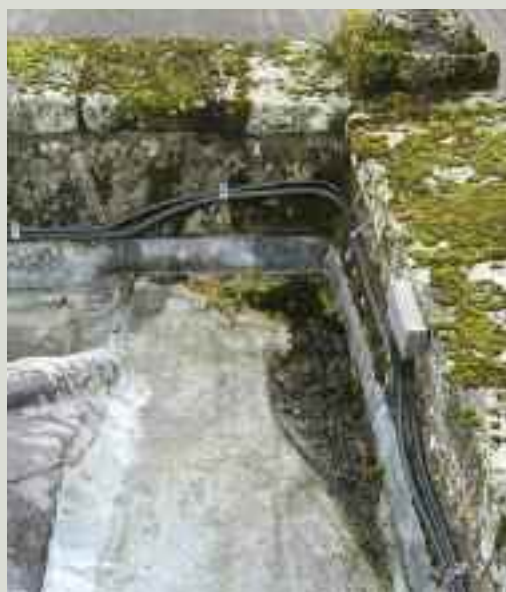
Ponding of water away from gutter outlets indicates a problem with the substrate timbers. In this case, a likely cause was poorly functioning flashings at the junction with the parapet wall

Sometimes damage to lead sheeting has been caused by the subsidence or failure of the supporting timbers. This can be identified by areas of water ponding away from the rainwater outlets or by soft spongy areas where the gutter or roof deflects noticeably underfoot. The timber boards may have deteriorated due to an ongoing problem with the supporting substructure, or a badly functioning rainwater outlet causing water to back up and to overflow the lead linings. In these instances the design of the leadwork may not need altering, but the sheets or gutter linings will have to be lifted where necessary to allow repair below. The reuse of the old metal sheeting may be possible, but frequently the lead in the damaged area will need replacing. Where the problem has been attributed to a blocked outlet, the rainwater disposal system should be investigated, as it may need repair or local redesign. The fitting of an overflow pipe should be considered, as this will give a warning if future blockages occur.

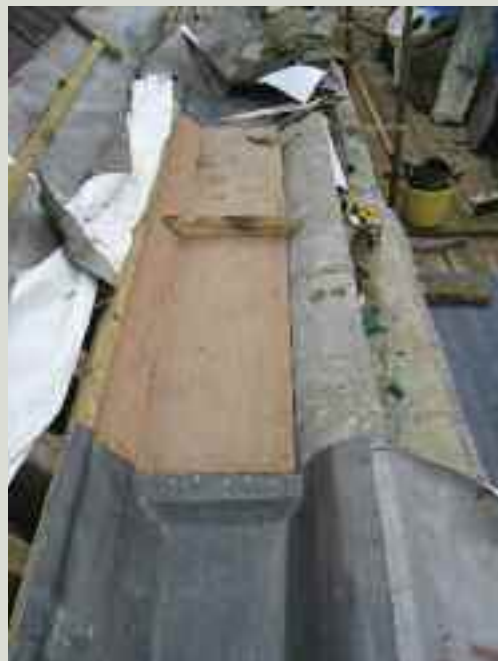
The design of this parapet gutter has been revised to achieve correct lead sheet lengths, falls and step heights in order to ensure that the newly-laid gutter will achieve a good lifespan. Note that the lead sheets have been fixed at the top end only (to allow for expansion and contraction), using copper nails in a staggered pattern

Falls to lead-lined gutters and flat roofs should not be less than 1:80. This amounts to a minimum drop of 25mm over 2 metres. Drip heights (the steps at joints in sheets down the slope) should be a minimum of 60mm for historic buildings. Where sheets need to be joined across the width or fall of a gutter or roof, then wood-cored rolls should be used. On pitched roofs and wall cladding, hollow rolls, welts or standing seams can be used. New leadwork requires coating with a

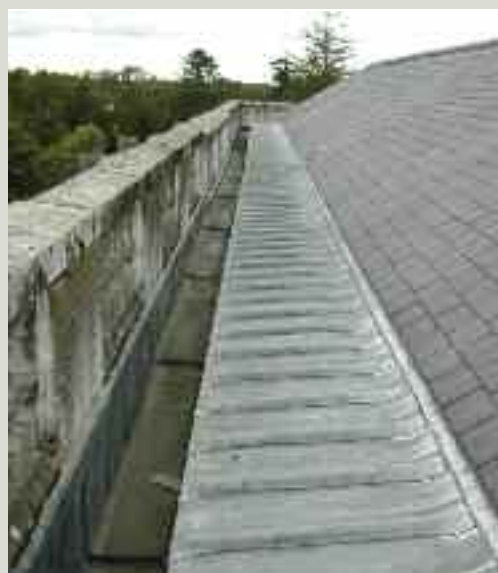
Welts to lead flashing to the vertical face of the parapet wall. Note the steps in the lead gutter and the rolls in the lead apron on the lower portion of the roof slope

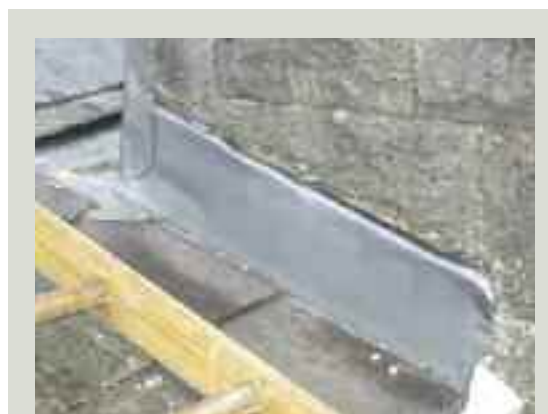
New lead flashing over lead soakers, turned into a mortar joint in the stonework at the base of a chimneystack and fixed using lead welts. The mortar joint is yet to be repointed

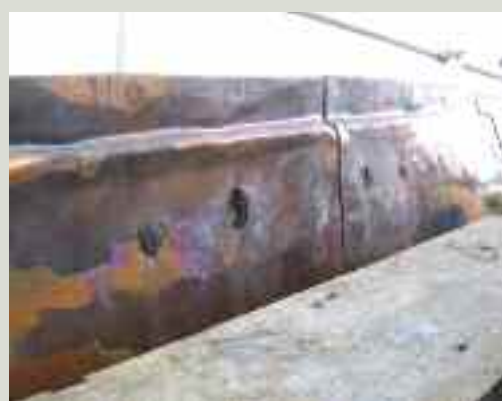
This copper parapet gutter lining has been lifted for inspection following water penetration problems. The bright salmon-coloured areas indicate that corrosion is occurring. Holes in the copper had been previously filled with a bitumen product in an earlier repair attempt which has exacerbated the problem, as bitumen corrodes copper

The flow of acidic water over a small area of copper, often called 'erosion corrosion,' occurs when large volumes of rain water run off an inert material such as slate or tile onto a specific point on a copper roof or copper-lined gutter. Bright salmon-pink areas on the copper indicate that corrosion is occurring. Newly laid copper sheet may deteriorate before it can develop a

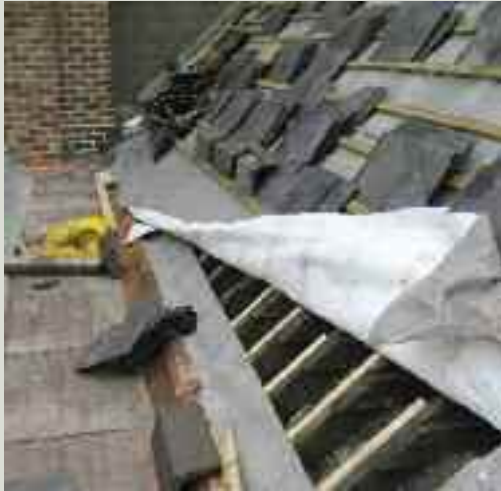
Re-lining a valley gutter in copper. Splice repairs were required to the ends of rafters where the previous valley had leaked over a significant length of time, causing decay of the timber structural elements below

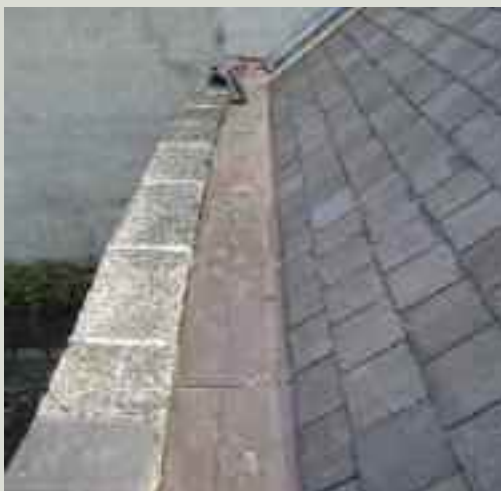
Parapet gutter re-lined in copper. The very shallow falls to this gutter precluded the use of lead

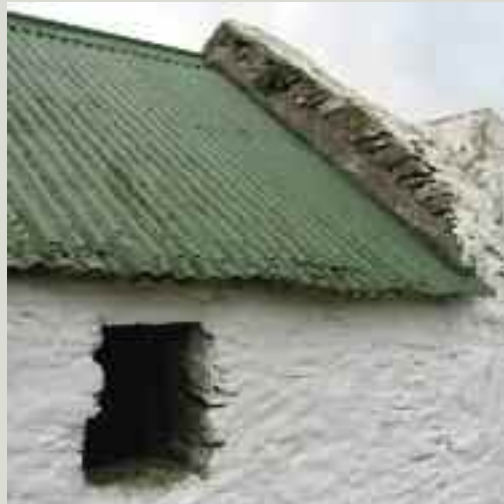
The eaves edge of corrugated-iron sheeting is particularly vulnerable to corrosion. Here, additional layers have been inserted under the eaves

Damage to sheets at eaves level can be temporarily repaired by inserting a short length under the existing sheets, allowing sufficient overhang to reach the gutter or to provide a good drip. It may also be necessary to replace a section or an entire sheet.

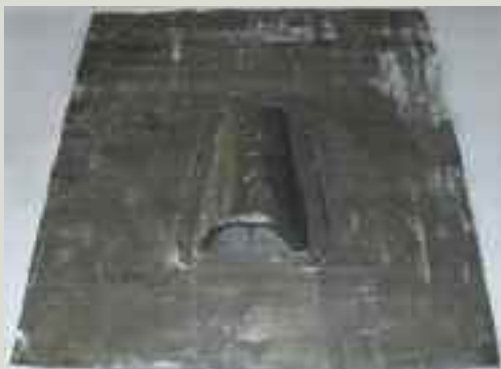
An especially formed lead vent with fly mesh, for use on a church roof. As they are quite distinctive and visible, the use of these vents on a roof where none existed previously should be discussed with the architectural conservation officer in the local authority

When a slate roof is to be stripped and re-covered, the opportunity to install insulation in the roof space should be considered. At the same time, it is necessary that a healthy level of ventilation in the roof be maintained to ensure that roof timbers remain in good condition. A proprietary ventilation system may need to be introduced to augment ventilation levels. There are many ventilation products on the market that are suitable for conservation work. It is important to carefully select the appropriate product, such as a flush vent slate or partially concealed eaves or ridge vent, which does not detract from the external appearance of the finished roof.
